AIRCRAFT ACCIDENT REPORT

MCDONNELL-DOUGLAS DC-9-31, N8967E

**AKRON-CANTON REGIONAL AIRPORT,
NORTH CANTON, OHIO**

REPORT NUMBER: NTSB-AAR-74-12

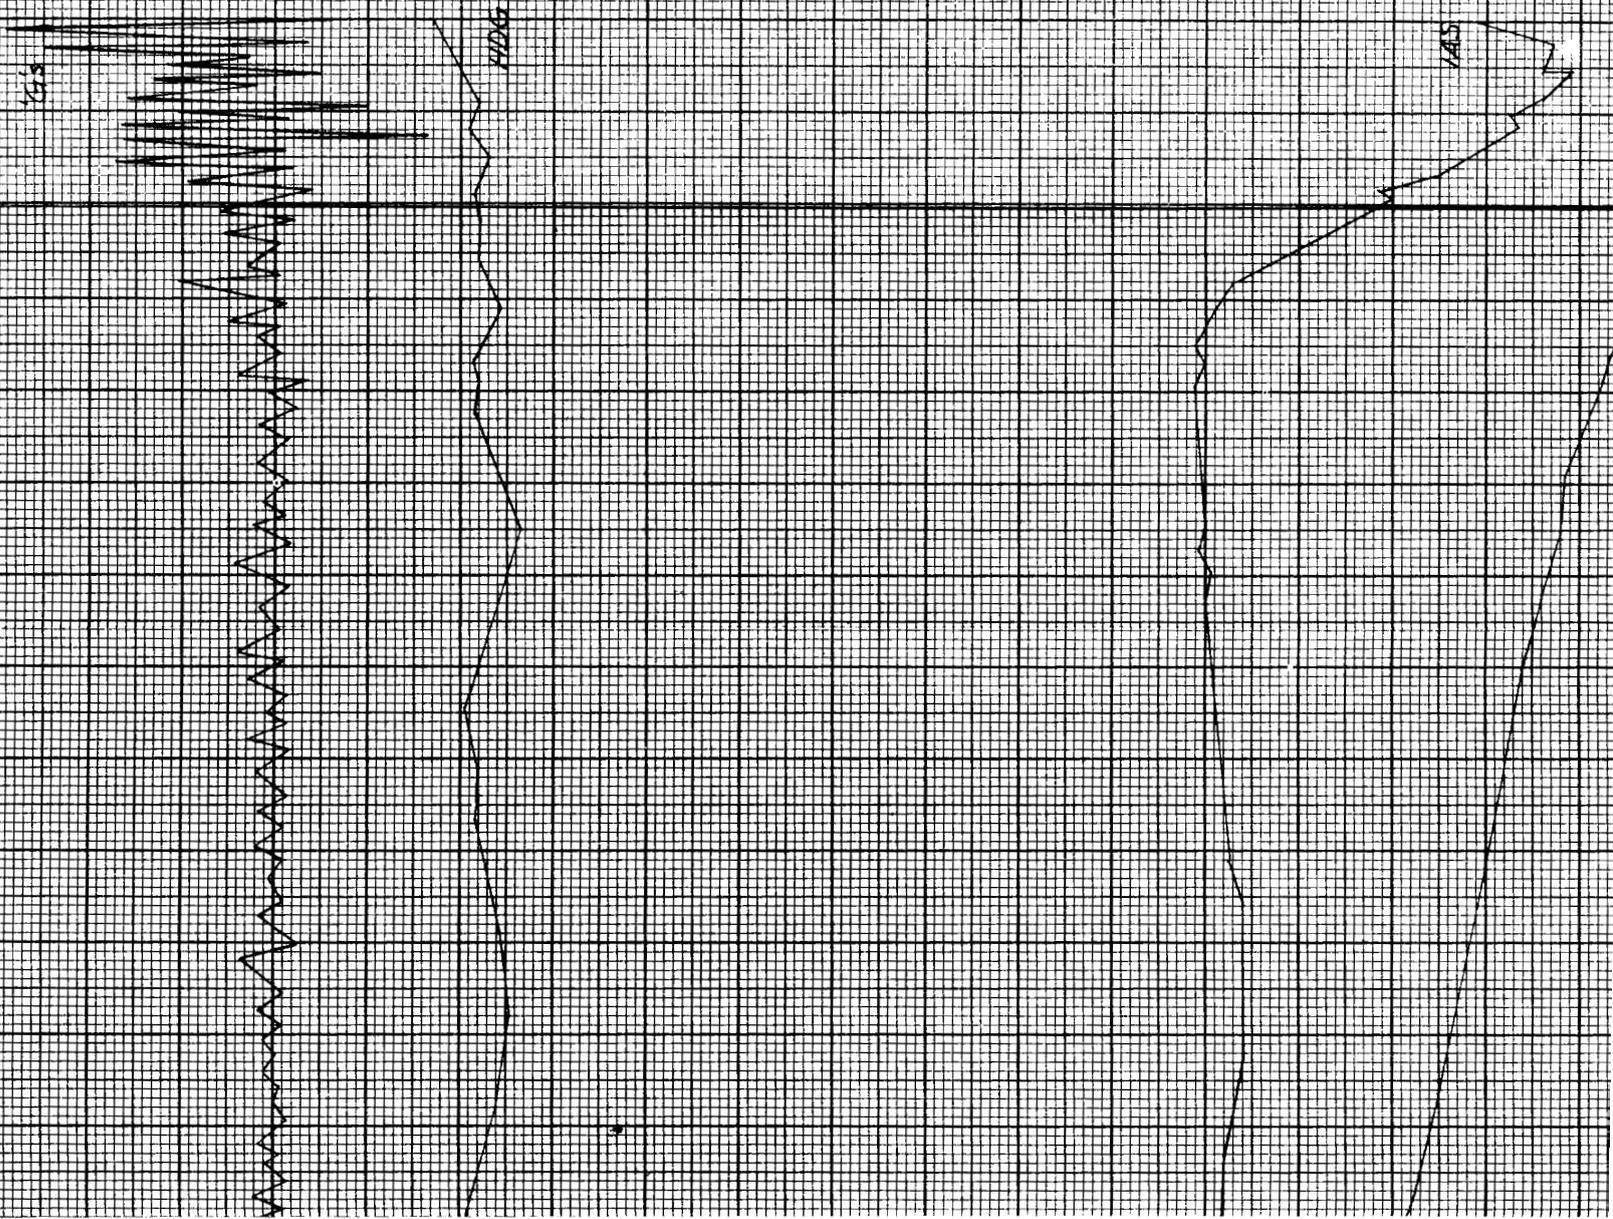
APPENDIX D

NATIONAL TRANSPORTATION SAFETY BOARD
 BUREAU OF AVIATION SAFETY
 WASHINGTON, D. C.
 EASTERN AIR LINES, BOEING 707-320C
 CANTON AIRPORT, AKRON, OHIO
 NOVEMBER 27, 1973
 LANDING ACCIDENT
 FLIGHT DATA RECORDER GRAPH
 PARACHILD MODEL T-5824, SN 1218
