AIRCRAFT ACCIDENT REPORT

PAN AMERICAN WORLD AIRWAYS, INC.

BOEING 707-321C, N458PA,

NOVEMBER 3, 1973

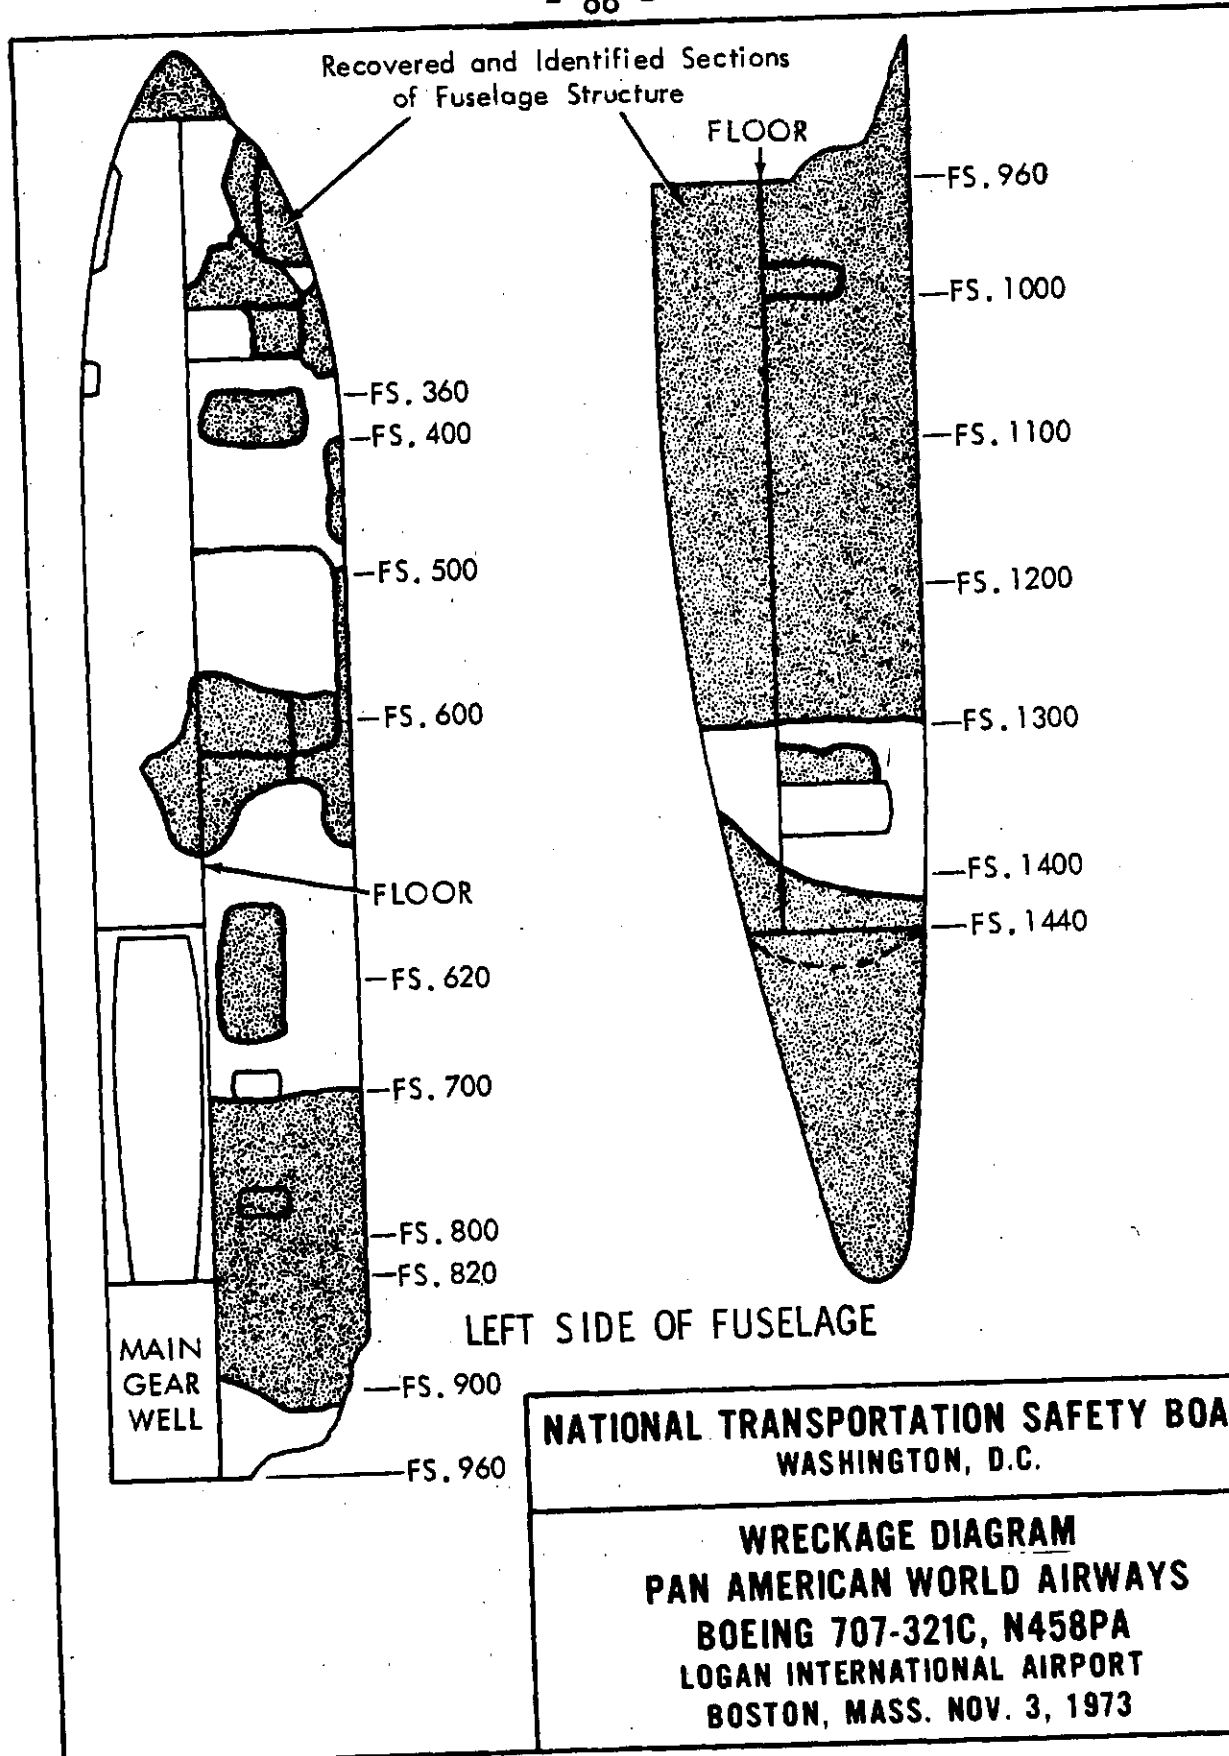
WRECKAGE DIAGRAM
PAN AMERICAN WORLD AIRWAYS
BOEING 707-321C, N458PA
LOGAN INTERNATIONAL AIRPORT
BOSTON, MASS. NOV. 3, 1973

1. NO. 2 ENGINE
2. GOUGE IN EARTH
3. CSD AND STARTER FROM NO. 2 ENGINE
4. FIRST IMPACT GOUGE IN EARTH
5. AIR CONDITIONING, HEAT EXCHANGER
6. ENGINE ACCESSORY PARTS

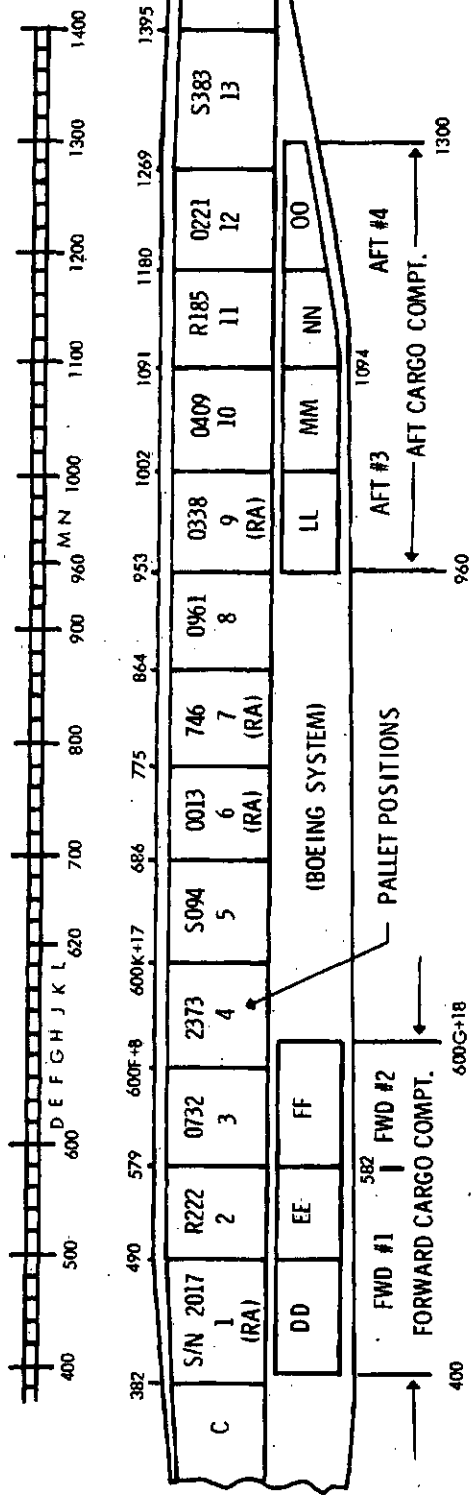
NATIONAL TRANSPORTATION SAFETY BOARD
Washington, D. C.
PALLET LOCATION CHART
PAN AMERICAN WORLD AIRWAYS
BOEING 707-321C. N458PA
LOGAN INTERNATIONAL AIRPORT
BOSTON, MASSACHUSETTS NOVEMBER 3, 1973

Preliminary indications are that on the accident aircraft some of the packages containing hazardous materials may have been placed on their sides.

Accordingly, the Safety Board recommends that the Federal Aviation Administration issue a telegraphic alert to all air carriers involved in the transportation of hazardous materials citing the dangers associated with the handling and transportation of liquid restricted articles, including the need to preclude the air shipment of any improperly labeled hazardous materials packages, and the need to comply with regulations concerning "This Side Up" or "This End Up" stencils on properly labeled hazardous materials packages, to prevent spillage from improperly oriented packages.
