1. Report No. NTSB-AAR-76-9		2. Government Accession No.		3. Recipient's Catalog No.	
4. Title and Subtitle Aircraft Accident Report - Aerotransportes Entre Rios S.R.L. Canadair CL-44-6, LV-JSY, Miami International Airport, Miami, Florida, September 27, 1975				5. Report Date March 10, 1976

AIRCRAFT ACCIDENT REPORT

AEROTRANSPORTES ENTRE RIOS S.R.L.  
CANADAIR CL-44-6, LV-JSY  
MIAMI INTERNATIONAL AIRPORT  
MIAMI, FLORIDA  
SEPTEMBER 27, 1975

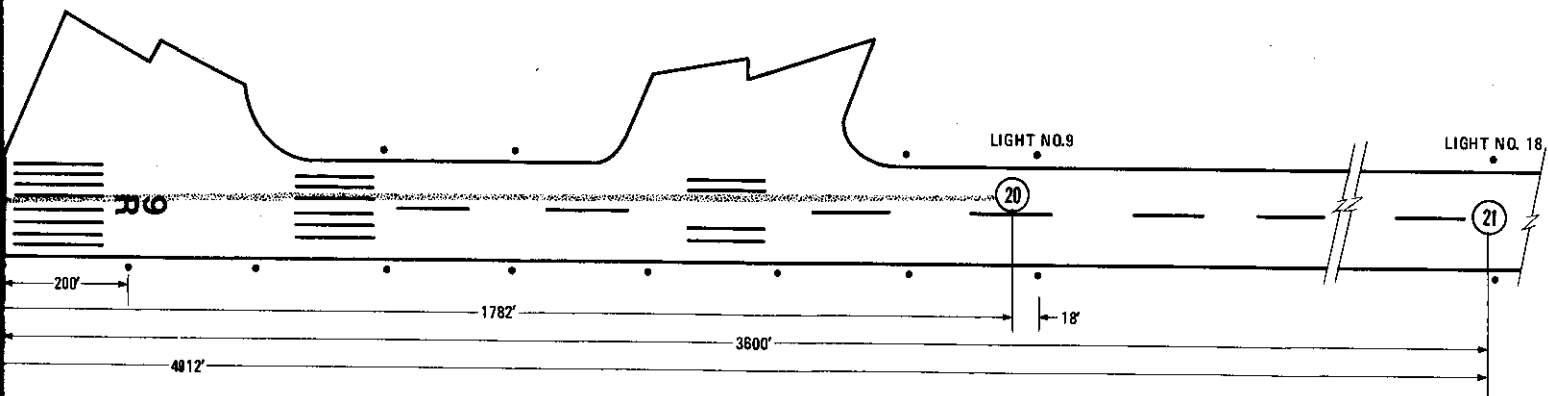
- EMPELLAGE WRECKAGE
- N. 3 PROPELLER ASSEMBLY
- N. 3 PROPELLER SPINNER
- RIGHT GEAR TIRE MARKS
- LEFT GEAR TIRE MARKS IN DIRT
- GOUGE IN ROAD
- GOUGE MARKS IN EMBANKMENT
- SECTION OF ILS PLATFORM
- SCATTERED PIECES OF ILS PLATFORM
- PIECES OF PROPELLER BLADE
- TWIN RIGHT GEAR TIRE MARKS, N. 9 LIGHT
- EAST OF 9R THRESHOLD.
- PIECES OF NOSE GEAR TIRE TREAD. N. 18
- LIGHT EAST OF 9R THRESHOLD
