1. Report No. NTSB-AAR-77-10	2. Government Accession No.	3. Recipient's Catalog No.	
4. Title and Subtitle Aircraft Accident Report Texas International Airlines, Inc., Douglas DC-9-14, N9104, Stapleton International Airport, Denver, Colorado, November 16, 1976		5. Report Date October 27, 1977	6. Performing Organization Code

AIRCRAFT ACCIDENT REPORT

TEXAS INTERNATIONAL AIRLINES, INC.  
DOUGLAS DC-9-14, N9104  
STAPLETON INTERNATIONAL AIRPORT  
DENVER, COLORADO  
NOVEMBER 16, 1976

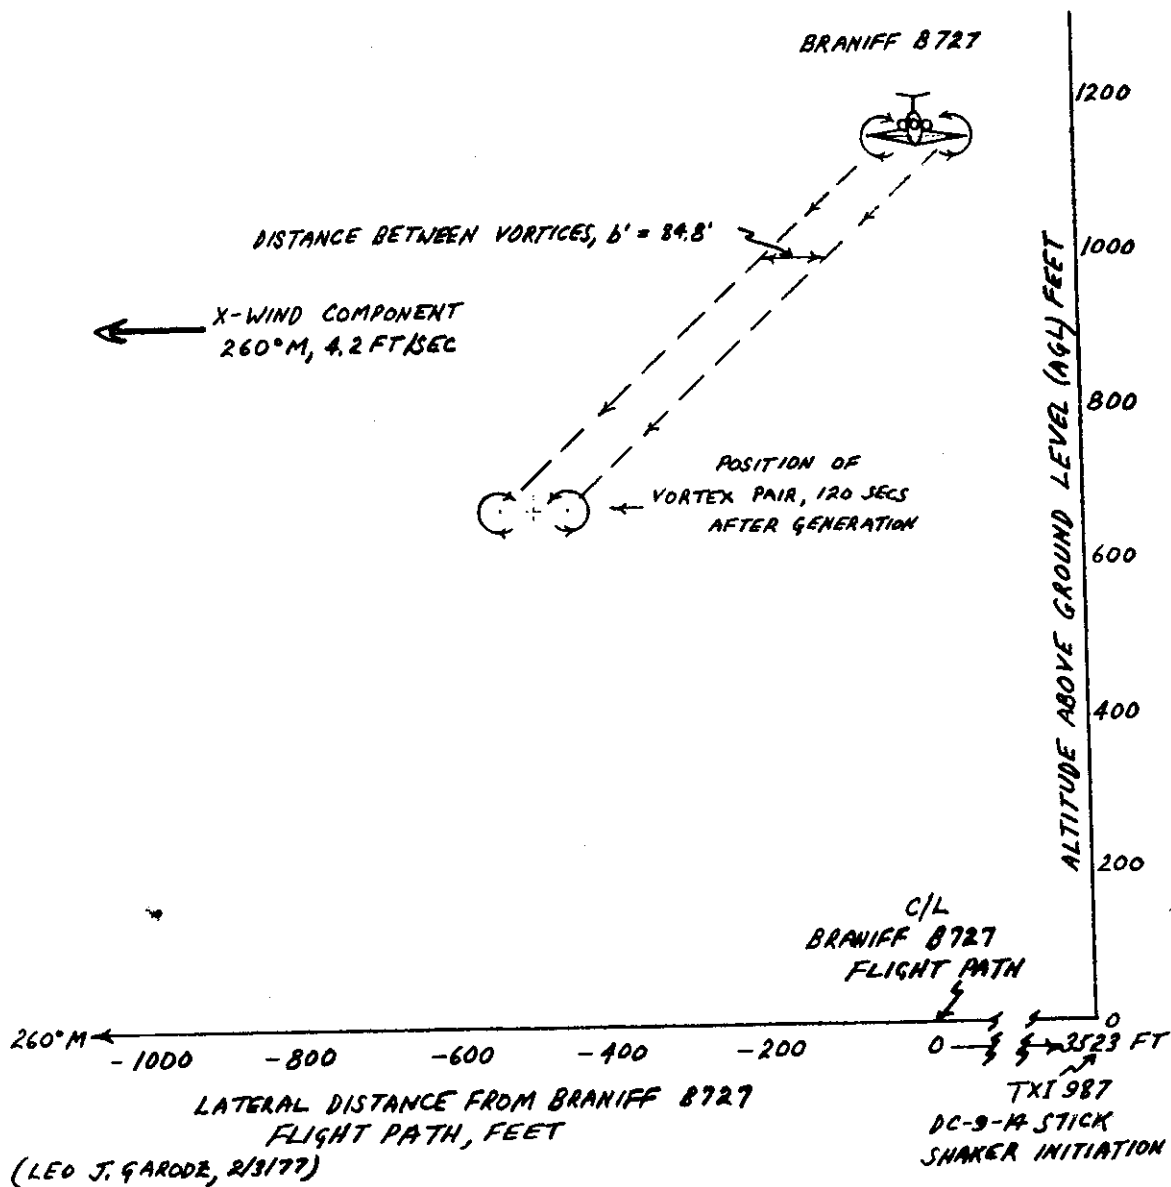
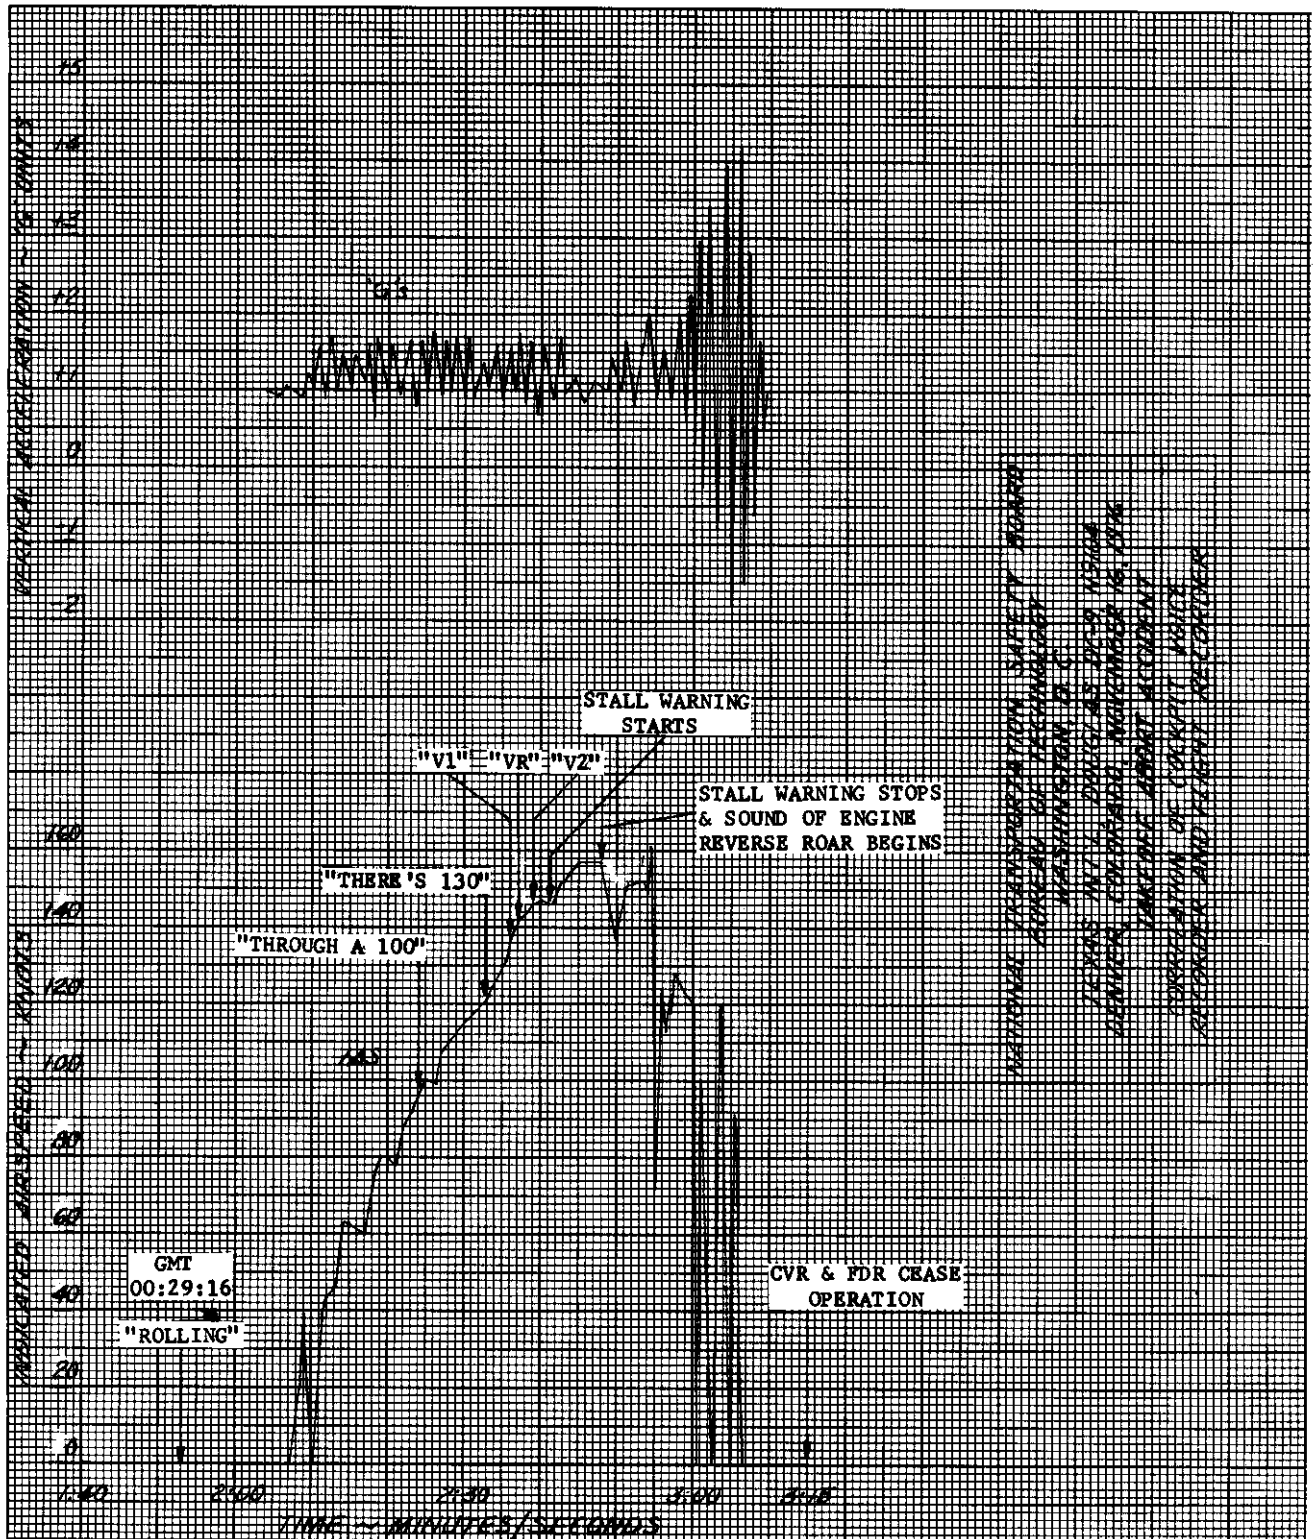
FIGURE 1  
 BRANIFF FLIGHT 928 - B727-100 - VORTEX TRAJECTORY - NOV 16, 1976  
 RELATED TO RWY 8R-26L, COMMON FLIGHT PATH POINT  
 B727 & TXI DC 9-14 (B727 PROJECTED TO GROUND)  
 STAPLETON INT'L AIRPORT

Summary: The probability is extremely low that the Braniff B-727 vortices could have impinged upon the Texas International DC-9 because: (1) based on the best available **data** to date, it has been found that the B-727 vortices persist at lower altitudes for less than 120 seconds which is less than the separation time between the flight path intersection for the two aircraft; (2) even if they did, for whatever reason. it is extremely unlikely that they would have descended to the level of the DC-9 airplane taking off or create a problem; and (3) regardless of the separation time interval between the two aircraft, assuming valid assumptions on wind speed and direction from the B-727's flight altitude to the surface, the B-727 vortices are drifting downwind of the projected flight path intersection of the two airplanes which is another 3,523 feet downwind of the DC-9 stick shaker initiation position.

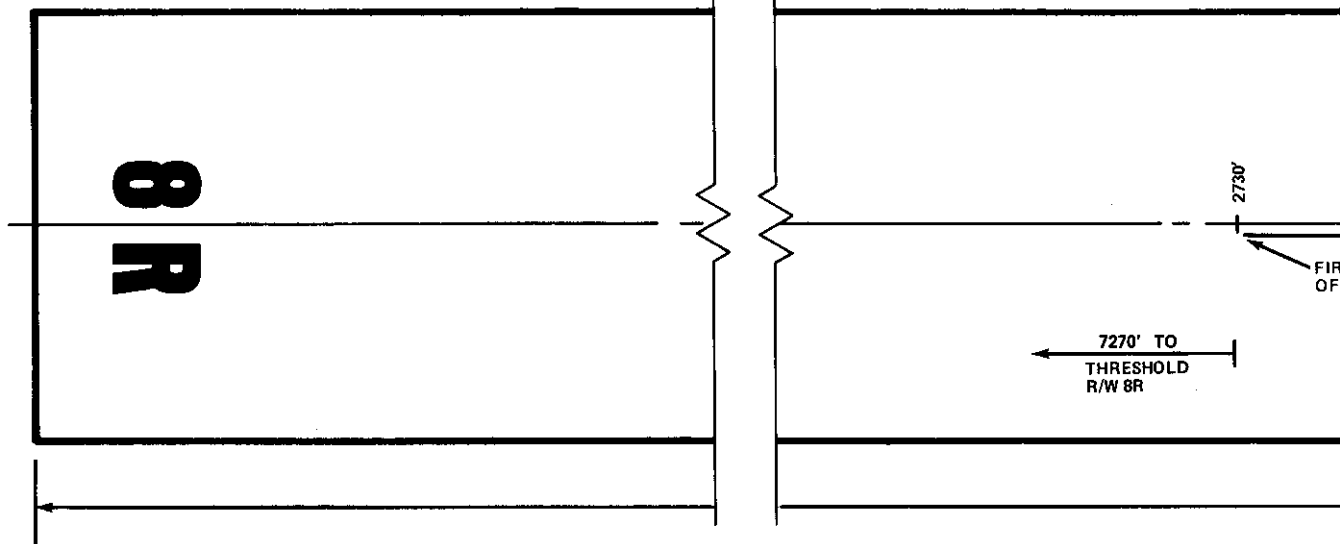
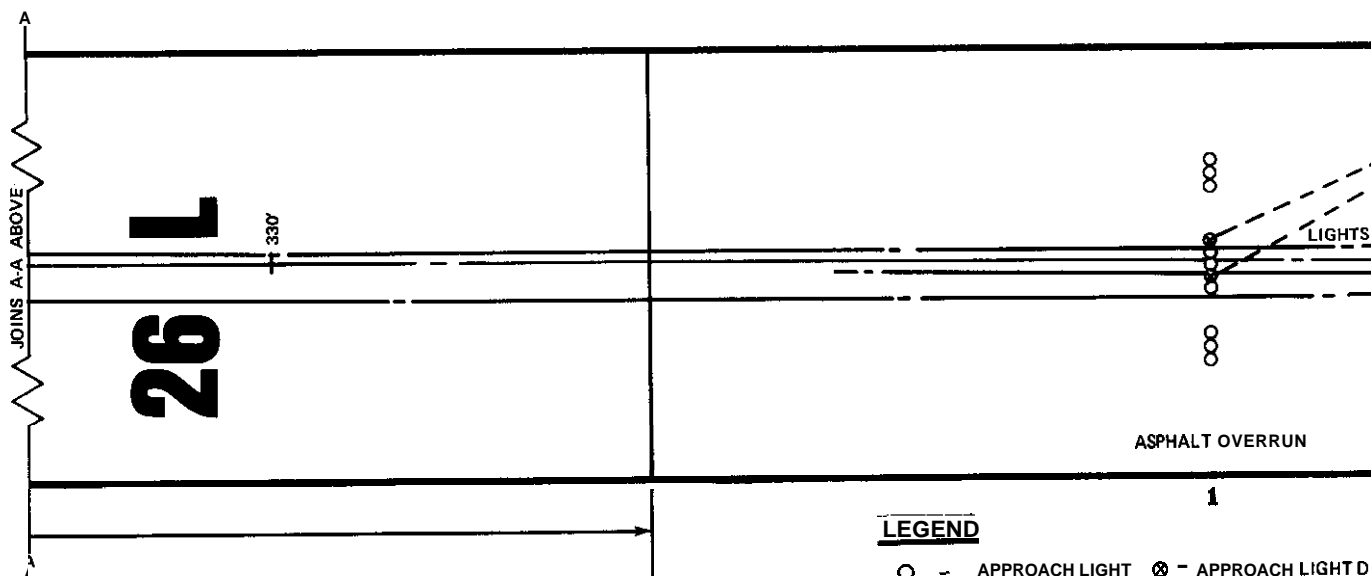
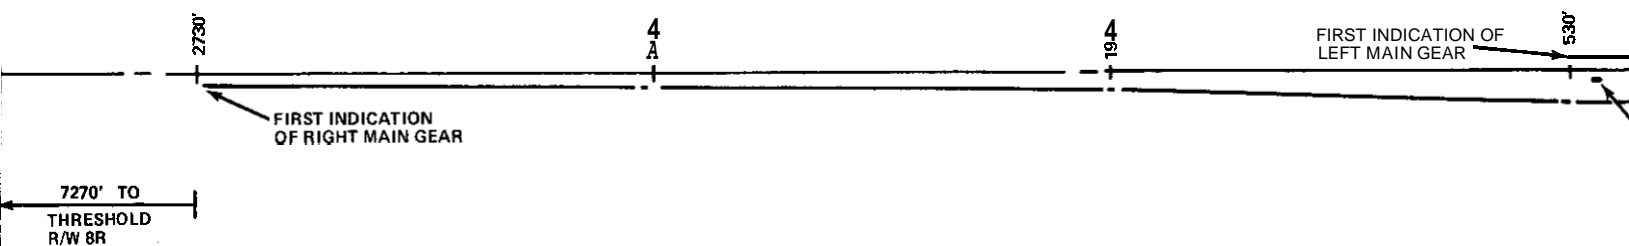
- - APPROACH LIGHT    ⊗ - APPROACH LIGHT DI
- R-1 - SPRAY DEFLECTOR LEFT MAIN GEAR
- R-2 - TIRE TREAD (13" x 4" FULL DEPTH)
- R-3 - LEFT MAIN LANDING GEAR DOOR
- R-4 - TIRE TREAD (14" x 6" FULL DEPTH)
- R-5 - NOSE GEAR DOOR
- R-5A - LEFT LANDING GEAR BOLT
- R-6 - LEFT WING FILLET
- R-7 - TIRE TREAD (9" x 6" FULL DEPTH)
- R-8 - TAIL CONE
