1. Report No. NTSB-AAR-78-14	2. Government Accession No.	3. Recipient's Catalog No.	
4. Title and Subtitle Aircraft Accident Report - Midair Collision Involving a Falcon Jet, N121GW and a Cessna 150M, N6423K, Memphis, Tennessee, May 18, 1978		5. Report Date November 30, 1978

AIRCRAFT ACCIDENT REPORT

MIDAIR COLLISION  
FALCON JET DA-20, N121GW  
AND  
CESSNA 150M, N6423K  
MEMPHIS, TENNESSEE  
MAY 18, 1978

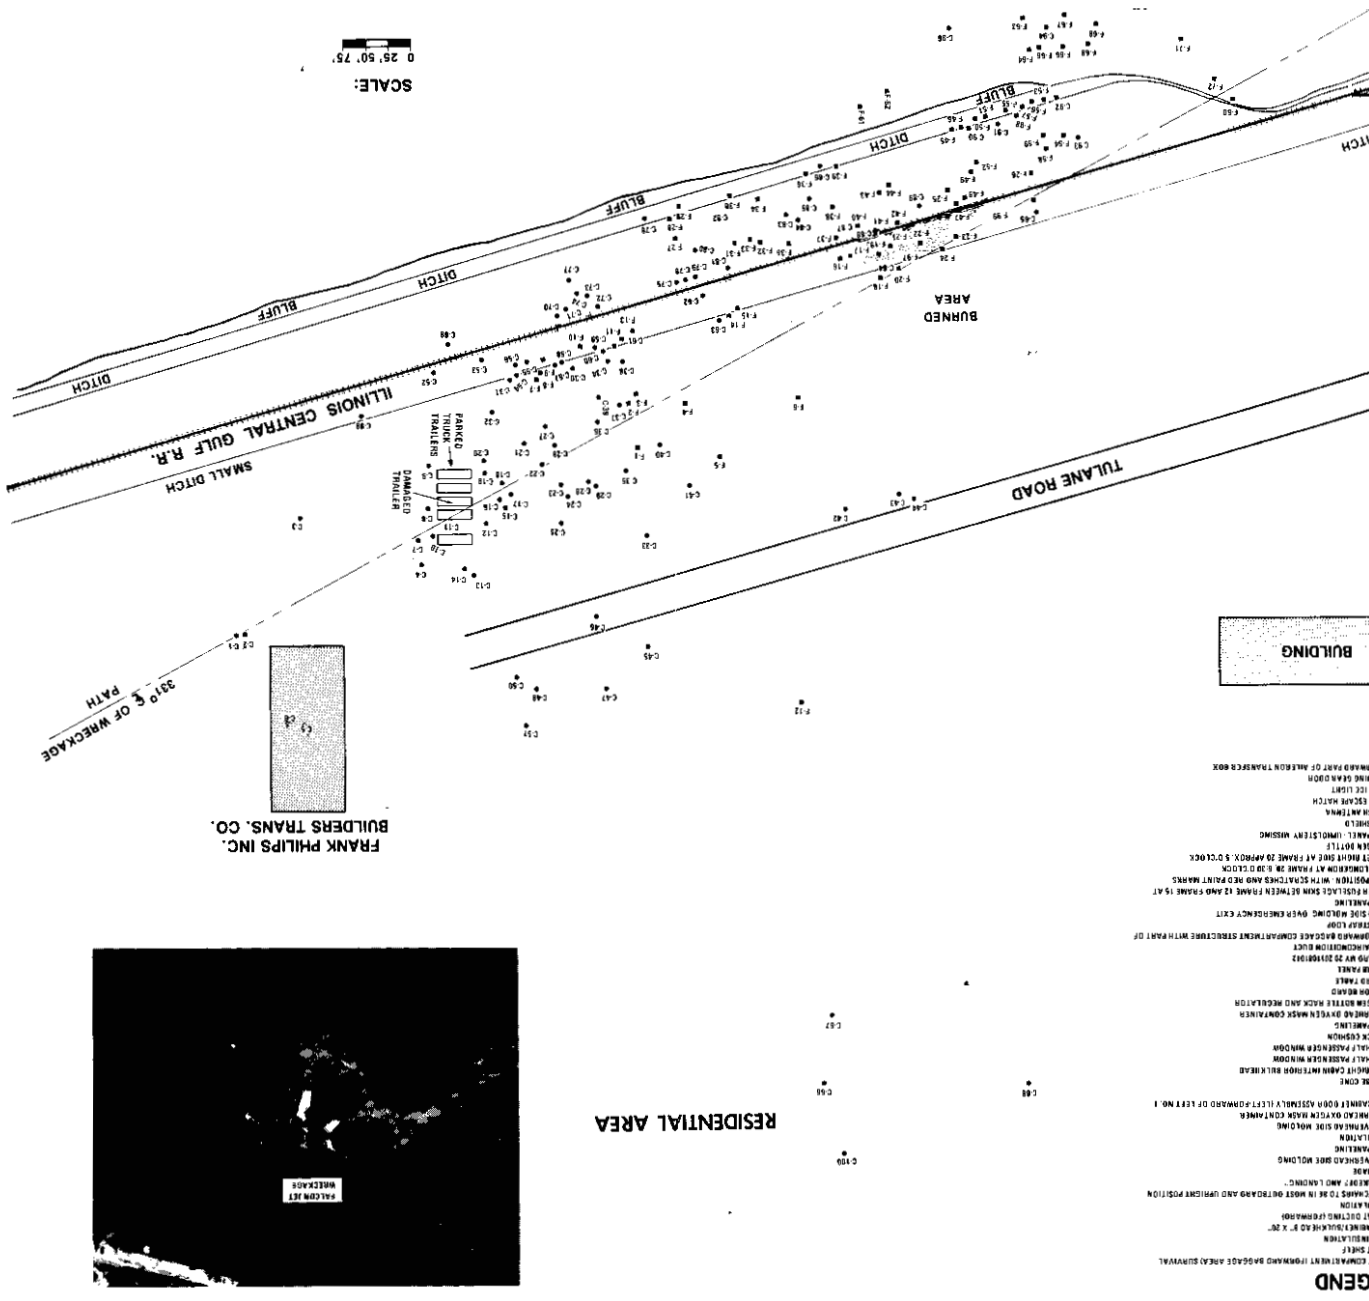
**NATIONAL TRANSPORTATION SAFETY BOARD**  
 WASHINGTON, D.C.  
 WRECKAGE DISTRIBUTION CHART  
 MIDAIR COLLISION  
 FLIGHT SAFETY INTERNATIONAL, FALCON JET,  
 N121GW AND MEMPHIS FLYING CLUB,  
 CESSNA 150M, N6423K

The Cessna 150 fragmented before ground impact. The right wing, which separated from the fuselage, exhibited a concaved leading edge just outboard of the right wing fuel tank. Blue paint scuff marks were noted at various locations on this wing leading edge.

The left wing leading edge, from the wing/fuselage root fairing outboard to rib 5, was broken into pieces of various sizes. Extensive red paint scuff marks were found on the lower skin surface. The red scuff marks extended outboard at 90° from the wing root rib for a distance of 69 inches. The scuff marks extended from the leading edge lower surface aft to the forward edge of the skin panel just forward of the rear spar. The red scuff marks were measured near the leading edge and near the wing root rib. This angle measured 27° from the wing root rib direction. The scuff mark angles after the initial impact point showed varied inconsistent angles.
