1. Report No. NTSB-AAR-78-15		2. Government Accession No.		3. Recipient's Catalog No.	
4. Title and Subtitle Aircraft Accident Report -- Columbia Pacific Airlines, Beech 99, N199EA Richland, Washington, February 10, 1978				5. Report Date December 21, 1978

AIRCRAFT ACCIDENT REPORT

At 1650 P.s.t. on February 10, 1978, Columbia Pacific Airlines, Inc., Flight 23, a Beech 99, crashed in visual flight rules conditions on takeoff from runway 36 at the Richland Airport, Richland, Washington. Flight 23, a regularly scheduled passenger flight to Seattle, had 15 passengers and 2 crewmembers on board. After liftoff, the aircraft climbed steeply to 400 feet above the runway, then stalled and crashed 2,000 feet beyond the end of the runway. A severe fire erupted after impact. All persons on board were killed, and the aircraft was destroyed.

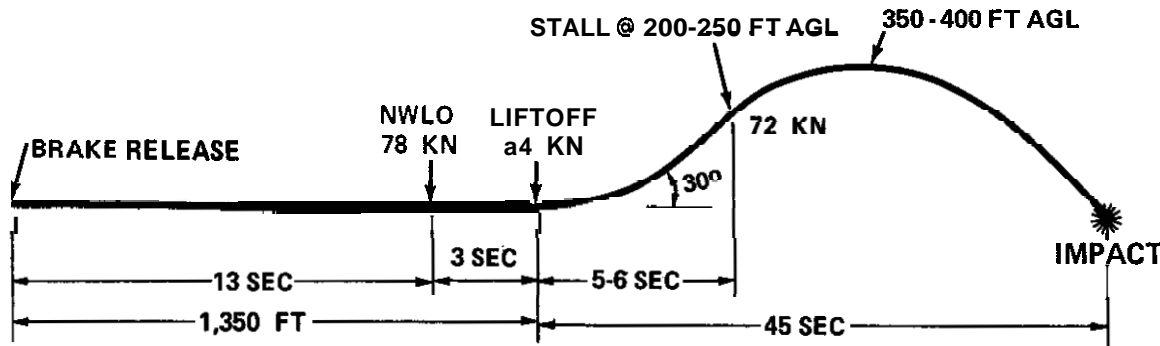
Figure 9. Flight profile of N199EA.

The flight profile of N199EA based on witnesses' observations and confirmed by the flight tests follows:

(5) Takeoff with an extreme noseup trim was determined to be the most probable condition which, combined with a center of gravity near the aft limit; would have caused the flight profile of N199EA. The aircraft was rotated and lifted off about 10 kns earlier than normally expected; however, pilot technique could vary the point at which rotation would begin. There were no abnormally high control wheel push forces generated before liftoff to warn a pilot of mistrim. Flight tests indicated that the Beech 99 is controllable on takeoff with full noseup trim and with the center of gravity near or at the aft limit. Although the control forces are high, they are manageable and within the limits specified by Federal Aviation Regulation Part 23.143. If, through inattention or for some other reason, the pilot permits the Beech 99 to rotate to a pitch attitude of 30" or greater during a climb after takeoff and if he then does not promptly correct the aircraft attitude, a stall will occur from which recovery is essentially impossible.

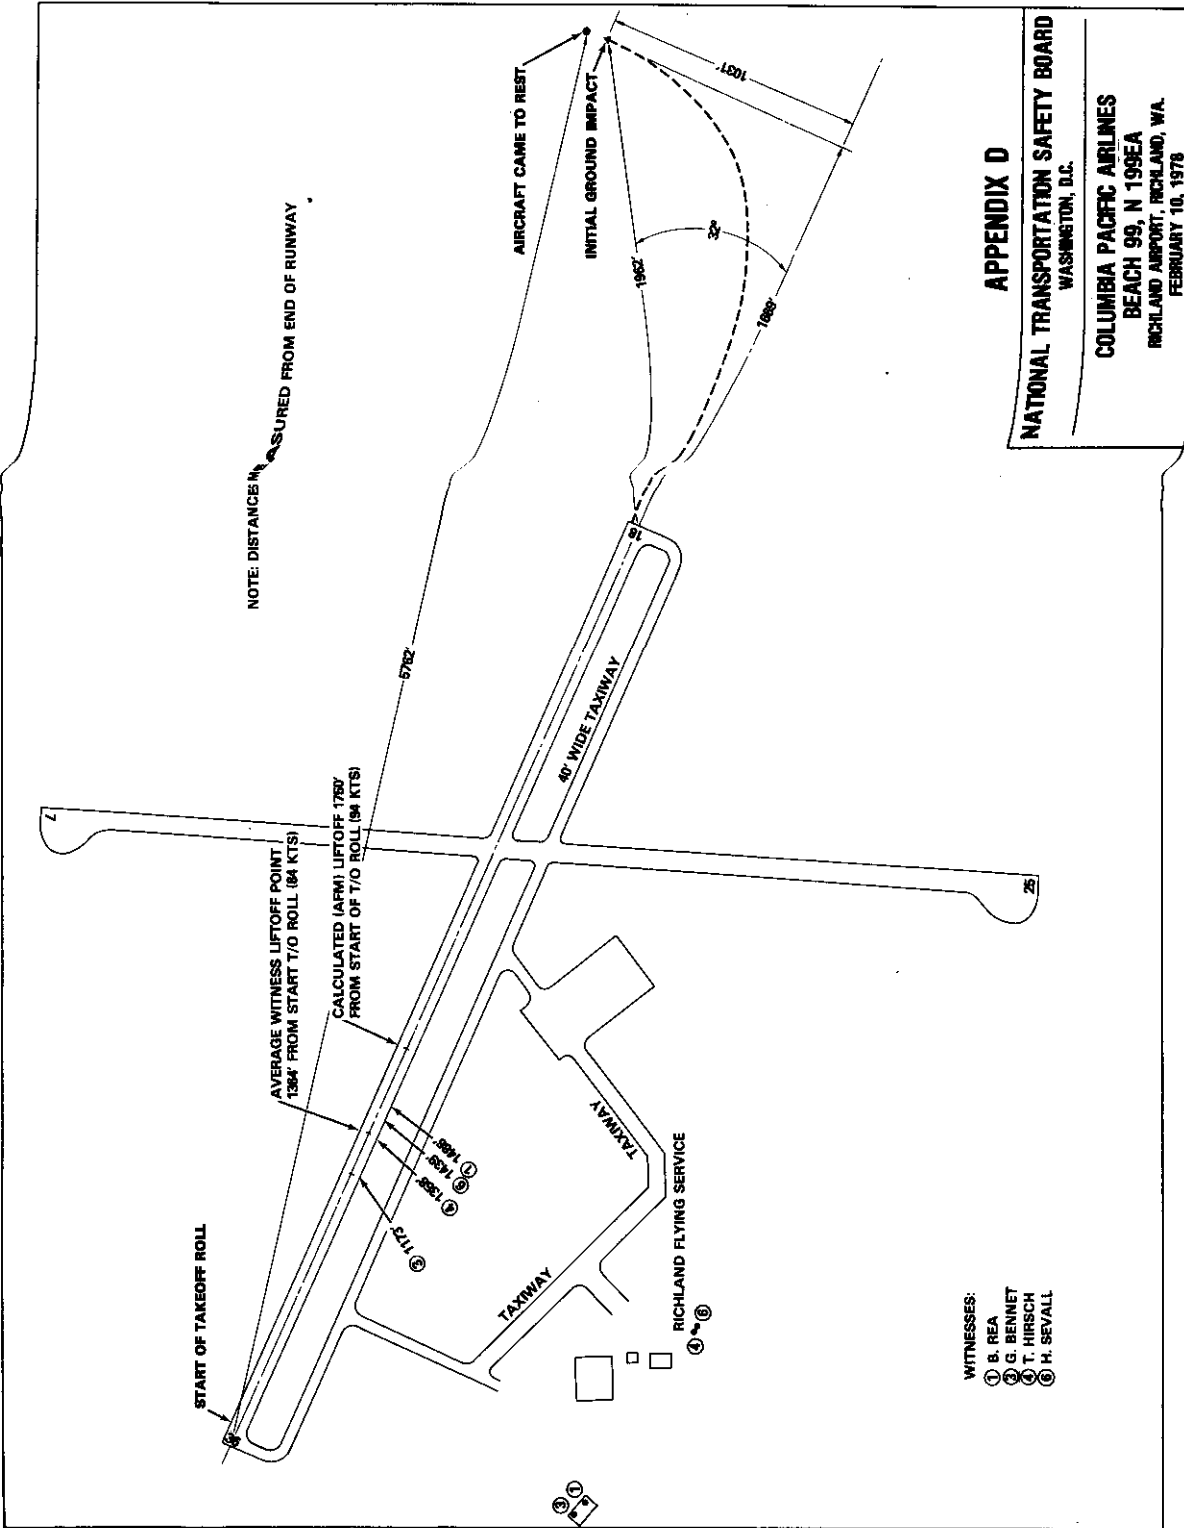
APPENDIX D

NATIONAL TRANSPORTATION SAFETY BOARD  
 WASHINGTON, D.C.  
 COLUMBIA PACIFIC AIRLINES  
 BEACH 99, N 199EA  
 RICHLAND AIRPORT, RICHLAND, WA.  
 FEBRUARY 10, 1978

- WITNESSES:  
 ① B. REA  
 ② G. BENNETT  
 ③ T. HIRSCH  
 ④ H. SEVALL

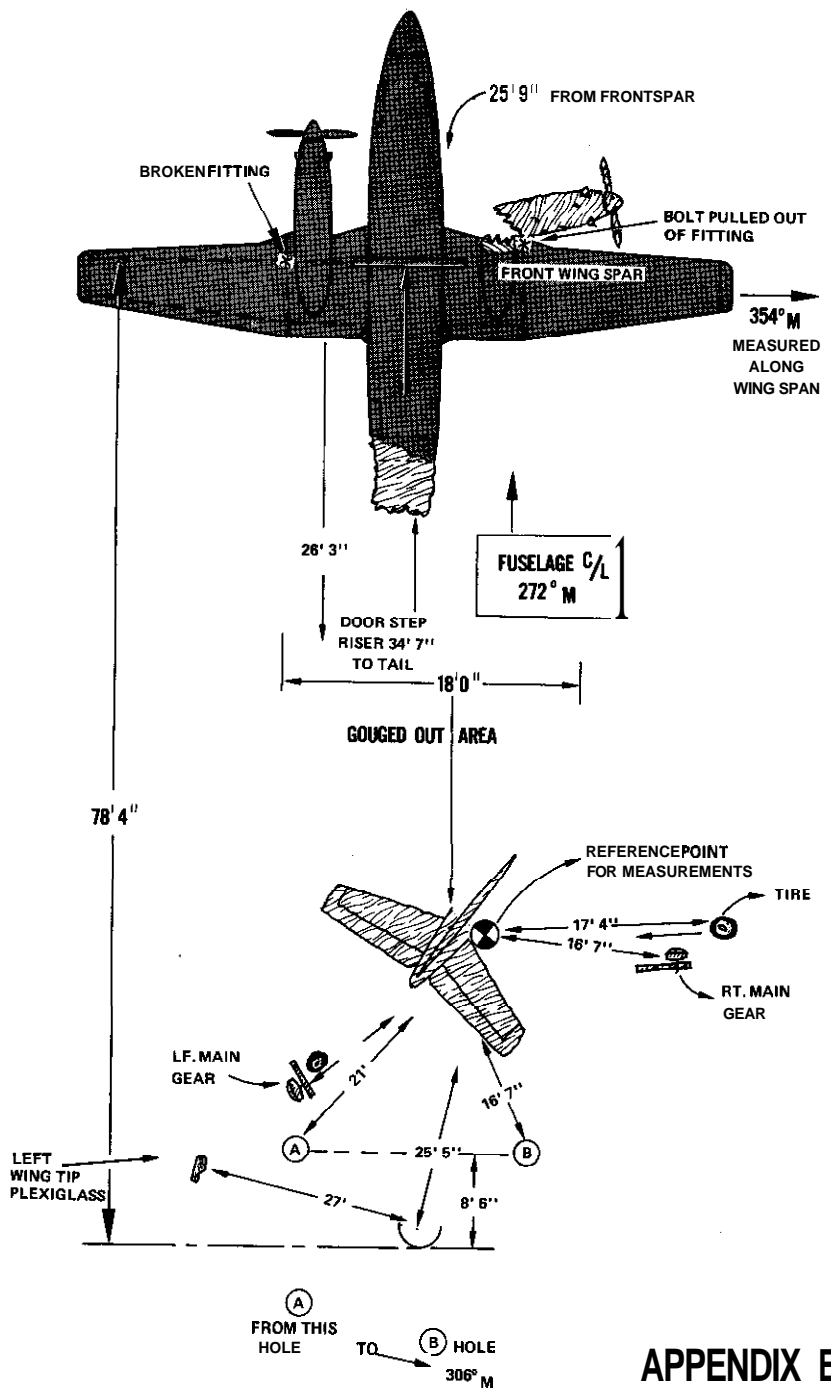
### APPENDIX E

NATIONAL TRANSPORTATION SAFETY BOARD  
Washington, D.C. 20594  
WRECKAGE DISTRIBUTION CHART  
COLUMBIA PACIFIC AIRLINES  
BEECH MODEL 99, N 199 EA  
Richland Washington Airport  
Richland, Washington  
February 11, 1978
