# NATIONAL TRANSPORTATION SAFETY BOARD

## ERRATA

AIRCRAFT ACCIDENT REPORT - North Central Airlines, Inc.  
Convair 580, N4825C, Kalamazoo Municipal Airport,  
Kalamazoo, Michigan, July 25, 1978, Report Number -  
NTSB-AAR-79-4

AIRCRAFT ACCIDENT REPORT

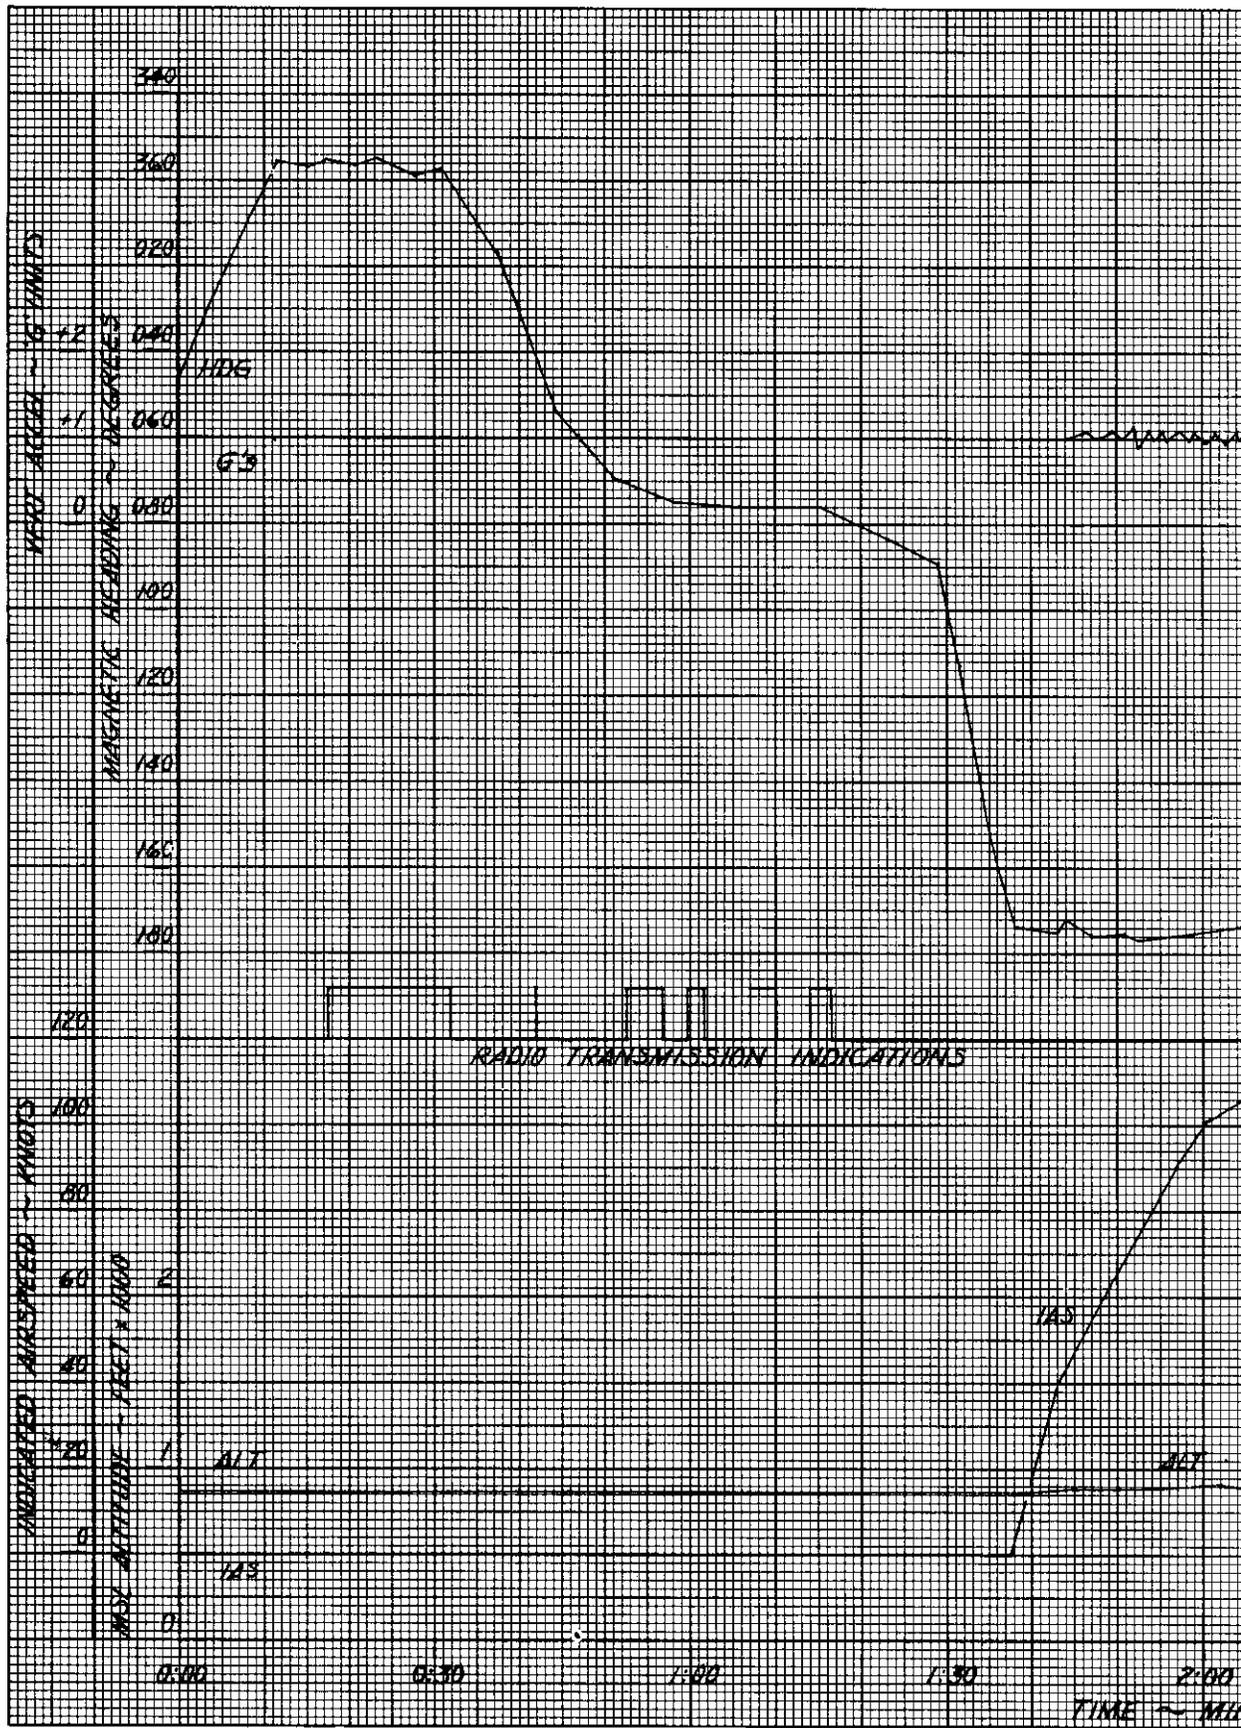
NATIONAL TRANSPORTATION SAFETY BOARD  
 BUREAU OF TECHNOLOGY  
 WASHINGTON, D.C.  
 MARTHA CENTRAL AIRLINES, CF 580, NABEPC  
 WASHINGTON, D.C., JULY 25, 1978  
 CRASH LANDING  
 FLIGHT DATA RECORDER GRAPH  
 SOUNDING OF 201 511-212
