TECHN.	LCAL REPORT DOCUMENTATION PAGE
Report No.	2.Government Accession No.	3.Recipient's Catalog No.
 Fille and Subtitle PRINAIR deHavilland H N575PR, Alexander Han St. Croix, US. Virgin Isl 	Aircraft Accident Report— eron, DH-114, nilton Airport, Christiansted, and, July 24, 1979	5.Report Date March 28, 1980 6.Performing Organization Code

NATIONAL TRANSPORTATION SAFETY BOARD WASHINGTON, D.C. 20594

Adopted: March 28, 1980

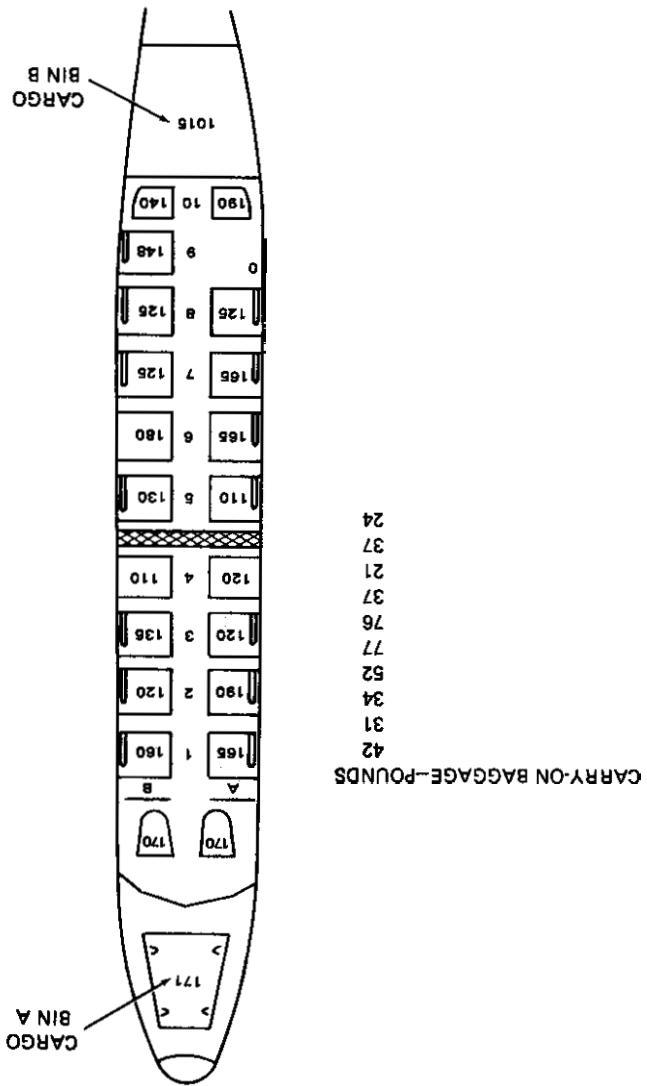
RECONSTRUCTED ACTUAL WEIGHTS

The gross weight of the aircraft at takeoff was found to be 1,060 lbs over the maximum allowable takeoff weight of 12,499 lbs, and the center of gravity was about 8 ins. beyond the maximum allowable rear limit.
