# NATIONAL TRANSPORTATION SAFETY BOARD

## AIRCRAFT INCIDENT REPORT

AEROMEXICO  
DC-10-30, XA-DUH  
OVER LUXEMBOURG, EUROPE  
NOVEMBER 11, 1979

NTSB-AAR-80-10

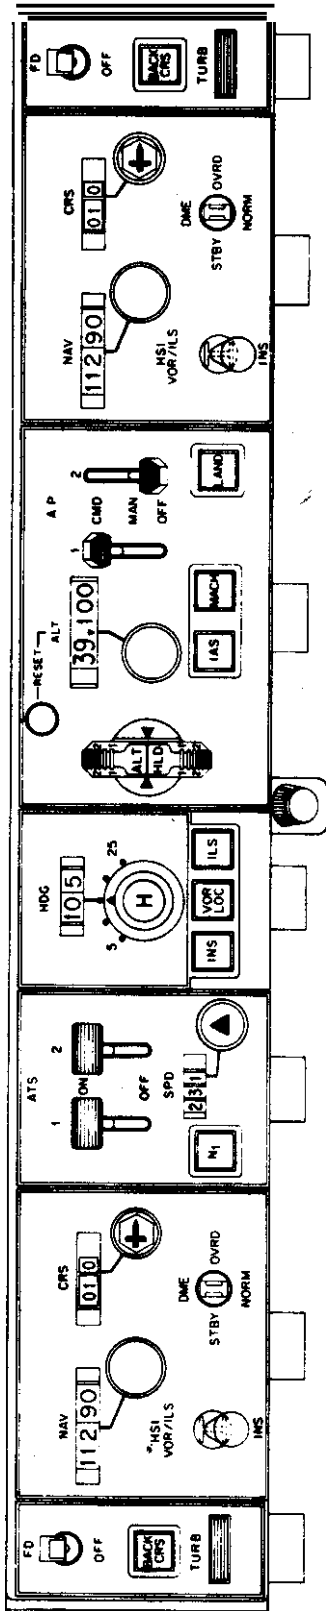
Figure 3.--Flight guidance and control system panel.

The manufacturer recommends that the autopilot "Indicated Airspeed Hold" (IAS Hold) and "Mach Hold" (MACH) modes be used primarily to climb or to descend. The IAS and MACH pushbutton switches are seen on the flight guidance and control panel below the autopilot levers in figure 3. With the autopilot in "CMD," pressing one of these switches commands the autopilot to adjust the pitch of the aircraft to maintain the airspeed or Mach existing when the switch was pressed. The pitch mode window annunciates IAS Hold or Mach Hold depending on which switch is depressed.

The vertical speed selector on the left side of the autopilot levers on the Flight Guidance and Control Panel, figure 3, is synchronized to the aircraft's vertical speed at all times except when the "Vertical Speed" (VERT SPD) or the "Altitude Hold" (ALT HOLD) mode is engaged. When the vertical speed selector is manually rotated to the altitude hold detent, the flight director pitch command bars will move correspondingly and the pitch annunciator will display "ALT HOLD." The vertical speed selector wheel functions as an indicator or as a control. If the altitude hold mode has been engaged, the vertical speed selector wheel will remain in the altitude hold detent and will command "ALT HOLD." If the vertical speed mode has been engaged (either a climb or a descent), the vertical speed selector wheel will remain in the selected position and will command a climb or a descent at the selected rate. When the "IAS Hold" or "Mach Hold" is engaged, the vertical speed selector wheel will automatically synchronize to the velocity of the aircraft.

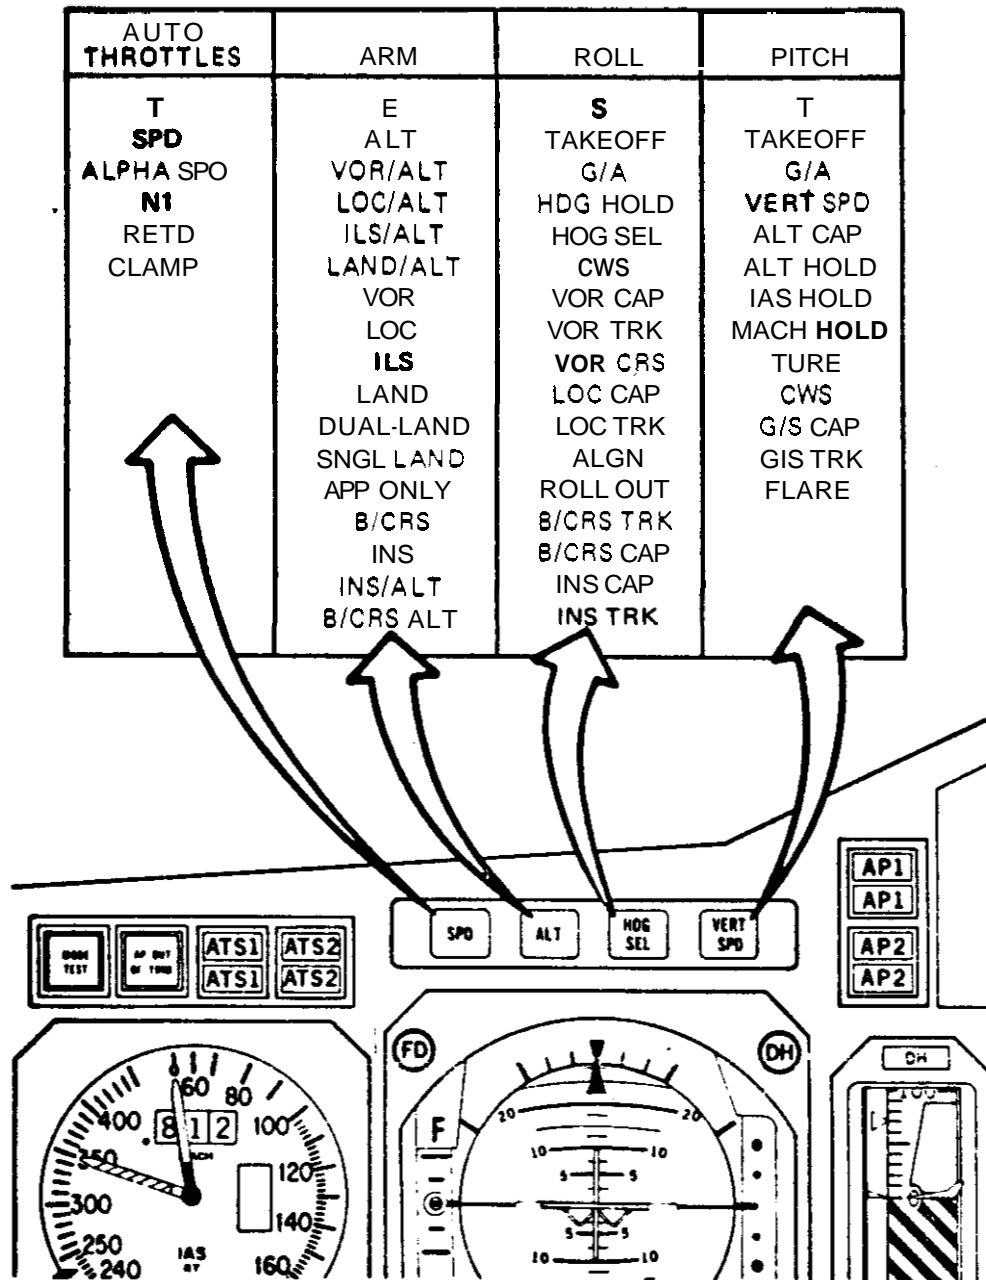
Figure 4.—Mode annunciator panel.

Some airline procedures allow an alternate use of vertical speed mode for the climb. Airspeed must be closely monitored for the vertical speed climb procedure as this FD/AP mode will try to maintain the climb rate programmed by the vertical speed wheel, regardless of airspeed or Mach. The autopilot will automatically command the trim and elevator to maintain this rate of climb at the sacrifice of airspeed at the higher altitudes. The flight recorder data for this incident showed a constant rate of climb with continually decreasing airspeed before buffet onset and sustained aircraft stall. A speed selection in the ATS speed readout, if it is in the  $N_1$  mode, would not result in any speed control of the aircraft until the ATS speed mode was engaged. If the ATS speed mode was engaged in the climb, a mode conflict between the FD/AP IAS Hold mode would cause the autopilot to revert to the VERT SPD mode. However, both airspeed and the VERT SPD mode of the FD/AP would be conspicuously annunciated. (See figure 4.)
