AIRCRAFT ACCIDENT REPORT

RONSON AVIATION
BELL 206B, N27670 AND
SEMINOLE AIR CHARTER
PIPER PA-34-200T, N8110R
MIDAIR COLLISION
EAST RUTHERFORD, NEW JERSEY
SEPTEMBER 23, 1981

NTSB-AAR-82-6

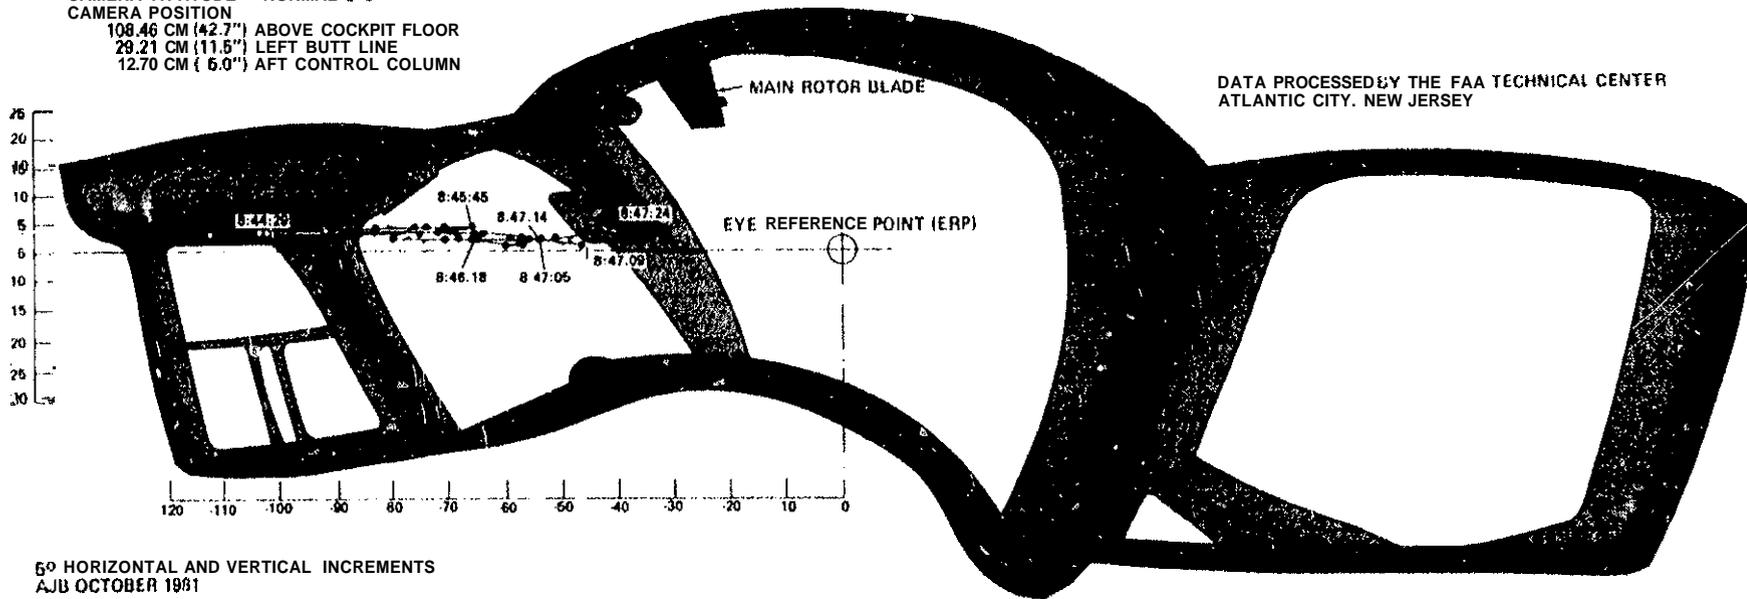
APPENDIX E

BELL 206B JET RANGER III (OH 68A)
 PILOTS ERP TO SUIT NTSB
 AIRCRAFT ATTITUDE -- RAMP LEVEL -- NOT CRUISE ATTITUDE
 CAMERA ATTITUDE -- NORMAL @ 0°
 CAMERA POSITION
 108.46 CM (42.7") ABOVE COCKPIT FLOOR
 29.21 CM (11.5") LEFT BUTT LINE
 12.70 CM (5.0") AFT CONTROL COLUMN

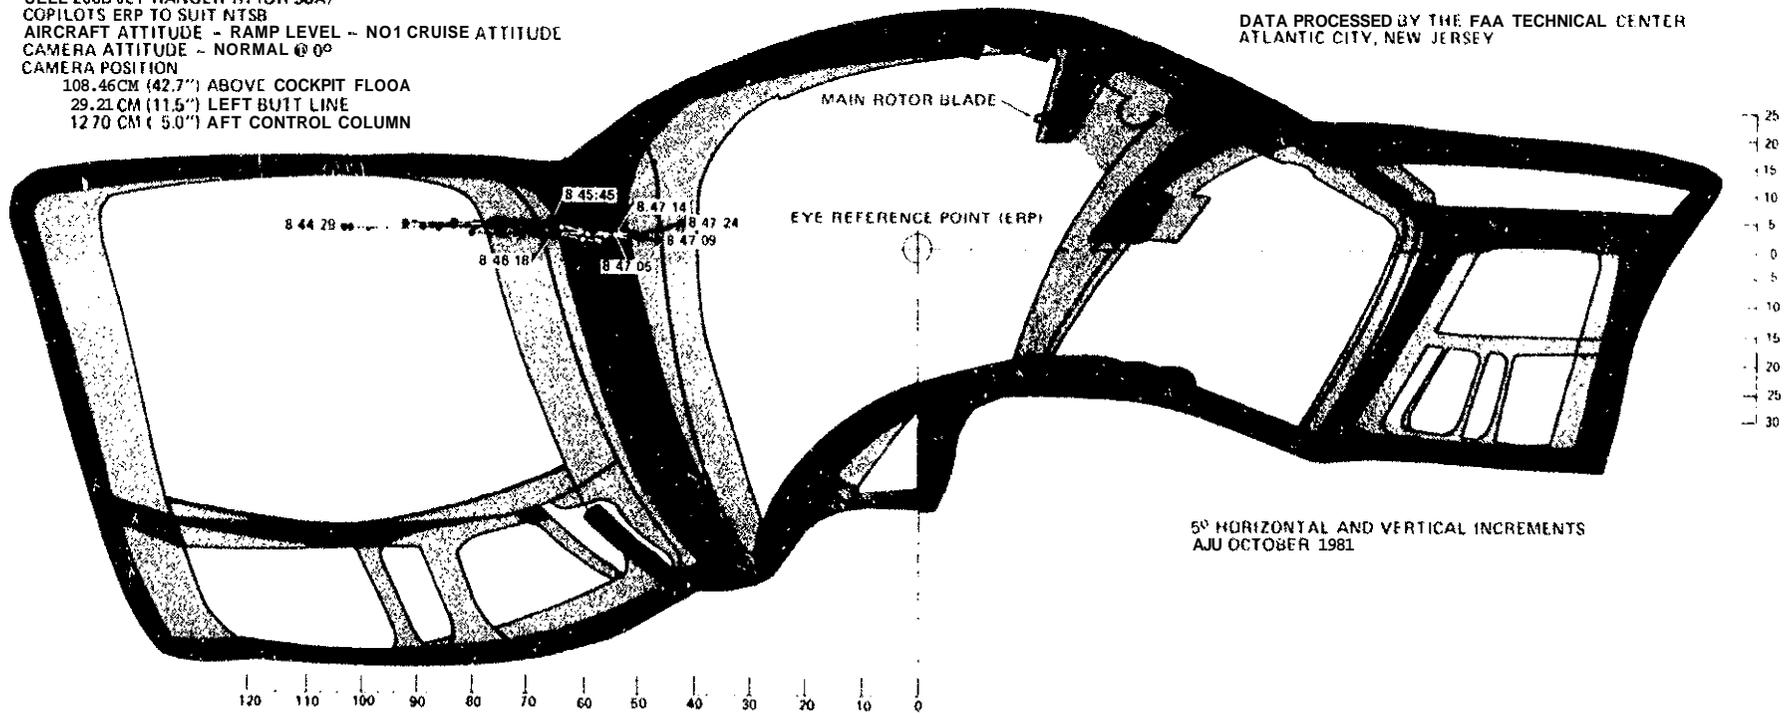
APPENDIX E

U-28B JET RANGER 1H (OH 58A)
 COPILOTS ERP TO SUIT NTSB
 AIRCRAFT ATTITUDE - RAMP LEVEL - NO1 CRUISE ATTITUDE
 CAMERA ATTITUDE - NORMAL @ 0°
 CAMERA POSITION
 108.46CM (42.7") ABOVE COCKPIT FLOOR
 29.21 CM (11.5") LEFT BUTT LINE
 12.70 CM (5.0") AFT CONTROL COLUMN

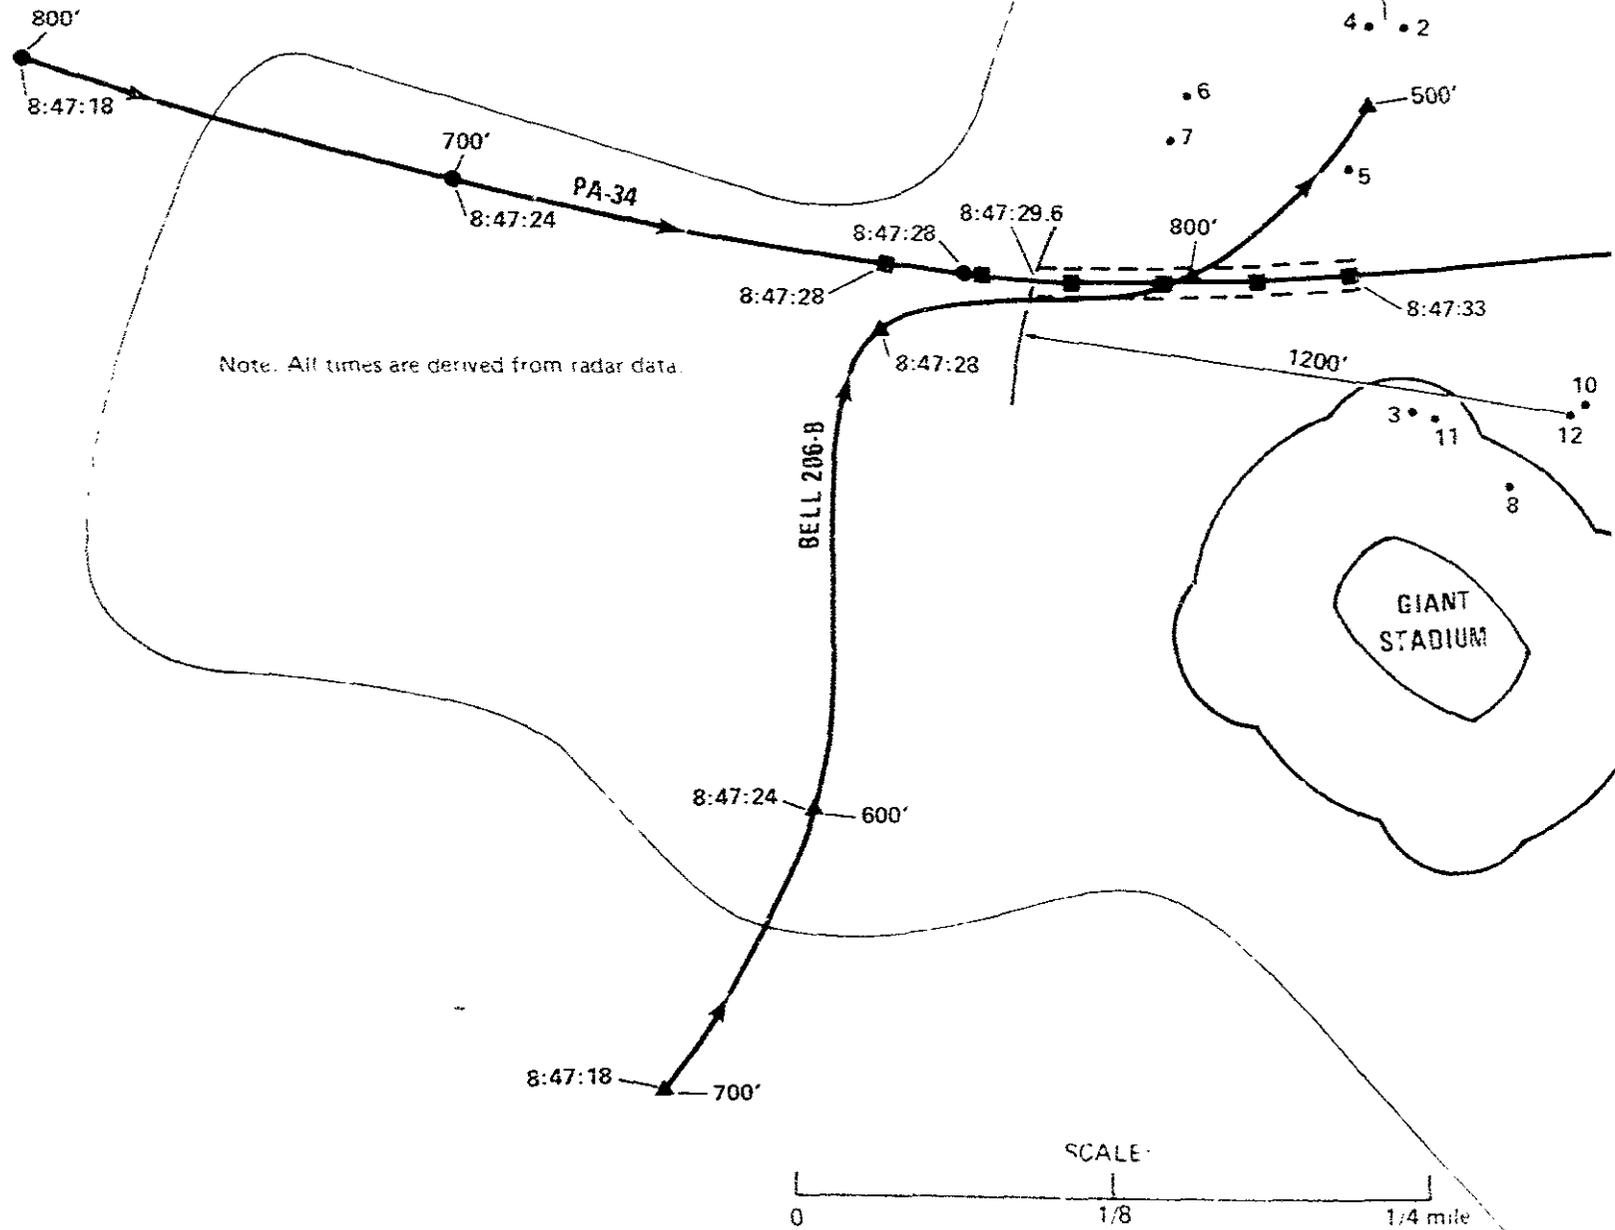
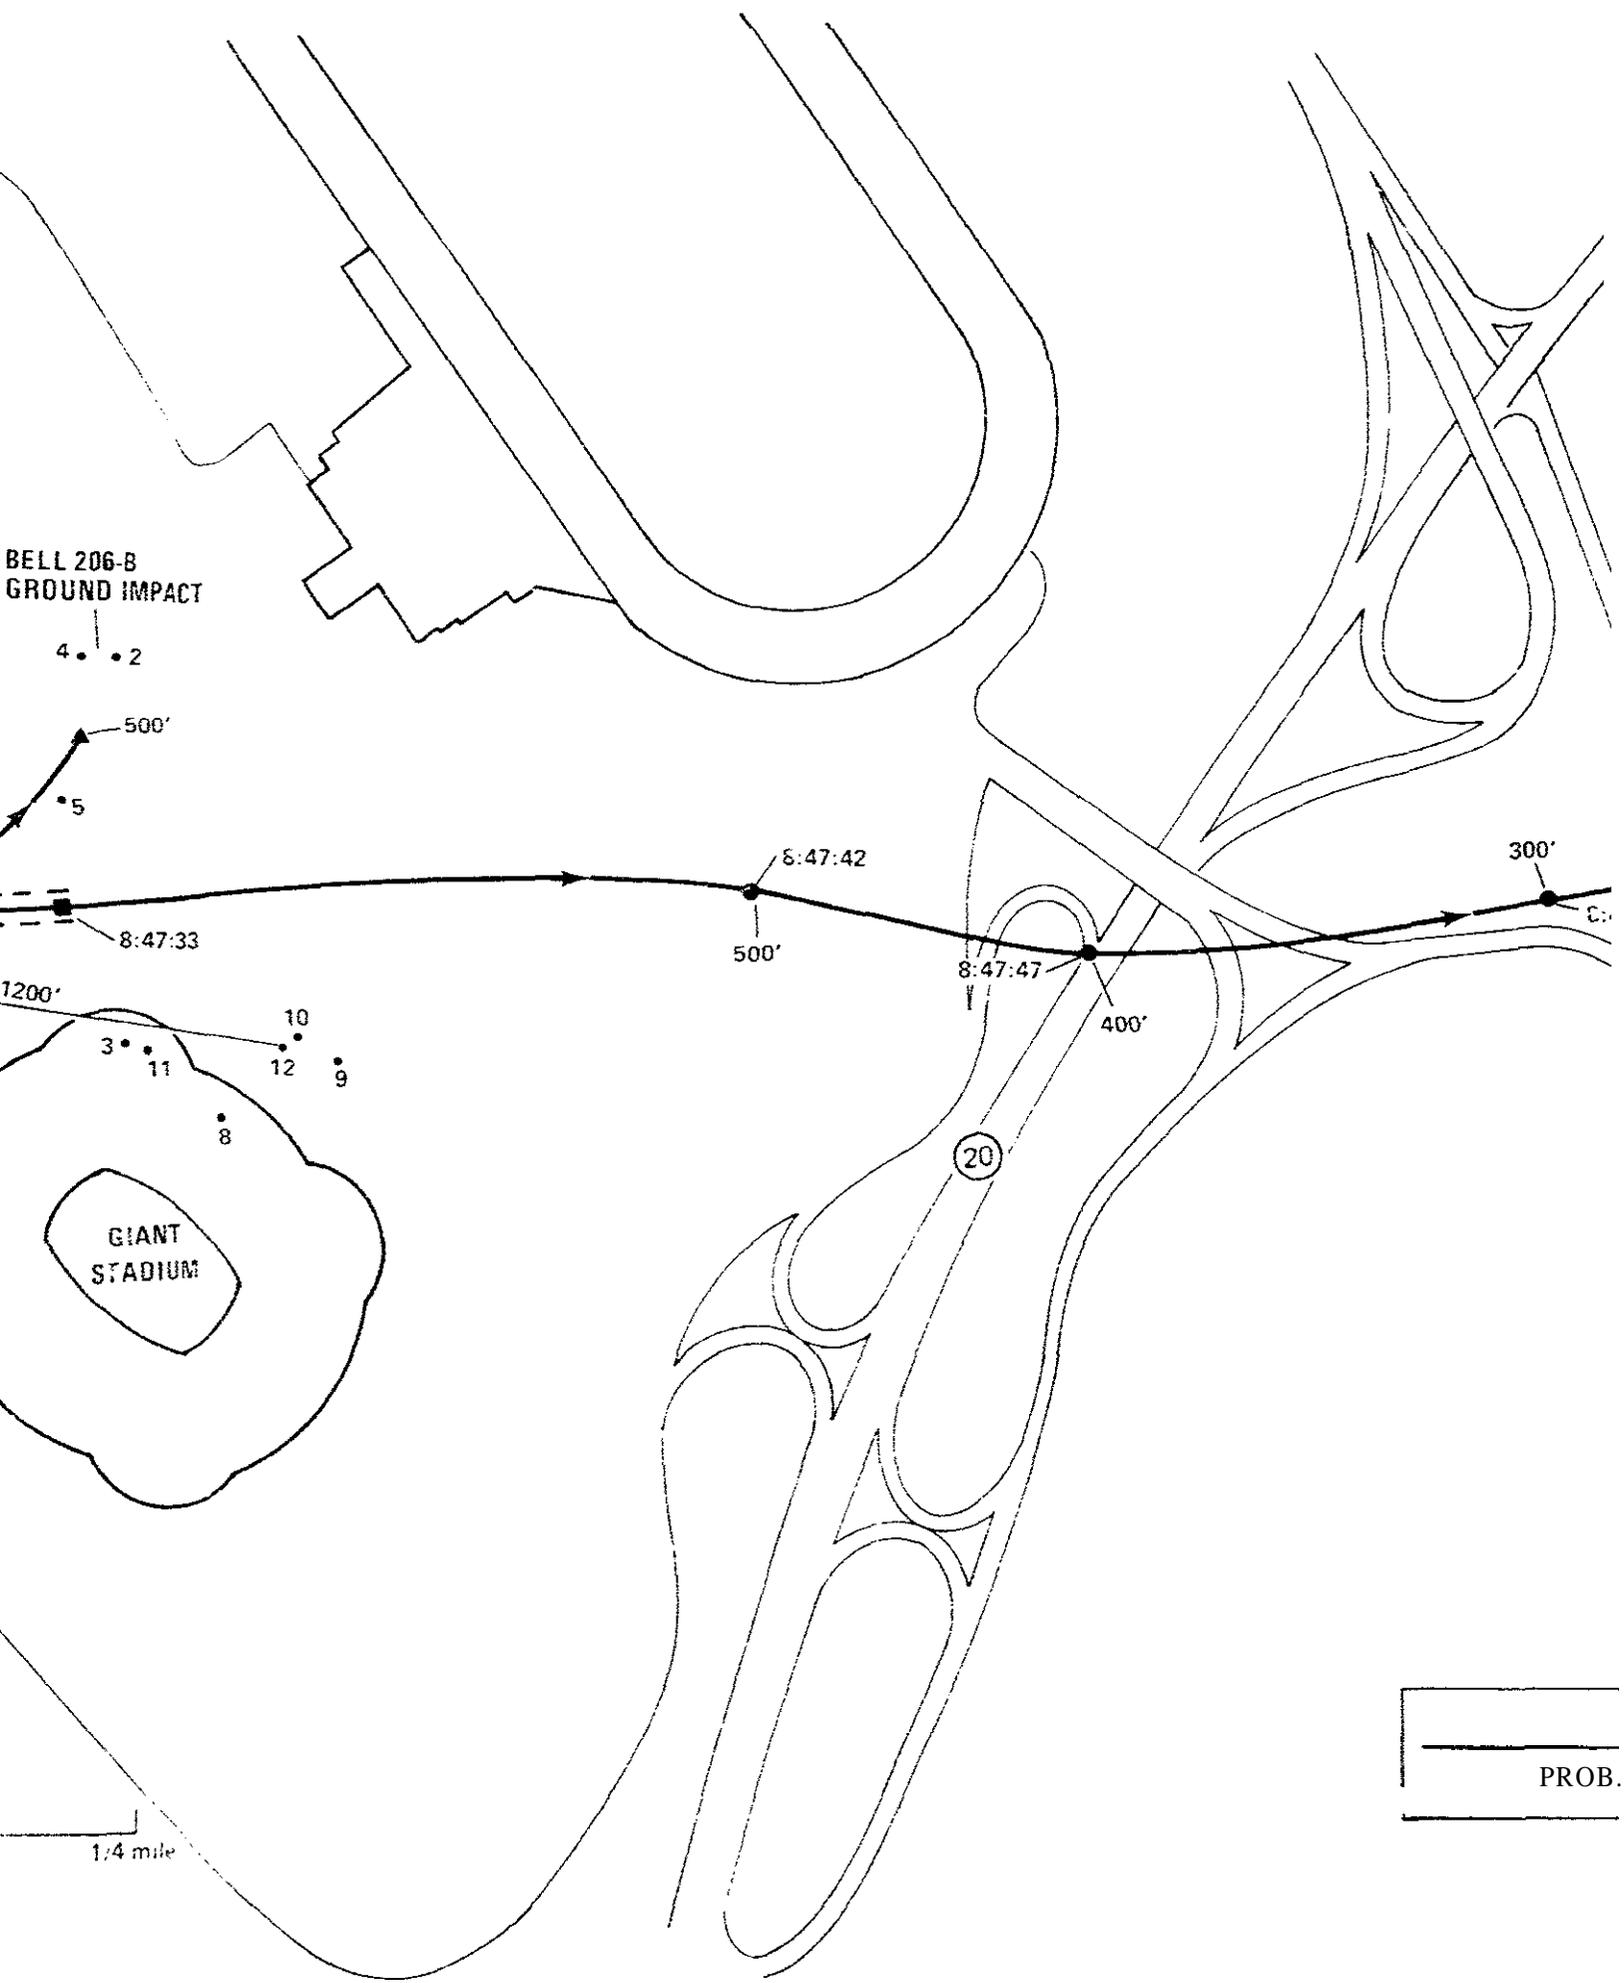
BELL 206-B
GROUND IMPACT

- ▲ Bell 206 (radar position data)
- PA-34 (radar position data)
- PA-34 Projected position data derived from radar return recorded at 12:47:18 and 12:47:24.

== Collision area

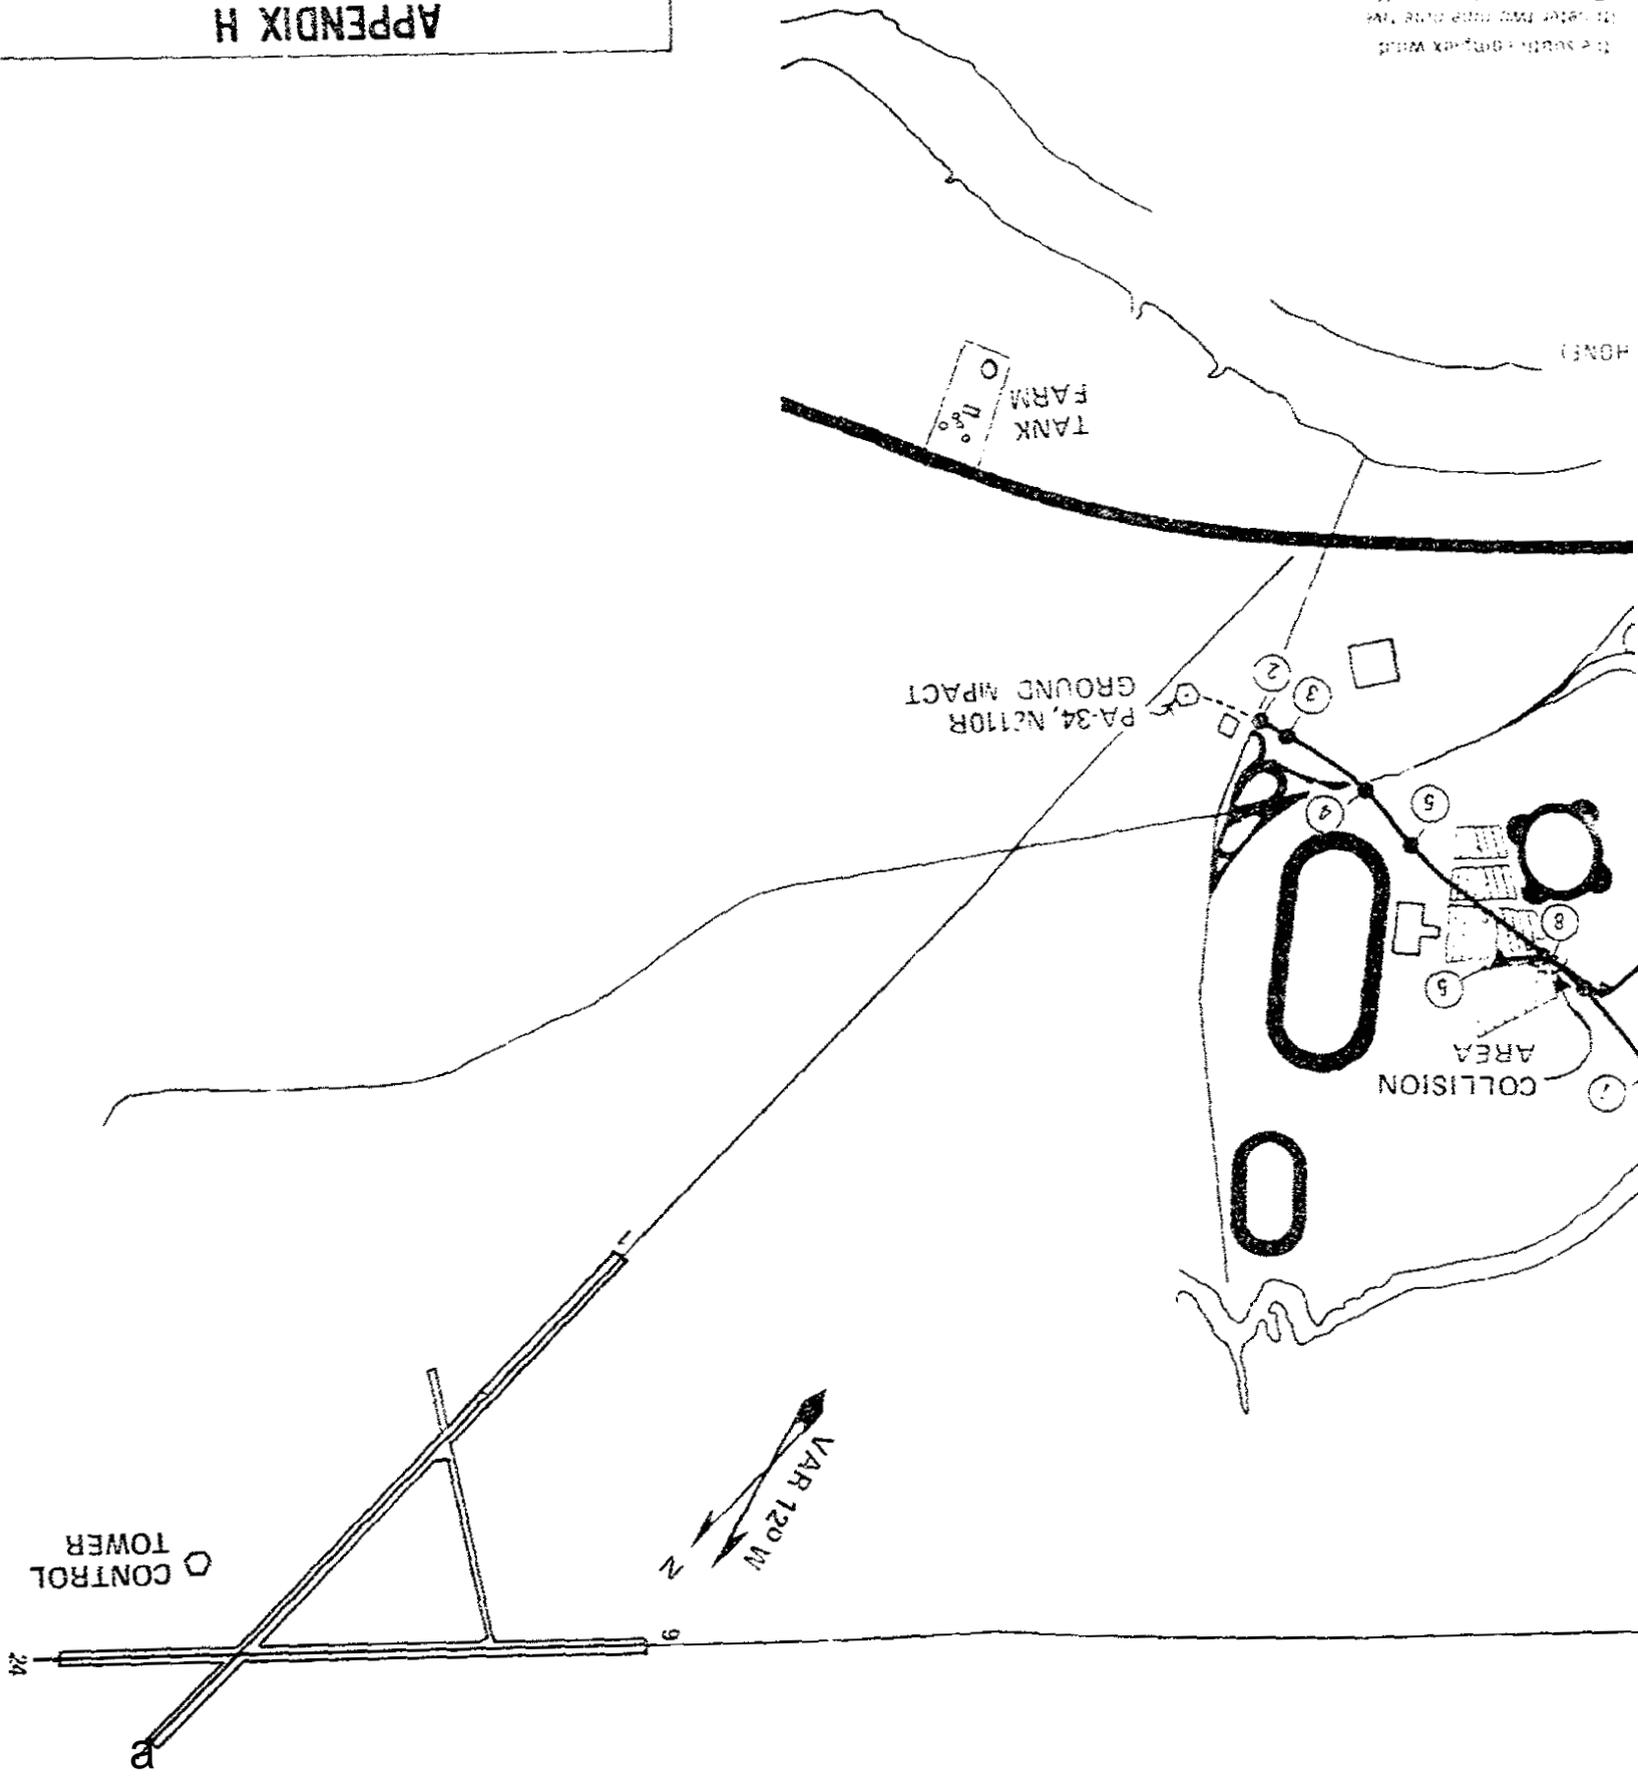
APPENDIX H
PROBABLE GROUND TRACK
(PLOT NO. 2)

PA-34, N2110R
GROUND IMPACT
