**NATIONAL
TRANSPORTATION
SAFETY
BOARD**

AIRCRAFT ACCIDENT REPORT

**AIR CANADA FLIGHT 797
McDONNELL DOUGLAS DC-9-32, C-FTLU
GREATER CINCINNATI
INTERNATIONAL AIRPORT
COVINGTON, KENTUCKY
JUNE 2, 1983**

NTSB/AAR-84/09

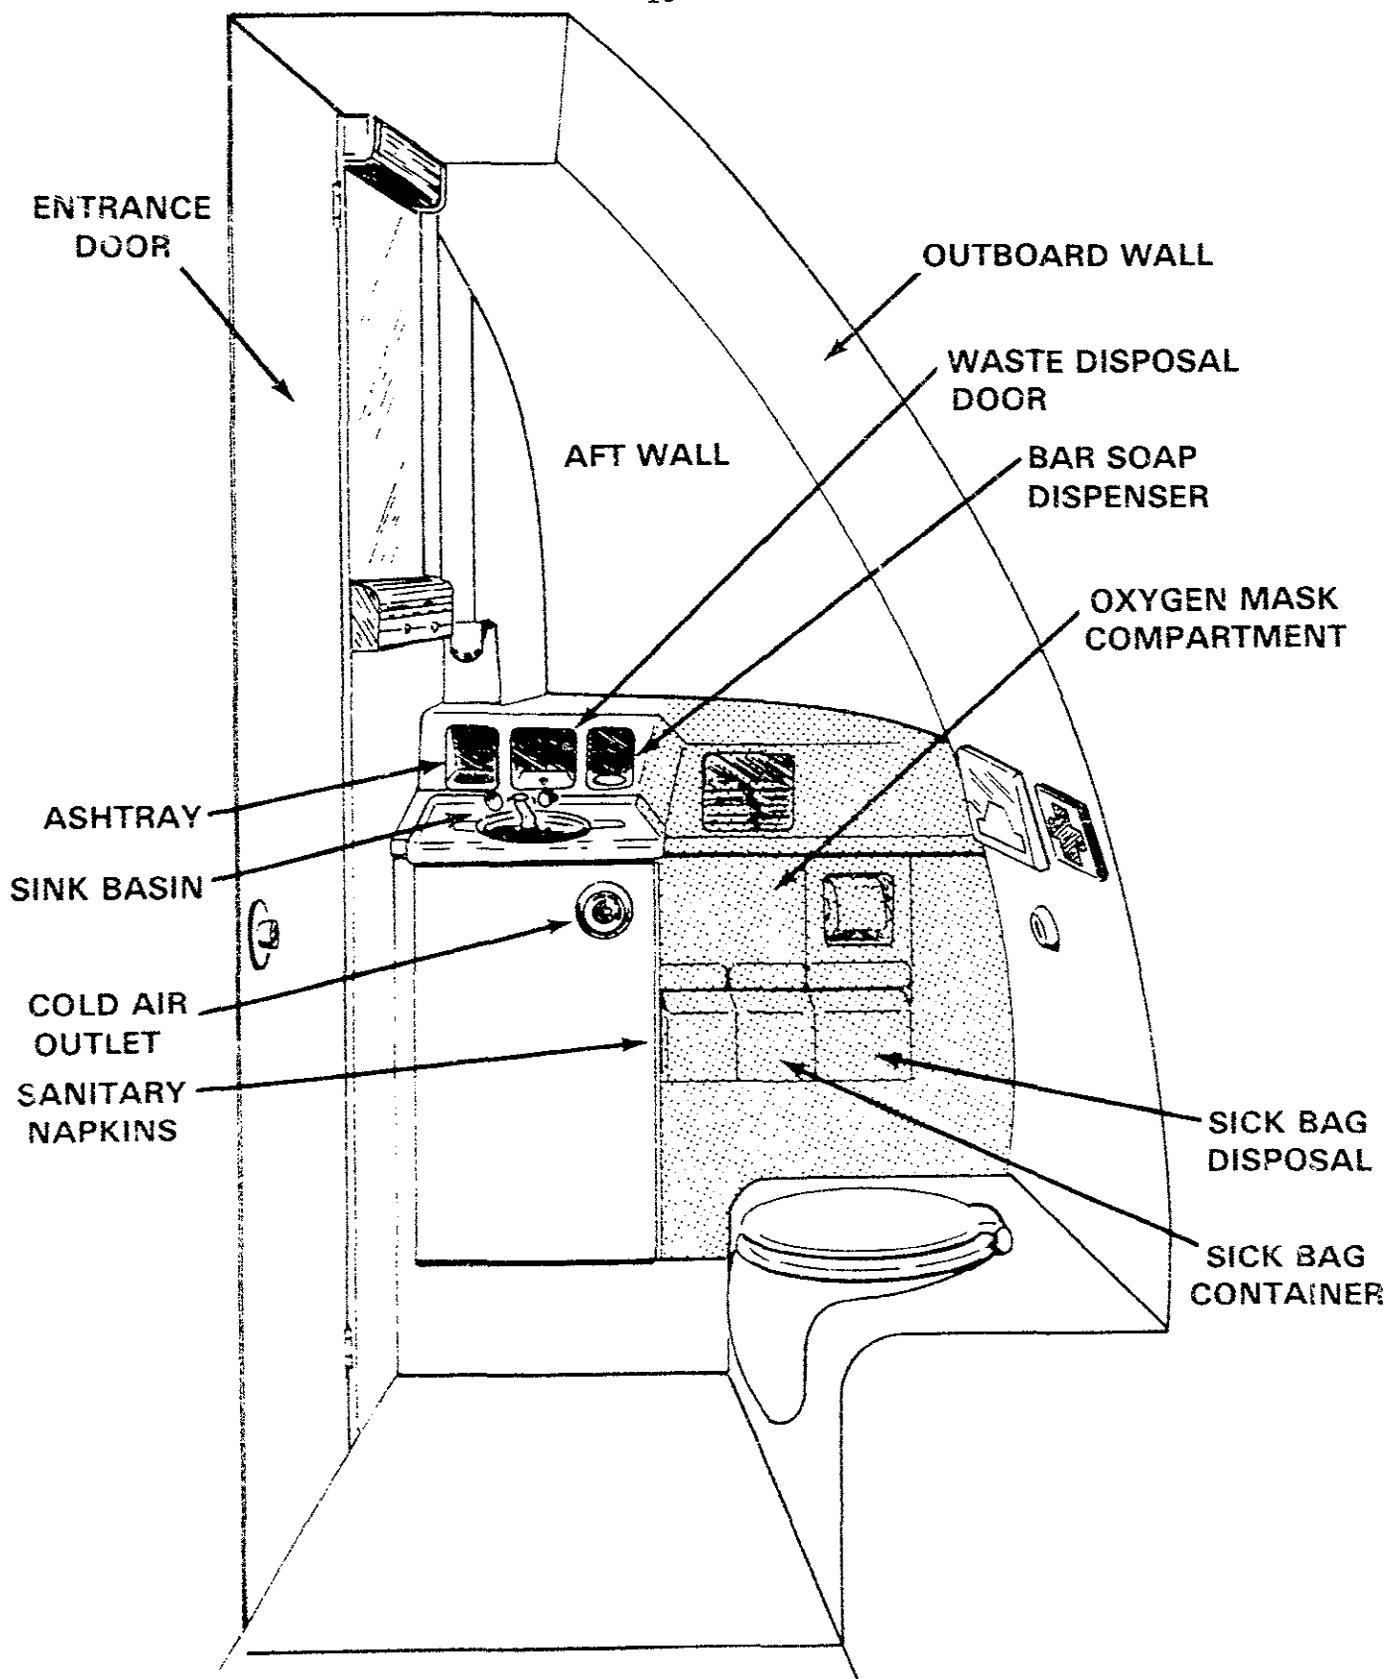
The aft lavatory was on the left side of the cabin, and began at FS 965 and extended aft to FS 1019, or just forward of the aft pressure bulkhead. The lavatory's outboard wall conformed essentially to the shape of the airplane's fuselage. There was a vanity section containing a stainless steel sink and amenities located along and extending forward from the aft wall. The commode containing a flushing motor was located along the lavatory's outboard wall. A trash chute and container were located below and behind the sink, and a fresh air supply outlet was positioned below the sink in the door of the vanity. Also, below the trash container, an aluminum shelf was installed. In addition, there was an oxygen outlet located in the oxygen mask compartment in the amenities section. (See figures 9 and 10.)

Figure 9.—Diagram of aft lavatory, viewed aft.

The amenities section of the vanity extends from the sink to the lavatory outboard wall and from the commode to the lavatory aft wall. The section contains the oxygen mask compartment and containers or dispensers for paper towels, toilet paper, sanitary napkins, and sick bags. (See figure 9.)
