NATIONAL TRANSPORTATION SAFETY BOARD

AIRCRAFT ACCIDENT REPORT

**SOUTHERN AIR TRANSPORT
LOGAIR FLIGHT 51, LOCKHEED L-382G
KELLY AIR FORCE BASE, TEXAS
OCTOBER 4, 1986**

NTSB/AAR-87/04

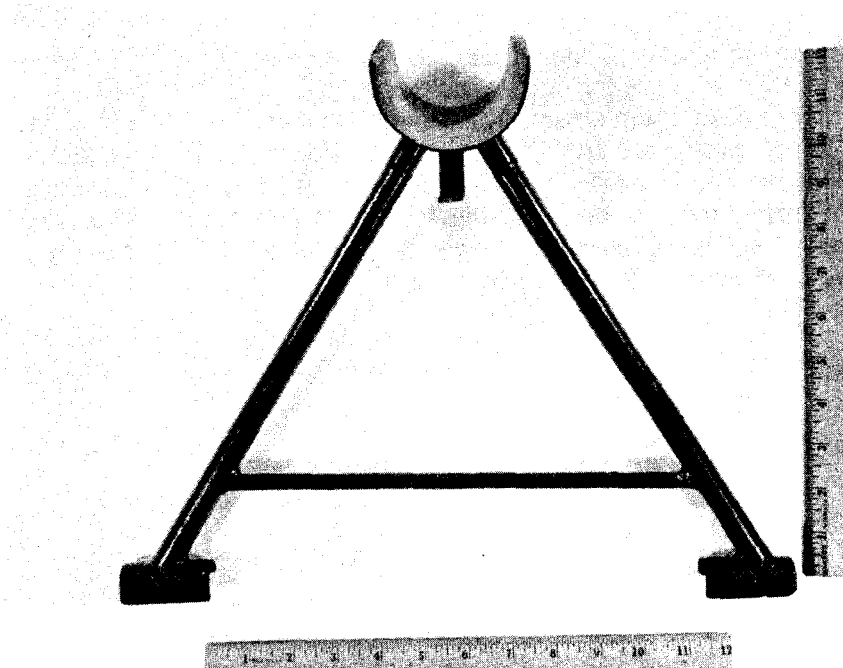
Figure 3.-SAT-type elevator control block.

SAT had also designed and fabricated an elevator control block, which was no longer in use, for use in their airplanes. The SAT design was different in size and shape from **TIA's** device. (See figure 3.) At the time of the accident, there was only one in existence. According to SAT, only four were ever constructed. **SAT's** elevator control block was constructed in a wishbone shape and displaced the control column so far aft of neutral that it would not be possible for the flightcrew to occupy their seats with it installed.

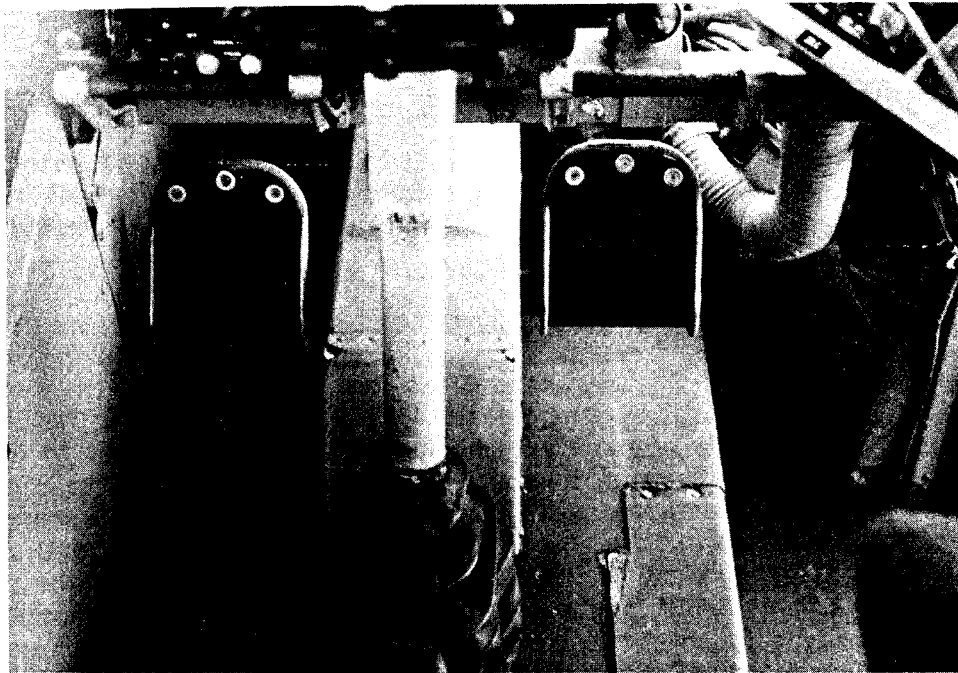
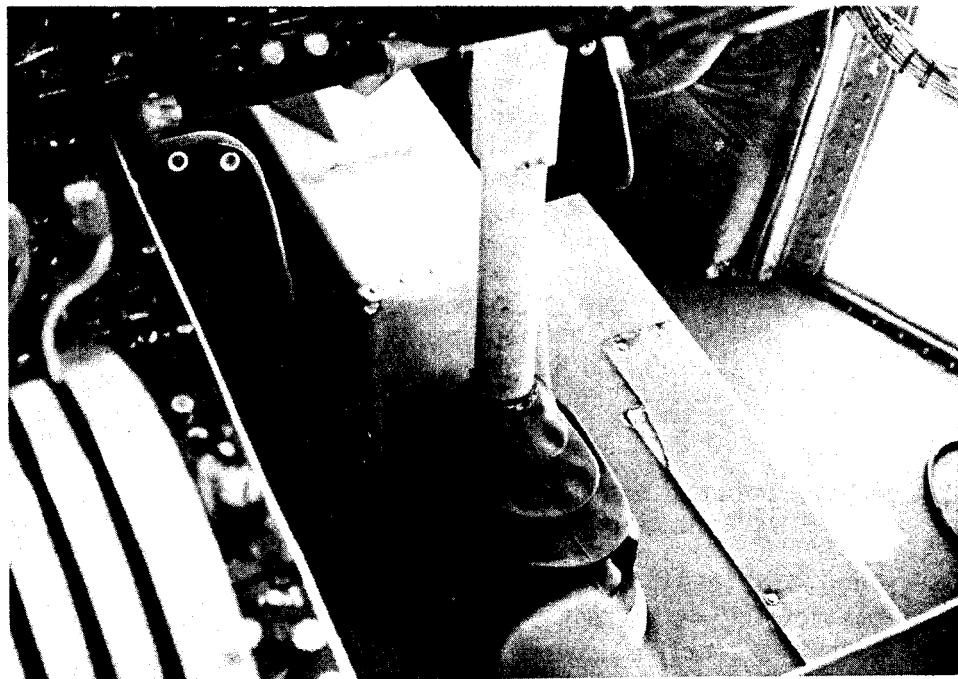
Figure 10.-Two views of control column and metal shroud.

The captain of the previous flight of **N15ST** stated in a postaccident interview that while performing the After Landing Checklist, "The first officer installed a gust lock between the 'foot rest' 5/ handles and the yoke on his [first officer's] side of the cockpit." (See figure 10.) The captain said that its installation was noteworthy to him because it had been a "considerable length of time" since he had seen a "gust lock" in use. (See section 1.6.) This captain had recently transferred from Transamerica Airlines (**TIA**), had been checked out as a captain, and had seldom flown in the **LOGAIR** system with **SAT**. The gust lock to which he referred also was called an elevator control lock, control block, **uplock**, or brace. This report will refer to the device as the **TIA**-type elevator control block. (See figure 1.) The elevator control block was nonapproved and was used to hold the elevator control surface in a **faired** to slightly trailing edge up position in order to prevent damage to the elevator control surface during cargo loading operations. Loading of the **L-382** is accomplished from the rear of the airplane below the horizontal stabilizer. The elevator control block to which the previous captain referred was constructed of aluminum with a 10-inch long V-shaped channel and a 4-inch long U-shaped channel connected by a 4-inch tube which held the two pieces together with a through bolt and nut.

A C-130 Phase II simulator flight test was conducted at Little Rock AFB, Arkansas, on October 21, 1986. Several flight scenarios were flown using the speeds, power settings, and weight and balance of the accident airplane. An intact elevator control block, identical in design and composition to the one aboard **N15ST** was used in the simulations. Placing the control block in the normally installed position between the footrests and the yoke produced a reading of **3.8°** aft of the control column's neutral position. Takeoffs with the control block installed in this manner did not produce the abrupt high pitch up observed by some witnesses to this accident; however, it did produce a premature rotation. The device could be lodged between the control column and the metal shroud between the rudders at a control column position of **6°** aft of its neutral position. This position produced an altitude of about 700 feet agl and a speed of about 80 KIAS before the simulator stalled and commenced a roll to the left. The Safety Board's measurements indicated that the distance between the control column and the metal shroud was similar in the C-130 simulator, a C-130, and an L-382. (See figure 10.) Lockheed confirmed that cockpit dimensions were identical in the C-130 and the L-382.

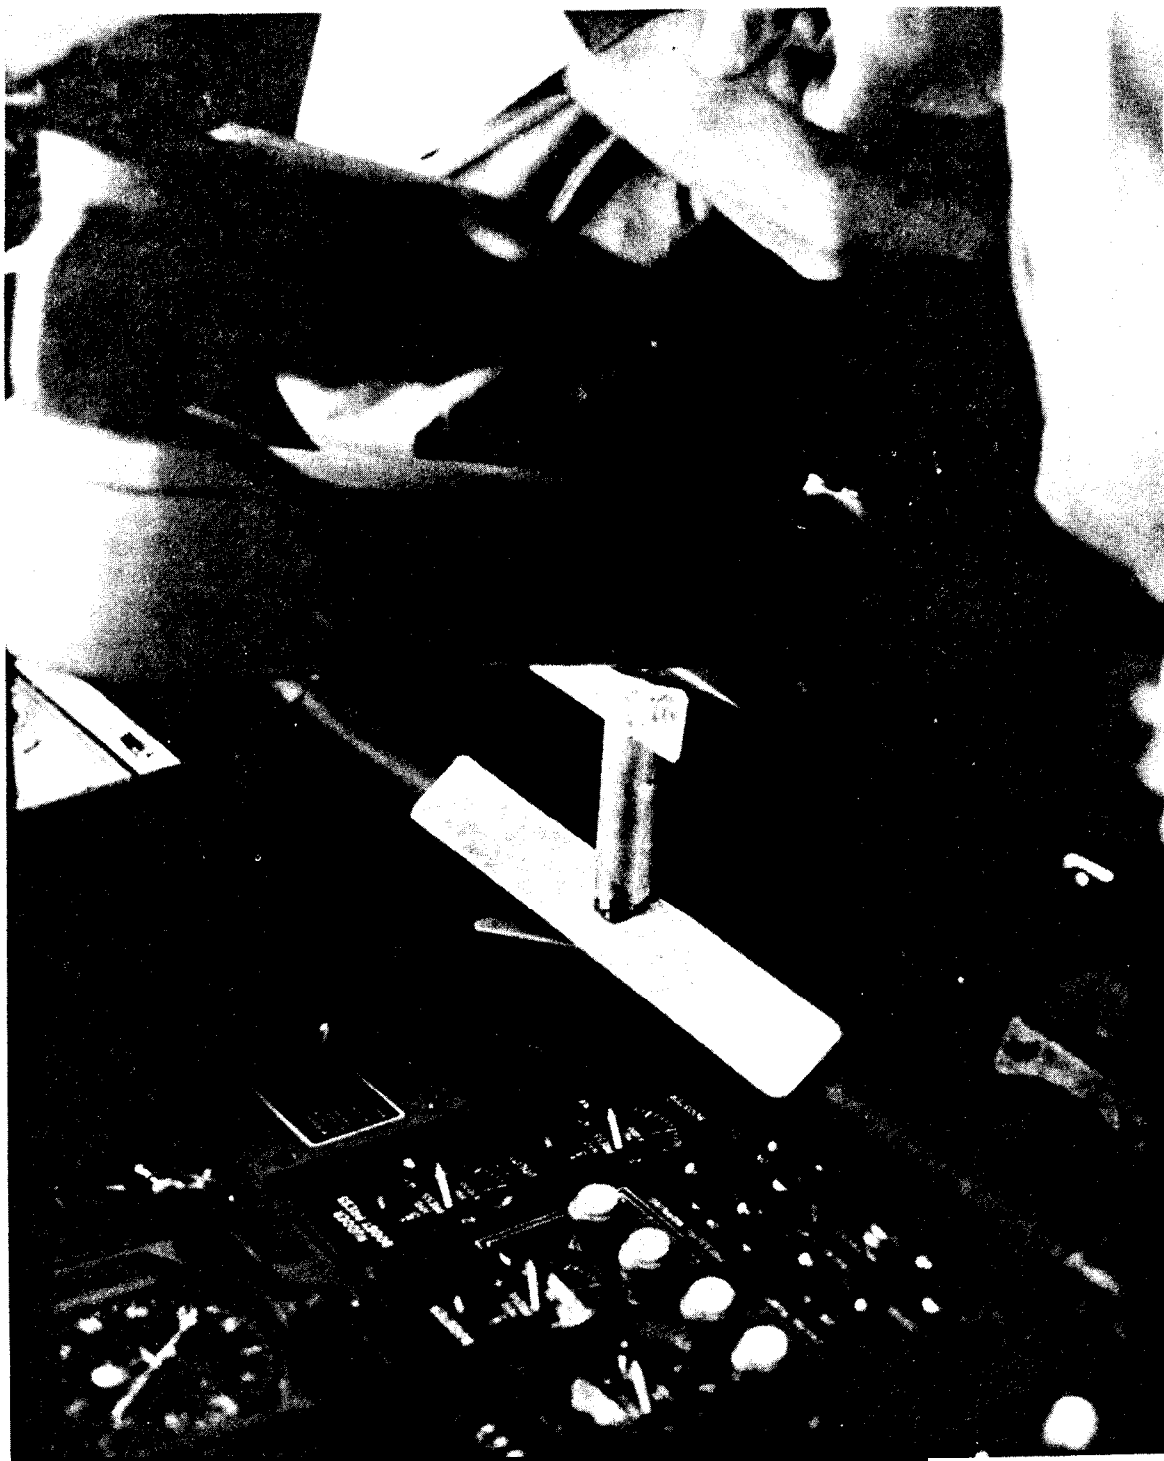
Figure 11.—Control block installed.

A former SAT L-382 first officer who flew infrequently in the **LOGAIR** system contacted the Safety Board and disclosed that on two separate occasions an elevator control block had been installed without his knowledge. (See figure 11.) In the first case, which occurred at Kelly AFB, he discovered the control block before takeoff when it fell to the cockpit floor as he pulled the control column full aft during the check of the flight controls.
