# **NATIONAL TRANSPORTATION SAFETY BOARD**

## **AIRCRAFT ACCIDENT REPORT**

**MIDAIR COLLISION OF  
NABISCO BRANDS, INC.,  
DASSAULT FALCON, DA50, N784B AND  
AIR PEGASUS CORPORATION  
PIPER ARCHER, PA28-181, N1977H  
FAIRVIEW, NEW JERSEY  
NOVEMBER 10, 1985**

NTSB/AAR-87/05

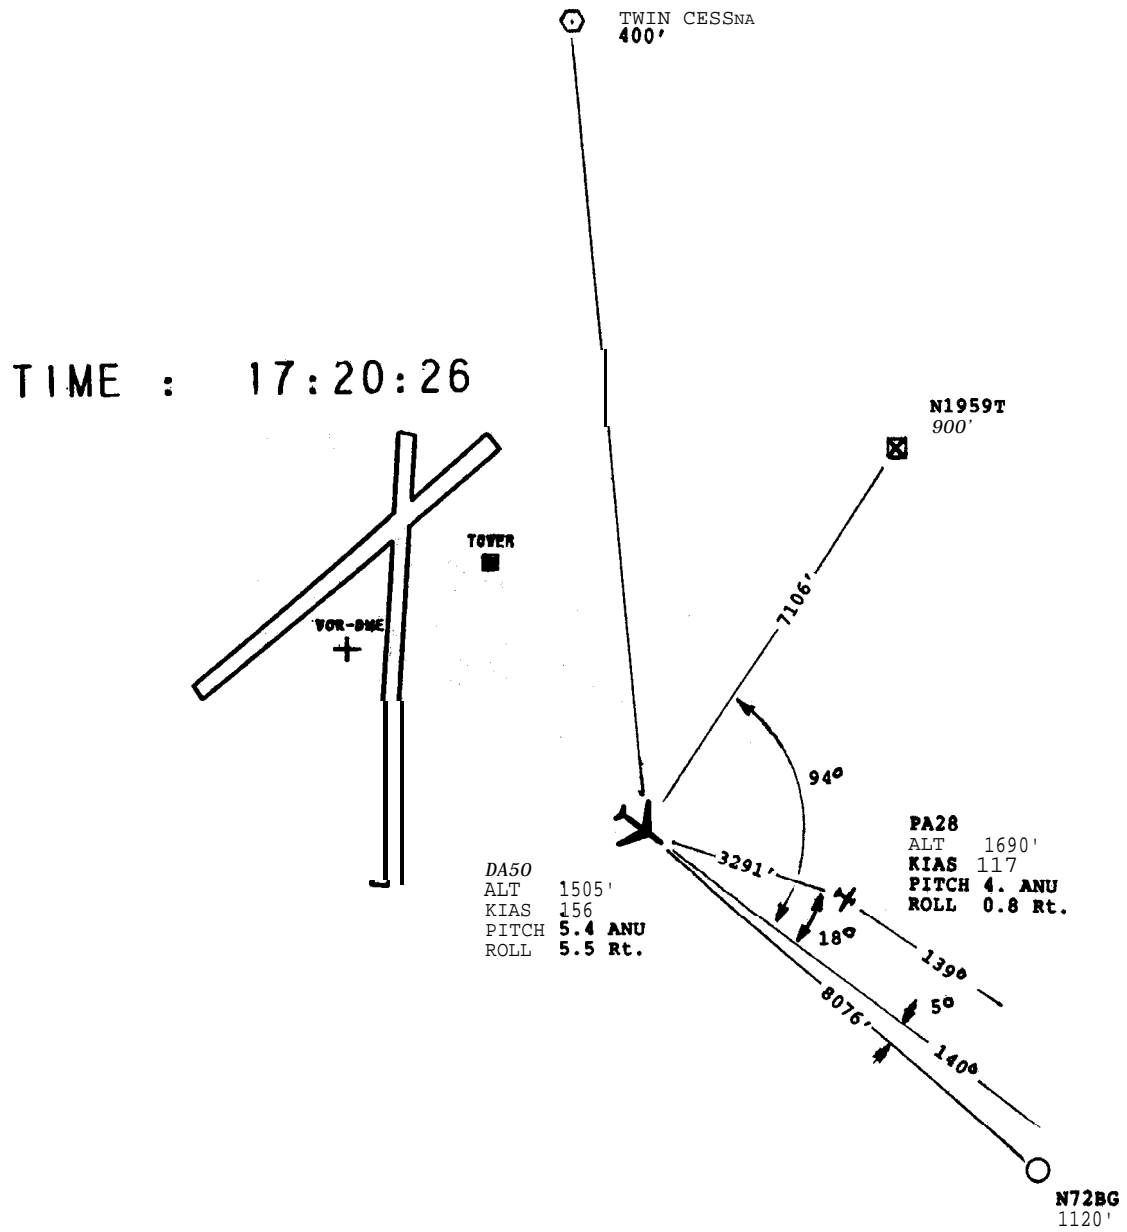
Figure 5.-Radar positions of aircraft at 1720:26.

One second later, another airplane called the controller for takeoff, but the local controller transmitted, "Seven seven hotel, traffic is a Falcon jet overtaking you from your, ah, six o'clock, ah [unintelligible]." (See figure 5.) An immediate response came from another airplane north of the airport that stated, "Uh, roger sir, ABC towers." (According to the CVR, at 1720:39, the captain stated, "Another one down low." The first officer responded with a word that was unintelligible, and then the captain stated, "Beneath him," and the first officer said, "I see him" which ended at 1720:42.) At 1720:41, the controller said, "Eight four bravo, you have the traffic sir," and the captain replied, \*\*Affirmative.\*\* The controller then stated, "Okay, sir, maintain visual." (See figure 6.) The crew did not acknowledge the instruction.

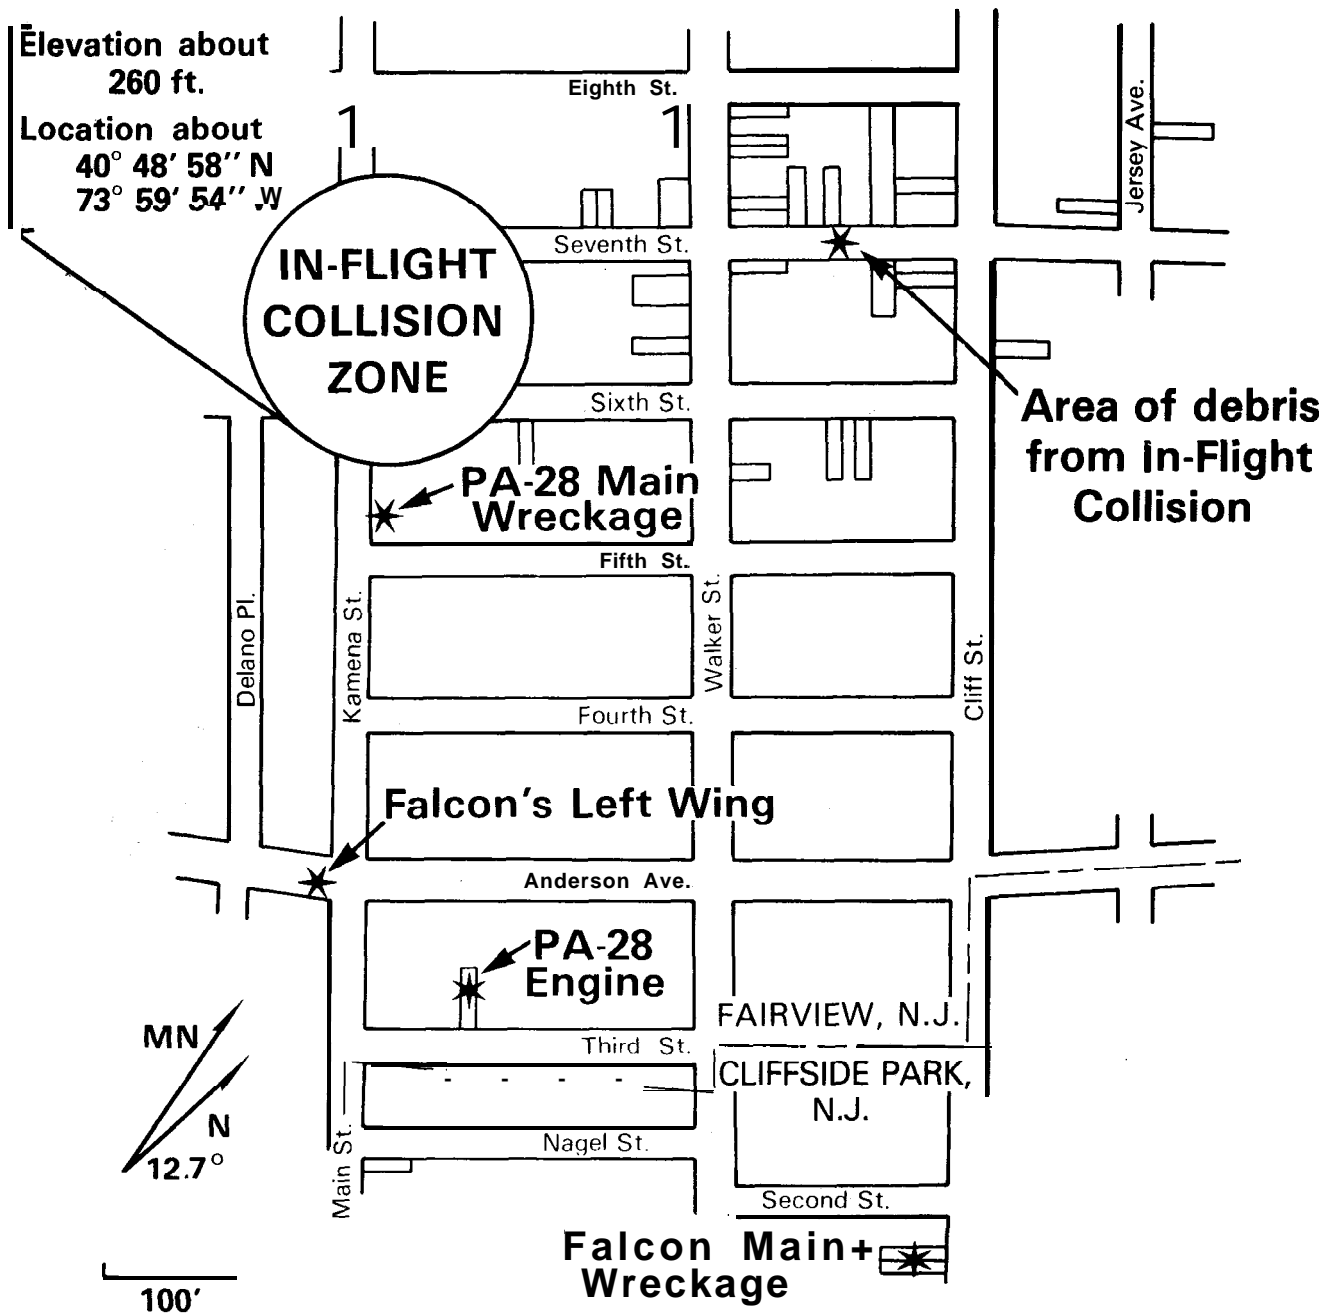
Figure 10.-Accident site location chart.

The main wreckage sites of the airplanes were about 700 feet apart. (See figure 10.) The wreckage was distributed over a four by eight city block area. Most of the wreckage scatter was concentrated in a six block area around the intersections of Walker Street and Sixth and Seventh Streets in Fairview.

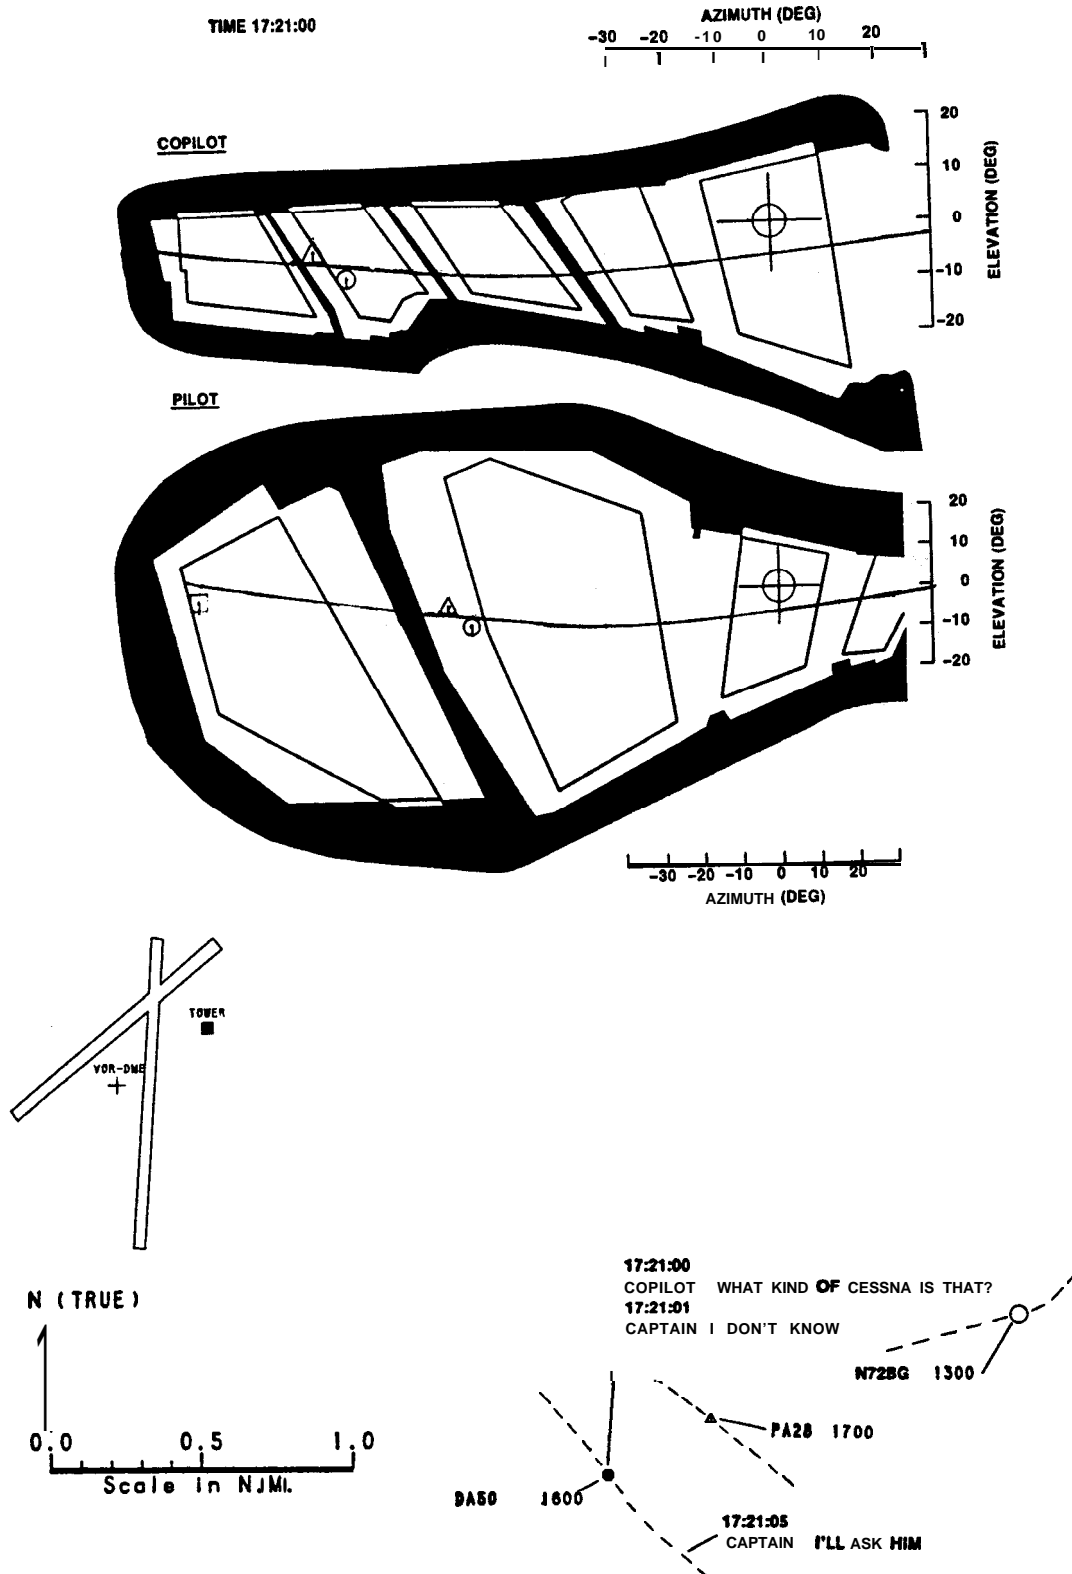
Figure 22.-Cockpit radar positions and cockpit visibility plot of aircraft at 1721:00.

At **1720:26**, when the local controller advised the pilot of the PA28 about the DA50 at his 6 o'clock position, all three airplanes were in view of the DA50 flightcrew. (See figure 20.) At **1720:41**, when the local controller asked the DA50 flightcrew if they saw the traffic, **N1959T** was in view about **124°** to their left almost 4 miles away traveling northbound on the downwind leg of the traffic pattern, the PA28 and **N72BG** appeared close together and in view about **40°** to the left of their DER points. The PA28 was about **3/4** mile ahead just above the horizon and **N72BG** was slightly below the horizon about 1.3 miles away, and to the right of the PA28. (See figure 21.) About this time, when the captain acknowledged sighting what is believed he thought to be the "westbound" traffic, all three airplanes were in his view, and only **N1959T** was far to the left, out of the first officer's view. Twenty seconds later, both the PA28 and **N72BG** maintained their approximate positions relative to one another and moved to the left horizontally about **46°**. **N1959T** moved horizontally to the left and out of the first officer's view. (See figure 22.)

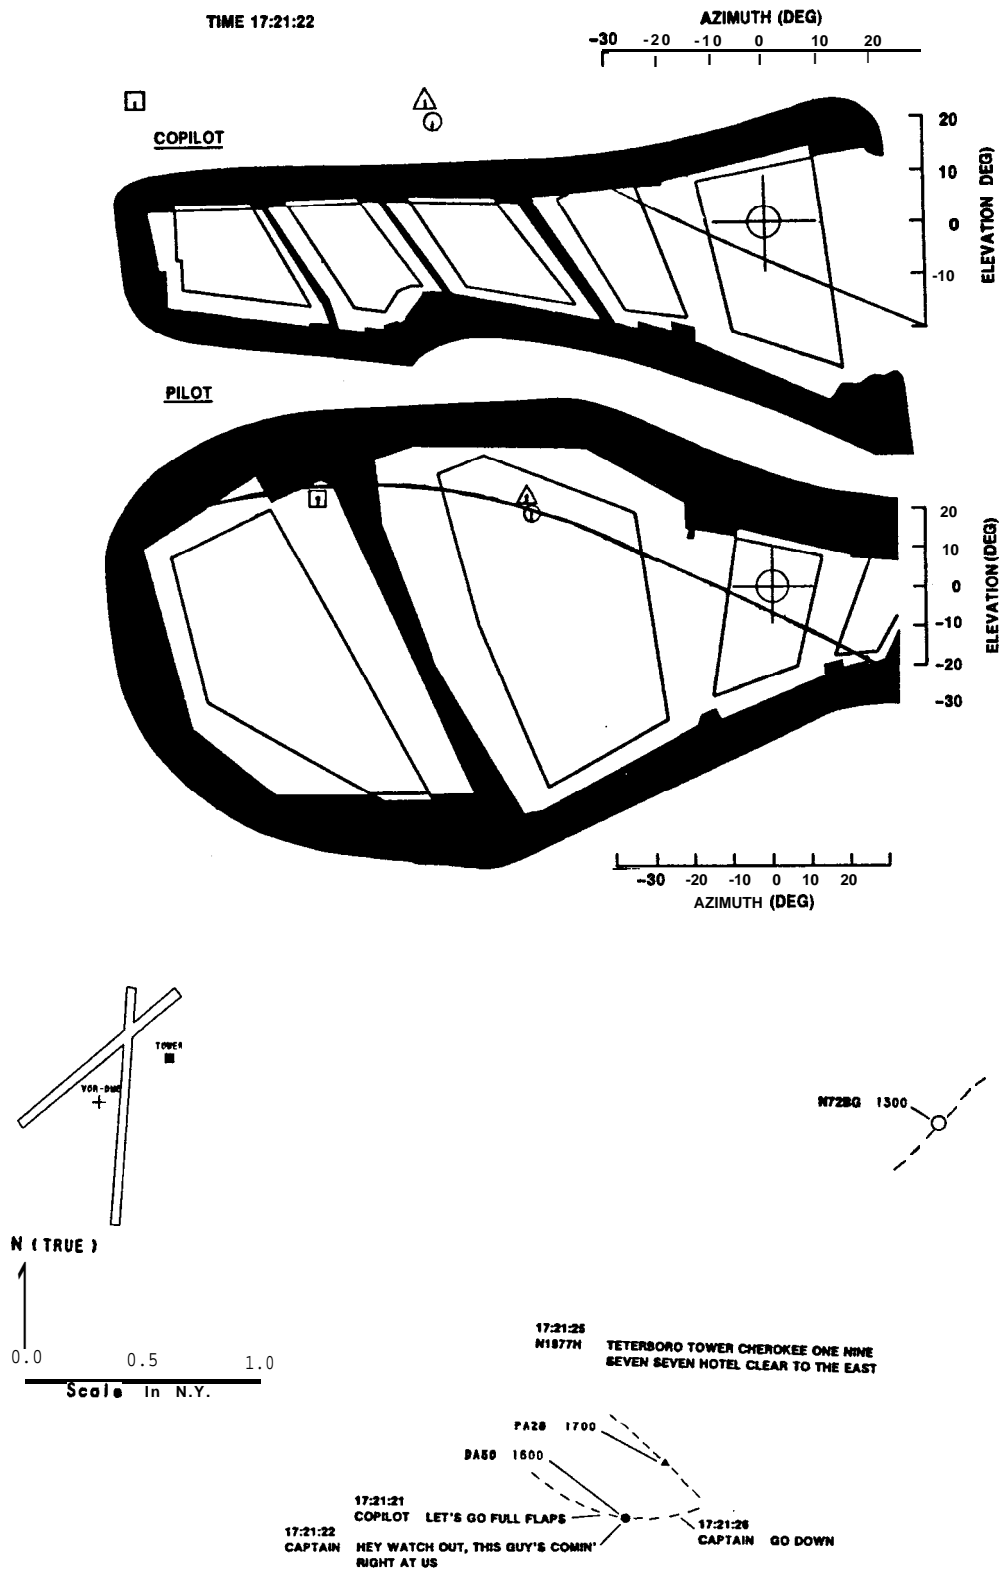
Figure 23.-Cockpit radar positions and cockpit visibility plot of aircraft at 1721:22.

At **1721:00**, when the first officer asked "What kind of Cessna is that?" the PA28 and **N72BG** remained in view in about their same relative positions about **80°** to the left of the crew's DER, but the PA28 was about 1/2 mile away and **N72BG** was about 1.6 miles away. Eight seconds before the collision when the captain said, "Hey, watch out, this guy's **comin'** right at us," the DA50 was in about a **30° left** bank and the PA28 and **N72BG** were about **63°** to the left and about **20°** above the DER for the captain. They were not in the first officer's view. The PA28 was just above the horizon and **N72BG** was directly below the PA28 which was about 1/3 mile away or about 2,006 feet from the DA50. **N1959T** was out of the view of both pilots. (See figure 23.)
