# **NATIONAL TRANSPORTATION SAFETY BOARD**

## **AIRCRAFT ACCIDENT REPORT**

**AIR NEW ORLEANS,  
DBA CONTINENTAL EXPRESS FLIGHT 962,  
BRITISH AEROSPACE 3101  
(JETSTREAM 31) N331CY,  
NEW ORLEANS INTERNATIONAL AIRPORT  
KENNER, LOUISIANA  
MAY 26, 1987**

NTSB/AAR-88/06

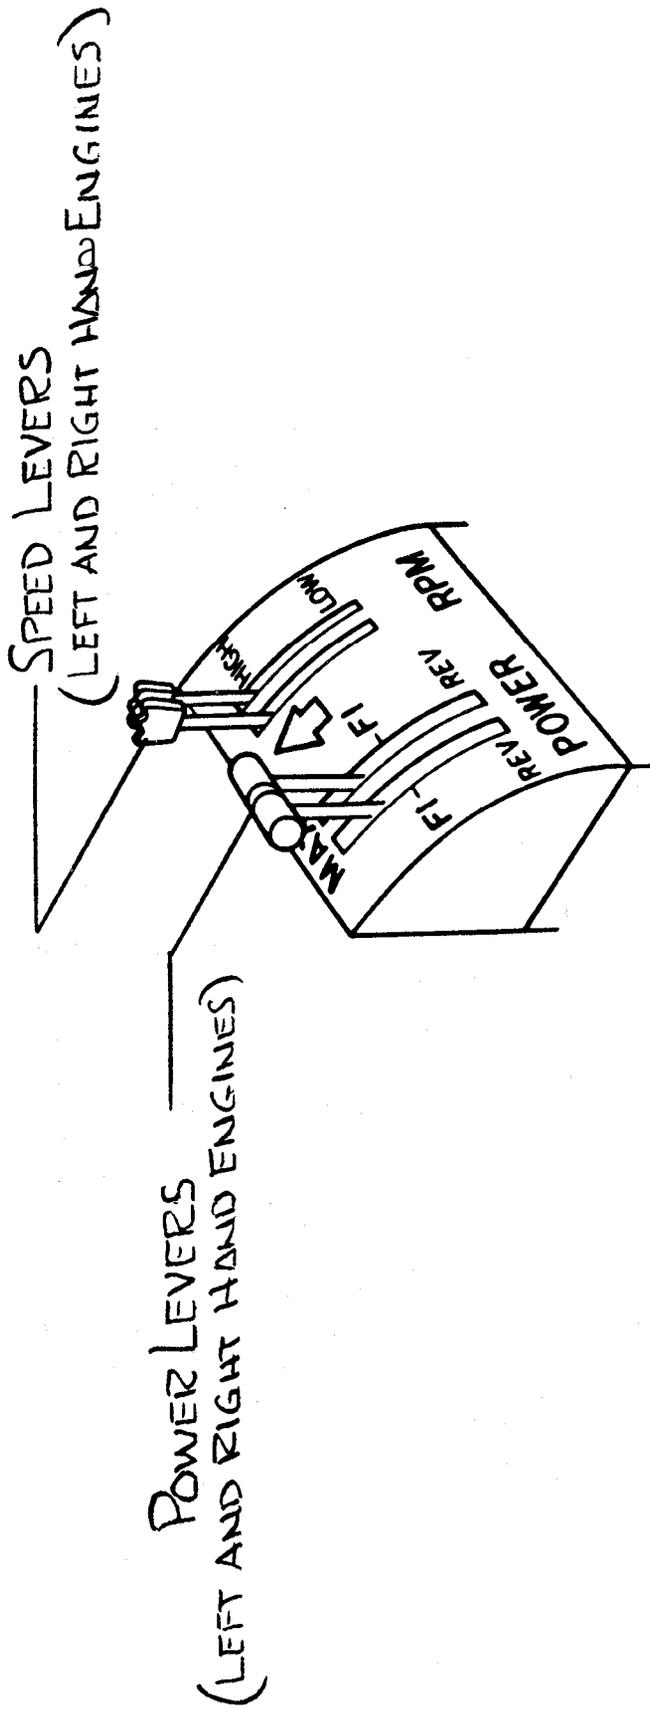
FIGURE 1

Engine speed (**rpm**) and power are controlled by 2 control levers, as shown in Figure 1, called the Speed Lever (S/L) and the Power Lever (P/L). These levers are located in the cockpit between the pilot and the co-pilot. In Takeoff (T/O), flight, and approach to landing, the engine is operated in the "prop governing" mode, i.e., **engine speed** is controlled by the prop governor (through the S/L setting) and fuel flow is controlled by the main fuel valve in the fuel control (through the power lever).

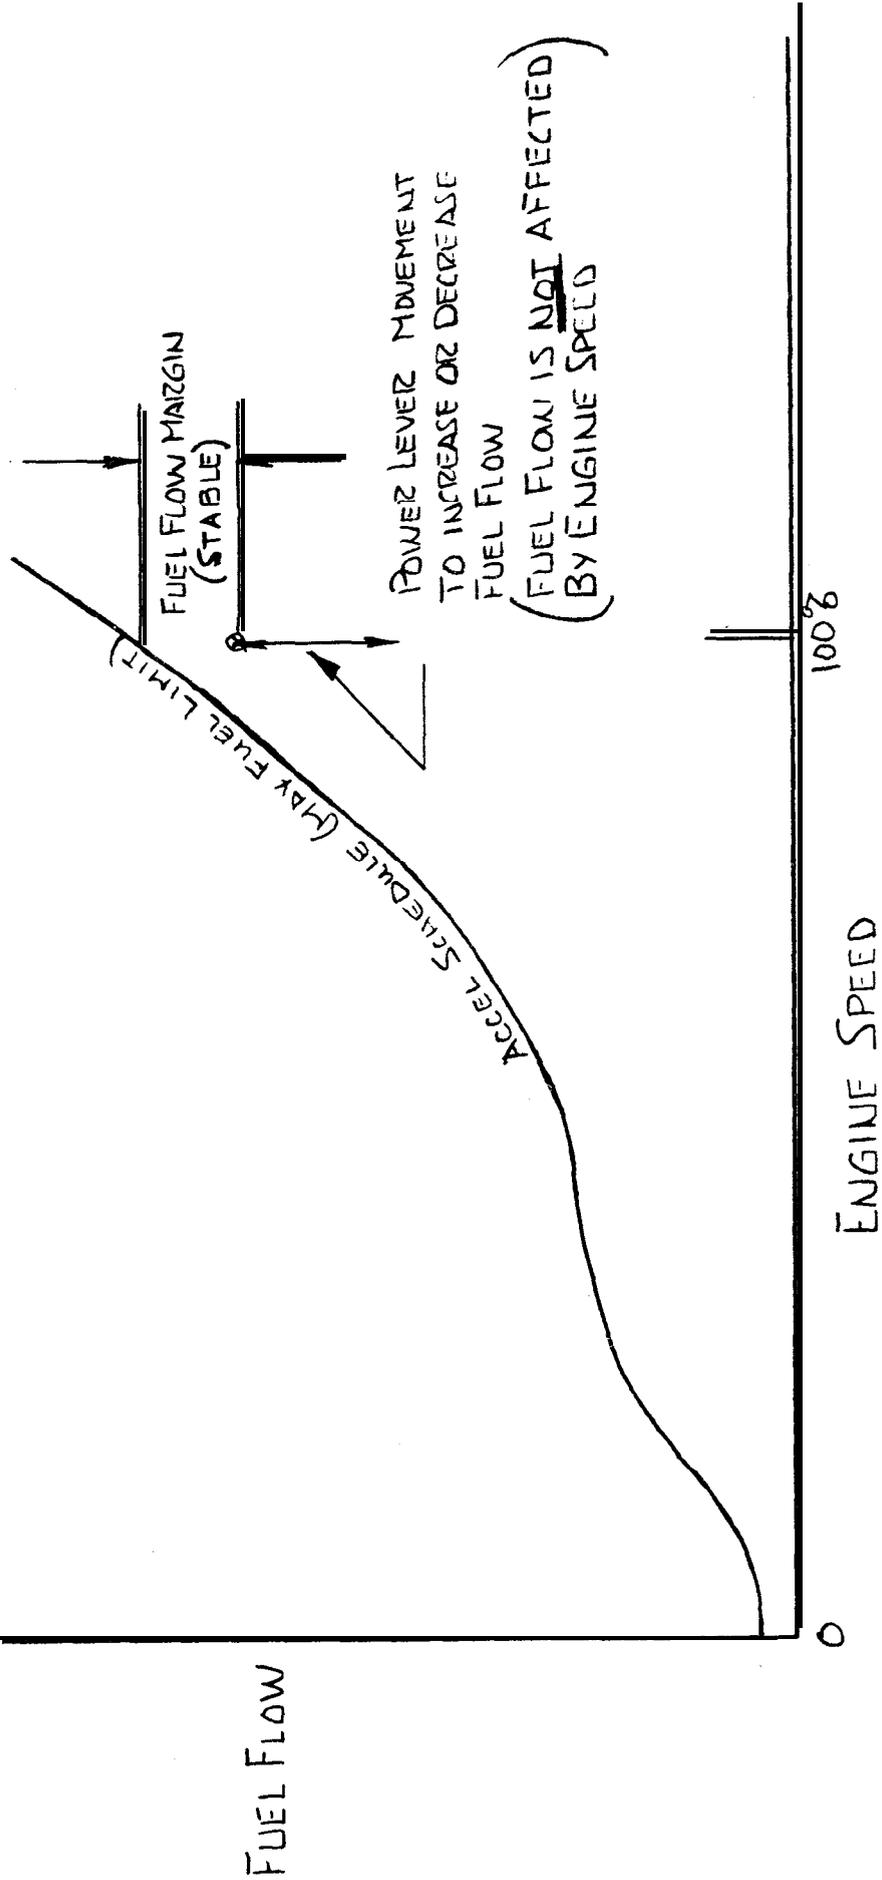
FIGURE 2

Note from Figure 2 that as the power lever is moved to the maximum position, there is always a healthy margin between the fuel flow demanded by the power lever schedule and the maximum fuel flow limit available from the accel schedule when the engine speed is at 100%.

As previously stated and as shown in Figure 2, the accel schedule dictates the max allowable fuel flow and is a function of engine rpm. This schedule does not affect fuel flow in normal operation. If, however, the engine is operating at 94% prop governing speed with a very high power demand from the pilot, the accel schedule will be low enough to assume control of fuel flow as shown in Figure 3. In this situation, fuel flow is a function of engine speed rather than being a fixed stable flow set by the power lever. The system dependence on speed in setting fuel flow causes instability. This instability is due to the prop governor trying to maintain engine speed by loading or unloading the propeller which is now responding to the fluctuations in fuel flow caused by the fluctuations in engine speed. This instability can be stabilized by either advancing speed lever or by reducing power lever, either of which will return control of fuel flow back to the power lever.
