PB90-910402  
NTSB/AAR-90/02

## AIRCRAFT ACCIDENT REPORT

EVERGREEN INTERNATIONAL AIRLINES  
McDONNELL DOUGLAS DC-9-33F, N931F  
SAGINAW, TEXAS  
MARCH 18, 1989

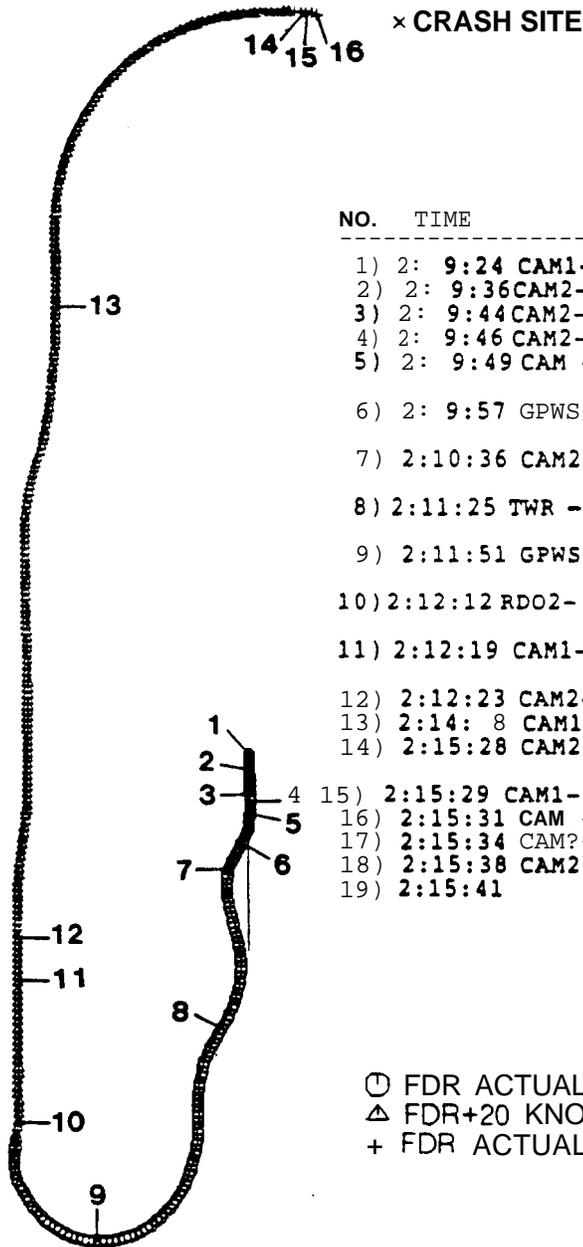
# FDR DERIVED GROUND TRACK AND CVR EVENTS

NO.	TIME	EVENT
1)	2: 9:24	CAM1- RAX POWER PLEASE
2)	2: 9:36	CAM2- EIGHTY KNOTS
3)	2: 9:44	CAM2- VEE ONE
4)	2: 9:46	CAM2- ROTATE
5)	2: 9:49	CAM - INCREASE IN BACKGROUND NOISE STARTS
6)	2: 9:57	GPWS- WHOOP WHOOP TERRAIN (REPEATED 3 TIMES)
7)	2:10:36	CAM2- WANT SOME HELP ON THE RUDDER
8)	2:11:25	TWR - . . . (LAST COMMUNICATION WITH THE CONTROL TOWER)
9)	2:11:51	GPWS- WHOOP WHOOP TERRAIN (REPEATED ONCE)
10)	2:12:12	RDO2- . . . (ATTEMPTED TO RADIO THE CONTROL TOWER)
11)	2:12:19	CAM1- WOULD YOU SAY THAT DOOR IS OPEN OR CLOSED
12)	2:12:23	CAM2- I CAN'T TELL
13)	2:14: 8	CAM1- ALLRIGHT I'M GONNA TURN NOW
14)	2:15:28	CAM2- I THINK YOU WANT TO GO THE OTHER WAY
15)	2:15:29	CAM1- I THINK YOU'RE RIGHT
16)	2:15:31	CAM - BACKGROUND NOISE DECREASES
17)	2:15:34	CAM?- NO
18)	2:15:38	CAM2- PUSH FORWARD PUSH FORWARD
19)	2:15:41	(( END OF RECORDING ))
