NATIONAL TRANSPORTATION SAFETY BOARD

AIRCRAFT ACCIDENT REPORT

FUEL FARM FIRE AT STAPLETON INTERNATIONAL AIRPORT DENVER, COLORADO NOVEMBER 25, 1990

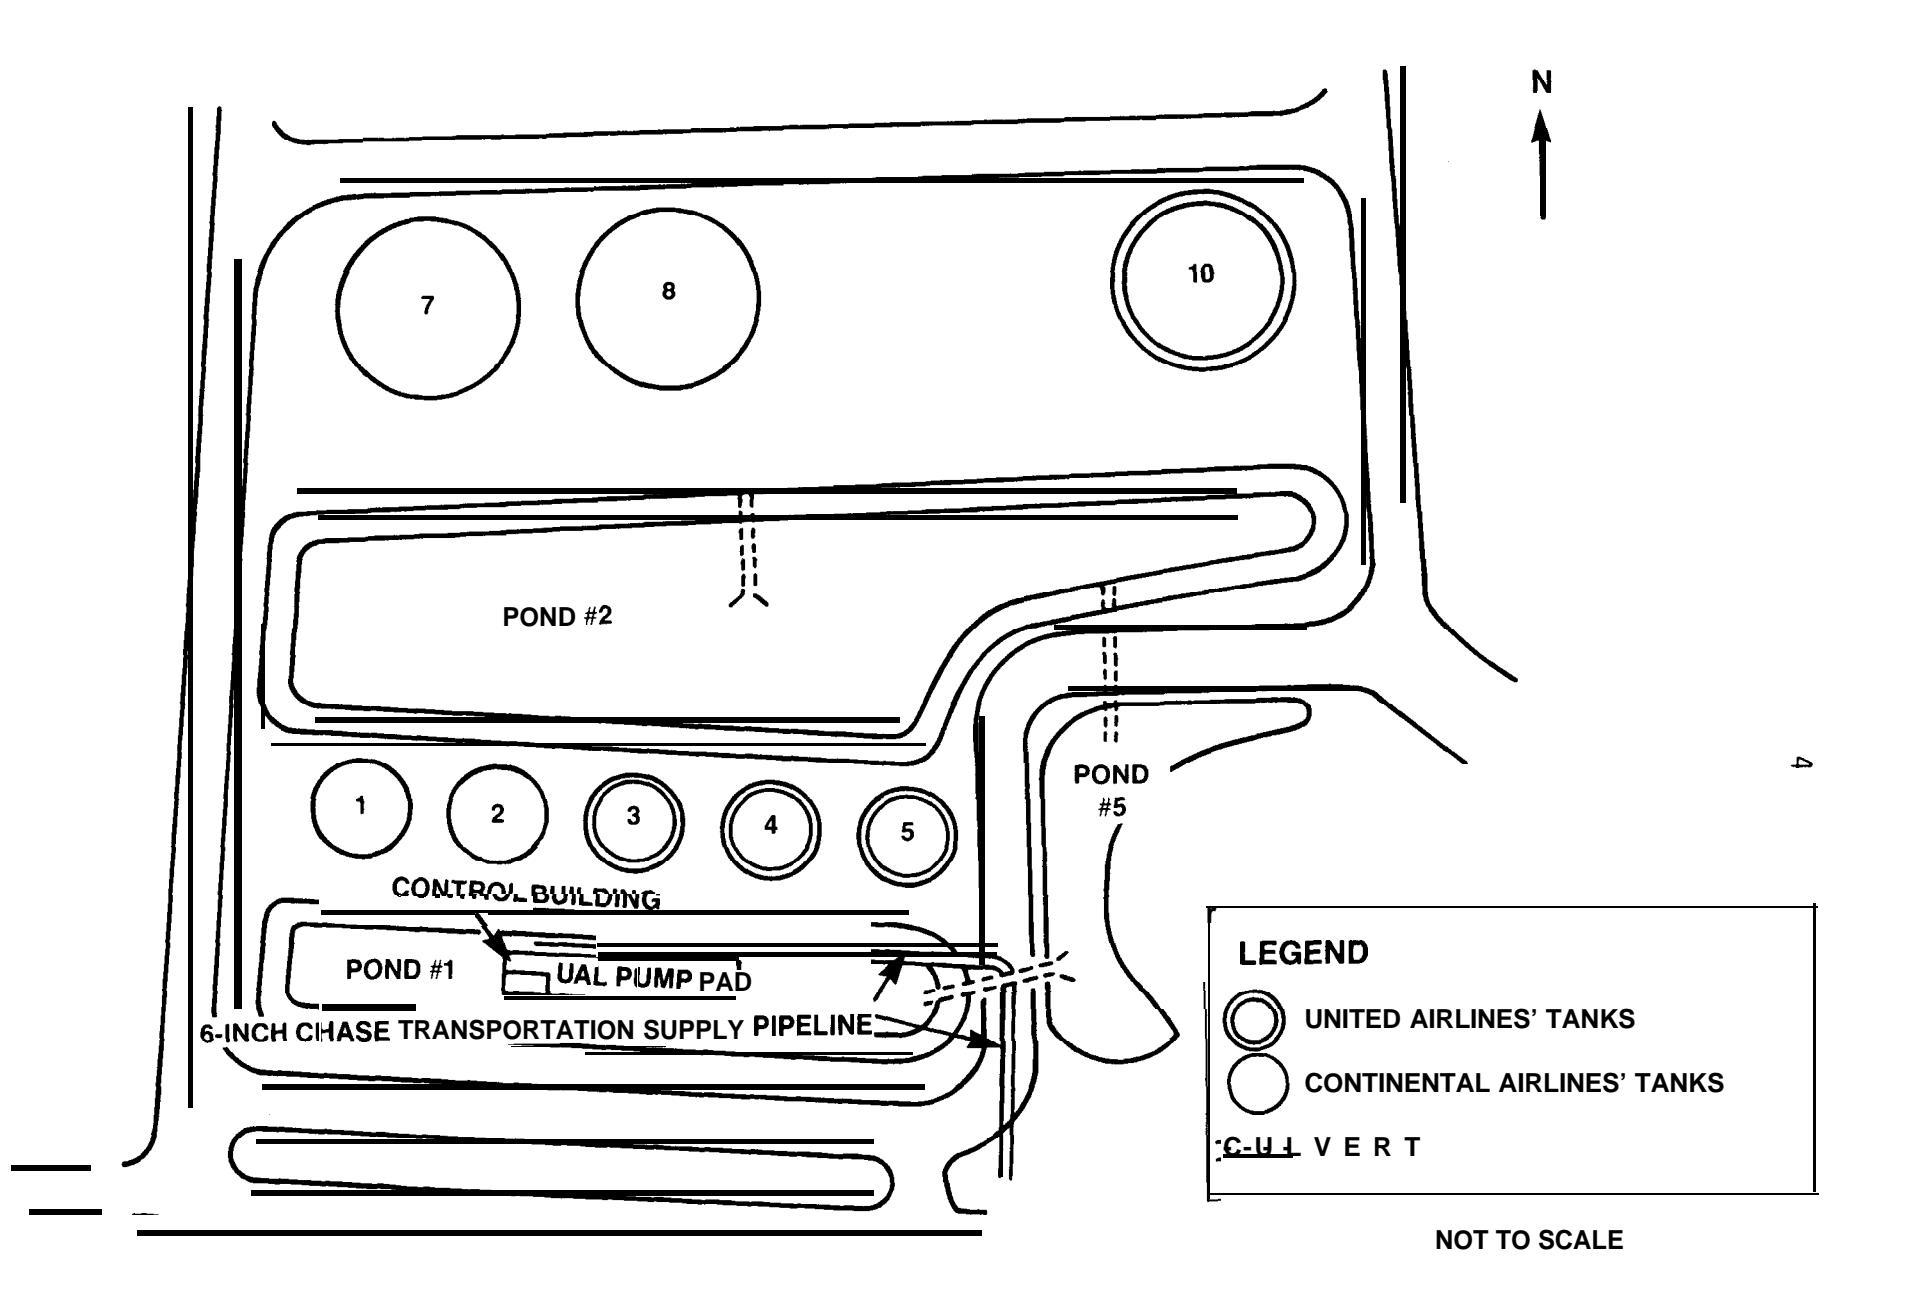
Figure 2. -- Portion of the fuel farm involved in the fire.

Arriving firefighting crews observed a large fire, near United's fuel tanks 3 and 4, in a containment area (pond 1)⁵ that contained pipes, pumps, valves, and a control building (see figure 2). Also, burning fuel was spraying from equipment in front of tanks 3 and 4 in "tentacles" 8 to 10 feet long.

About 2130, a large amount of fuel began to flow into the containment area (pond 1). Firefighters stated that they believed that this increase in fuel was caused from the release of a discharge pipe attached to tank 4. Fuel and water began overflowing pond 1 and flowed into pond 2 via pond 5 (see figure 2). Burning fuel was then impinging on tanks 1 and 10, in addition to tanks 2, 3, 4, and 5. As flames from the burning fuel continued to impinge on tanks 1 and 2, firefighters applied hose streams directly on those tanks to keep them cool and to preclude their rupture.

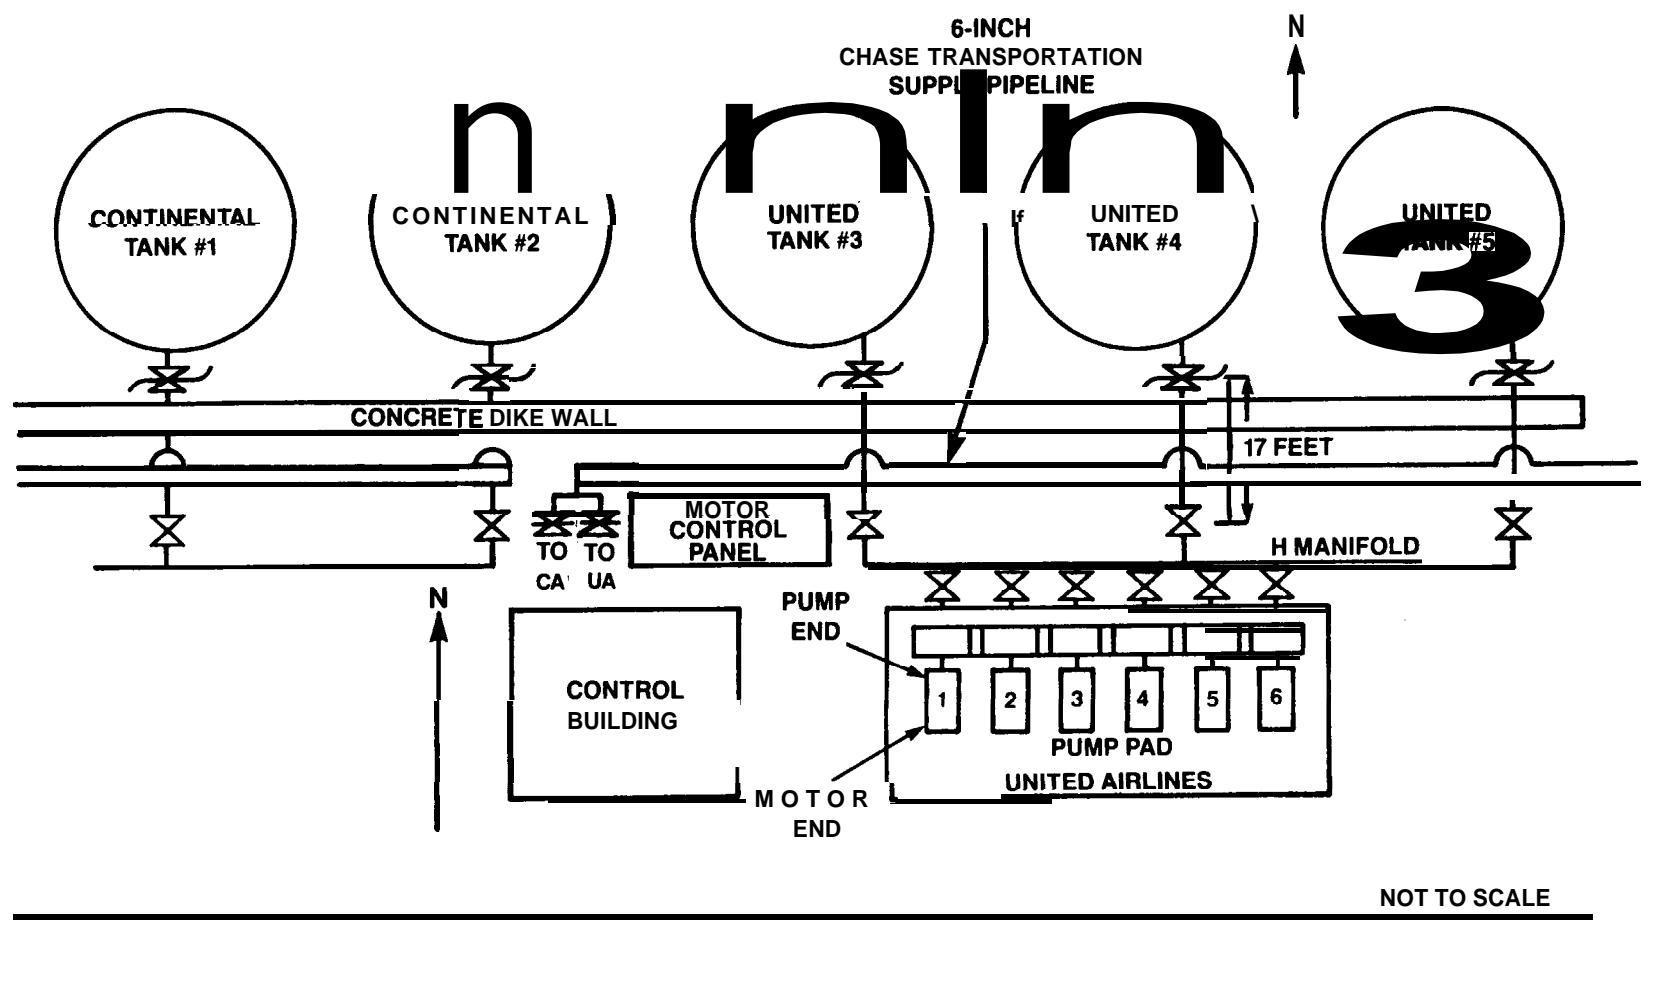
Figure 5. — Location of various valves in relation to tanks and motor/pump units.

The inlet/outlet piping on tanks 1, 2, 3, 4, 5, 7, 8, and 10 had manually operated "butterfly" values at the base of each tank." (See figure 5.) These fire-rated¹² steel values were bolted externally onto the tank outlets. According to United, these values were primarily closed for maintenance purposes, but were otherwise normally left open.

Tanks 1 through 5 had pneumatically operated control values on both the inlet and outlet piping located about 17 feet from the manually operated "butterfly" values. (See figure 5.) These values on the piping for tanks 1, 3, and 4 were designed to automatically close if electrical power was lost and air pressure remained on the value's operating control system In the event air pressure was also lost, the values would have to be closed manually. The pneumatically operated control values on tanks 2 and 5 were fail-safe in the sense that they were designed to automatically close (spring loaded) if either electrical or air pressure was lost. The compressors providing the air supply for operating these values were located in the control building, which was located in the containment area (pond 1).

United Airlines piped fuel from tanks 3, 4, and 5 to six motor/pump units (see figure 5) that discharged fuel into a manifold that was connected to underground pipelines that ran to the airport terminal for fueling aircraft.¹⁴ The number of pumps in operation at any particular time depended on fuel demand, measured by line pressure and fuel flow. Each month a different motor/pump unit was designated as the lead pump; other pumps would automatically be switched on as determined by fuel demand. For the month of November. pump 4 was the lead pump. As demand dictated. pump 3 would be activated after pump 4, followed by pumps 2, 1, 6, and 5. A 24-hour. 2-channel circular paper chart recorder recorded line pressure and fuel flow The chart recorder, the pumping controls, and associated to the terminal. electrical equipment switches for the United fueling system were housed in the control building located in the containment area (pond 1) forward of tanks 2 and 3 (see figure 2).
