AIRCRAFT ACCIDENT REPORT

INADVERTENT IN-FLIGHT SLAT DEPLOYMENT
CHINA EASTERN AIRLINES FLIGHT 583
McDONNELL DOUGLAS MD-11, B-2171
950 NAUTICAL MILES SOUTH OF SHEMYA, ALASKA
APRIL 6, 1993

Adopted: October 27, 1993
Notation 6180

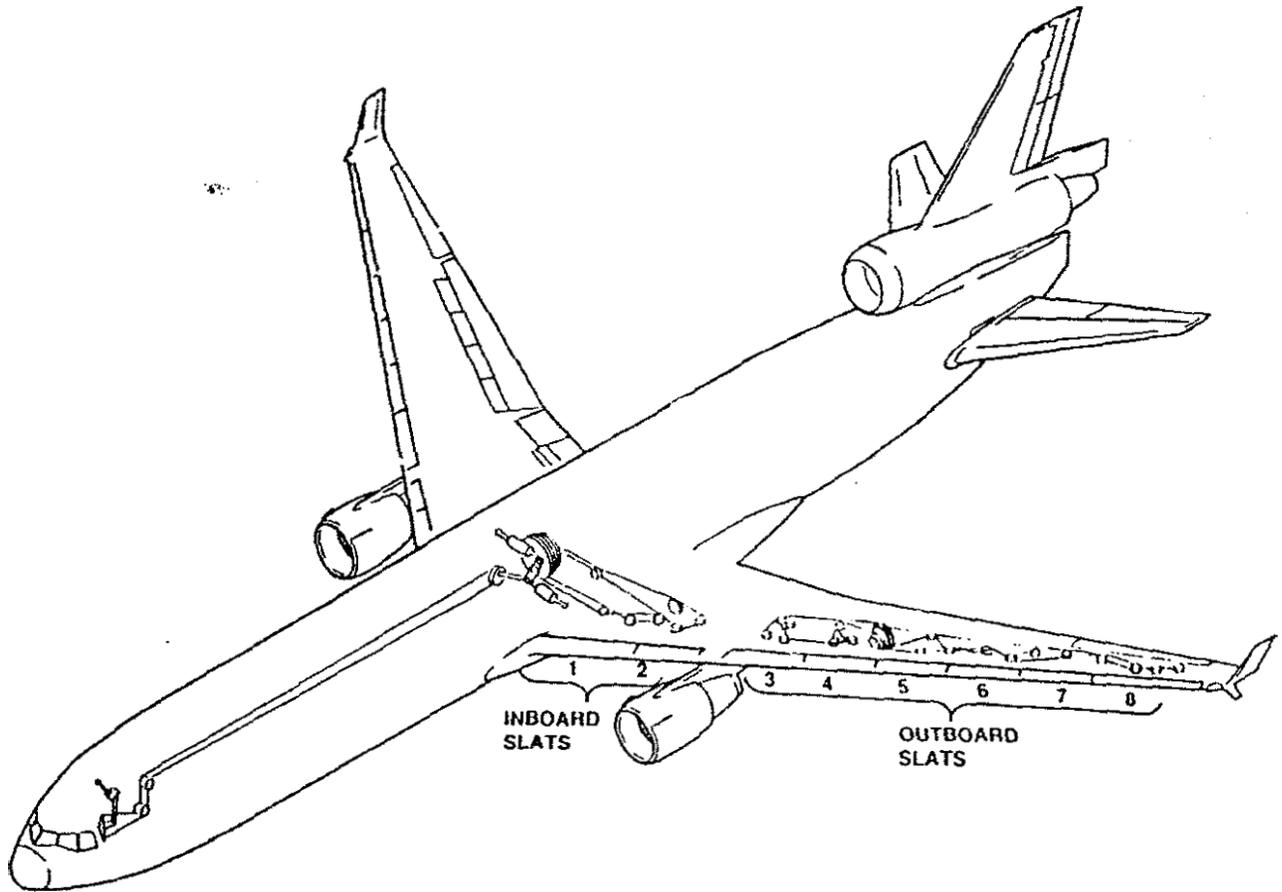
Figure 1.--Slat cable system.

The flap/slat handle moves a closed-loop control cable system (see figure 1) to operate the inboard slat control valve. The inboard slat control valve supplies hydraulic pressure to two inboard slat actuators. These actuators rotate the inboard cable drive drum to extend or retract the inboard slats. As the inboard slats extend or retract, follow-up cables and mechanical linkages move the outboard slat control valve.

The outboard slat control valve supplies hydraulic pressure to four outboard slat actuators. These actuators rotate the outboard drum to extend or retract the outboard slats. The slats are supplied pressure by two completely

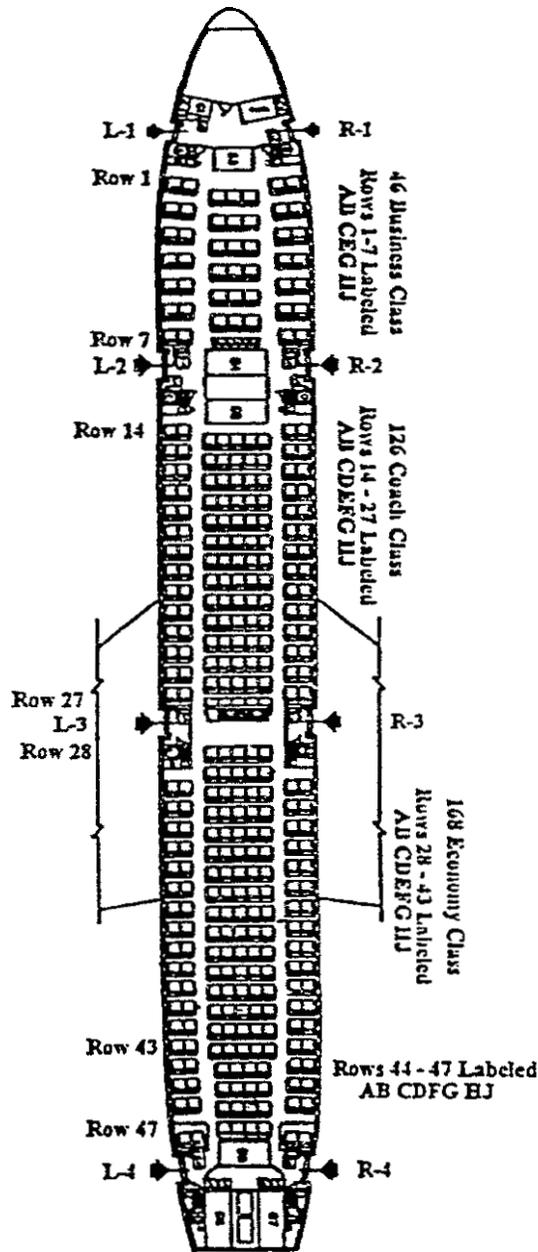
Figure 6.--Passenger cabin configuration.

The passenger cabin was configured for 46 business and 294 coach class seats. (See figure 6).
