# **NATIONAL TRANSPORTATION SAFETY BOARD**

## **AIRCRAFT ACCIDENT REPORT**

**RUNWAY OVERRUN FOLLOWING REJECTED TAKEOFF  
CONTINENTAL AIRLINES FLIGHT 795  
McDONNELL DOUGLAS MD-82, N18835  
LaGUARDIA AIRPORT  
FLUSHING, NEW YORK  
MARCH 2, 1994**

**Abstract:** This report explains the accident involving Continental Airlines flight 795, an MD-82 airplane, which experienced a runway overrun following a rejected takeoff from runway 13 at LaGuardia Airport, Flushing, New York, on March 2, 1994. Safety issues discussed in the report include the availability of takeoff performance data for flightcrews, the proper functioning of pitot/static heat systems, the duration of cockpit voice recordings, and problems associated with passenger evacuations from airplanes. Safety recommendations concerning these issues were addressed to the Federal Aviation Administration and to Continental Airlines, Inc.

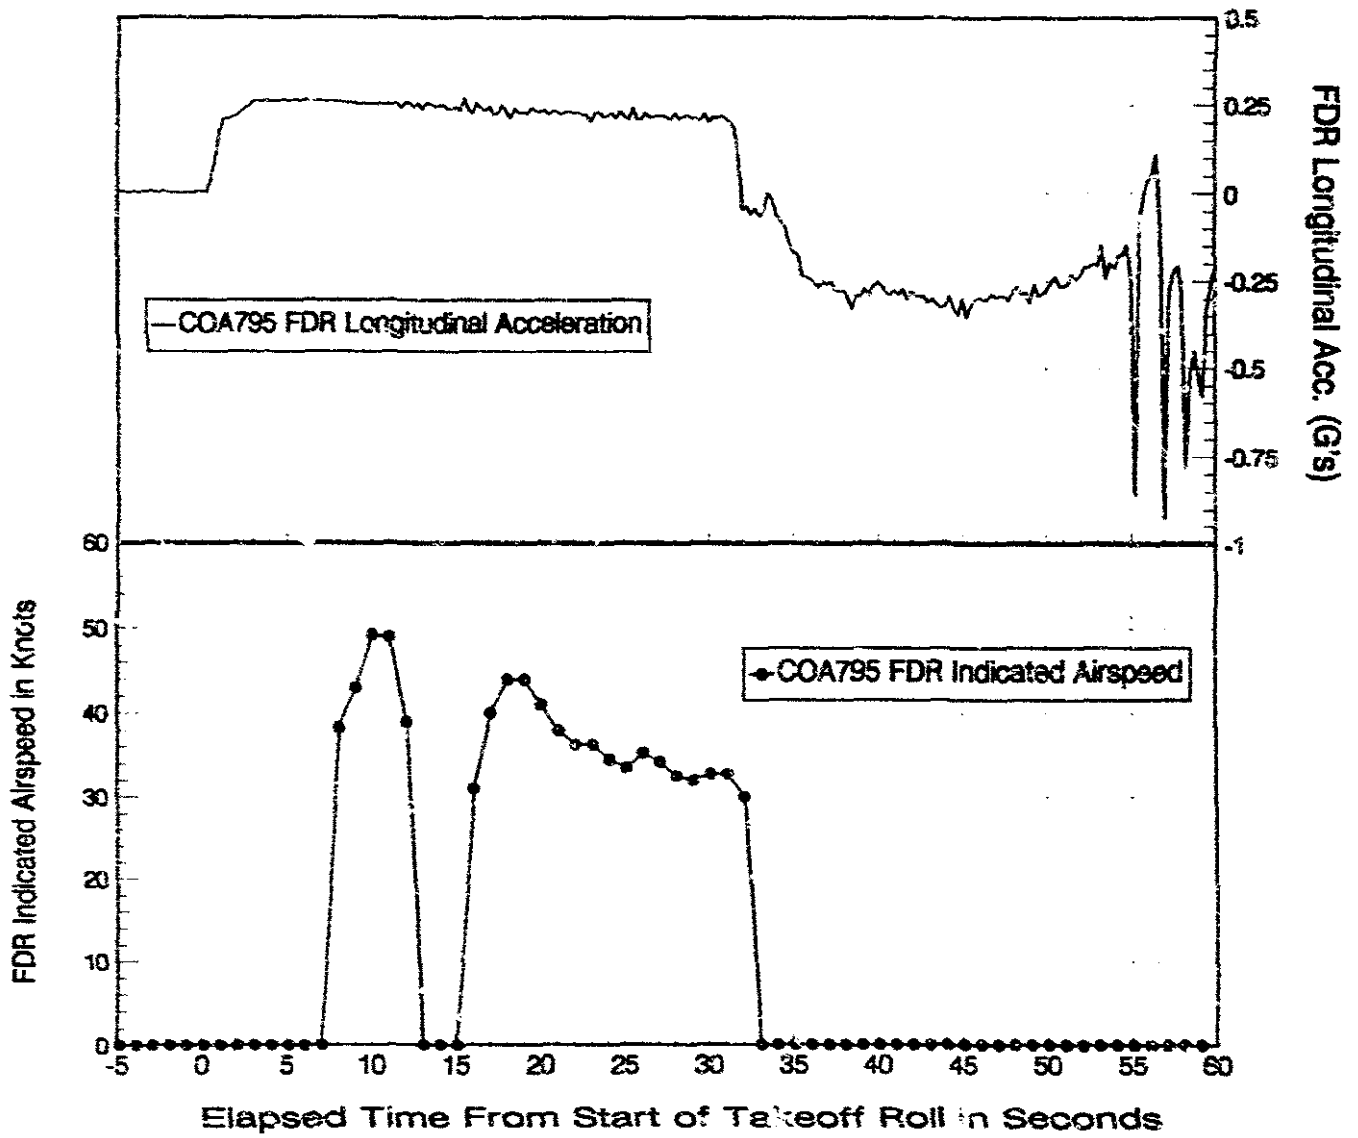
Figure 4.--FDR data.

The FDR indicated airspeed data were determined to be erroneous. Therefore, an airplane performance study was accomplished to determine groundspeed and time-distance histories of the airplane. Additionally, various takeoff/stop scenarios were examined. FDR longitudinal acceleration data, FDR pitch data, and prevailing winds were used to calculate indicated airspeed and distance traveled during the takeoff roll. (See figure 4).
