PB95-910404
NTSB/AAR-95/04
DCA95MA007

AIRCRAFT ACCIDENT REPORT

CRASH DURING EMERGENCY LANDING
PHOENIX AIR
LEARJET 35A, N521 PA
FRESNO, CALIFORNIA
DECEMBER 14, 1994

Abstract: This report explains the accident involving the Phoenix Air Learjet 35A that crashed while attempting an emergency landing at Fresno Air Terminal, Fresno, California, on December 14, 1994. Safety issues in the report focused on maintenance, inspection and quality assurance. Safety recommendations concerning these issues were made to the Federal Aviation Administration, Phoenix Air, and the Department of Defense.

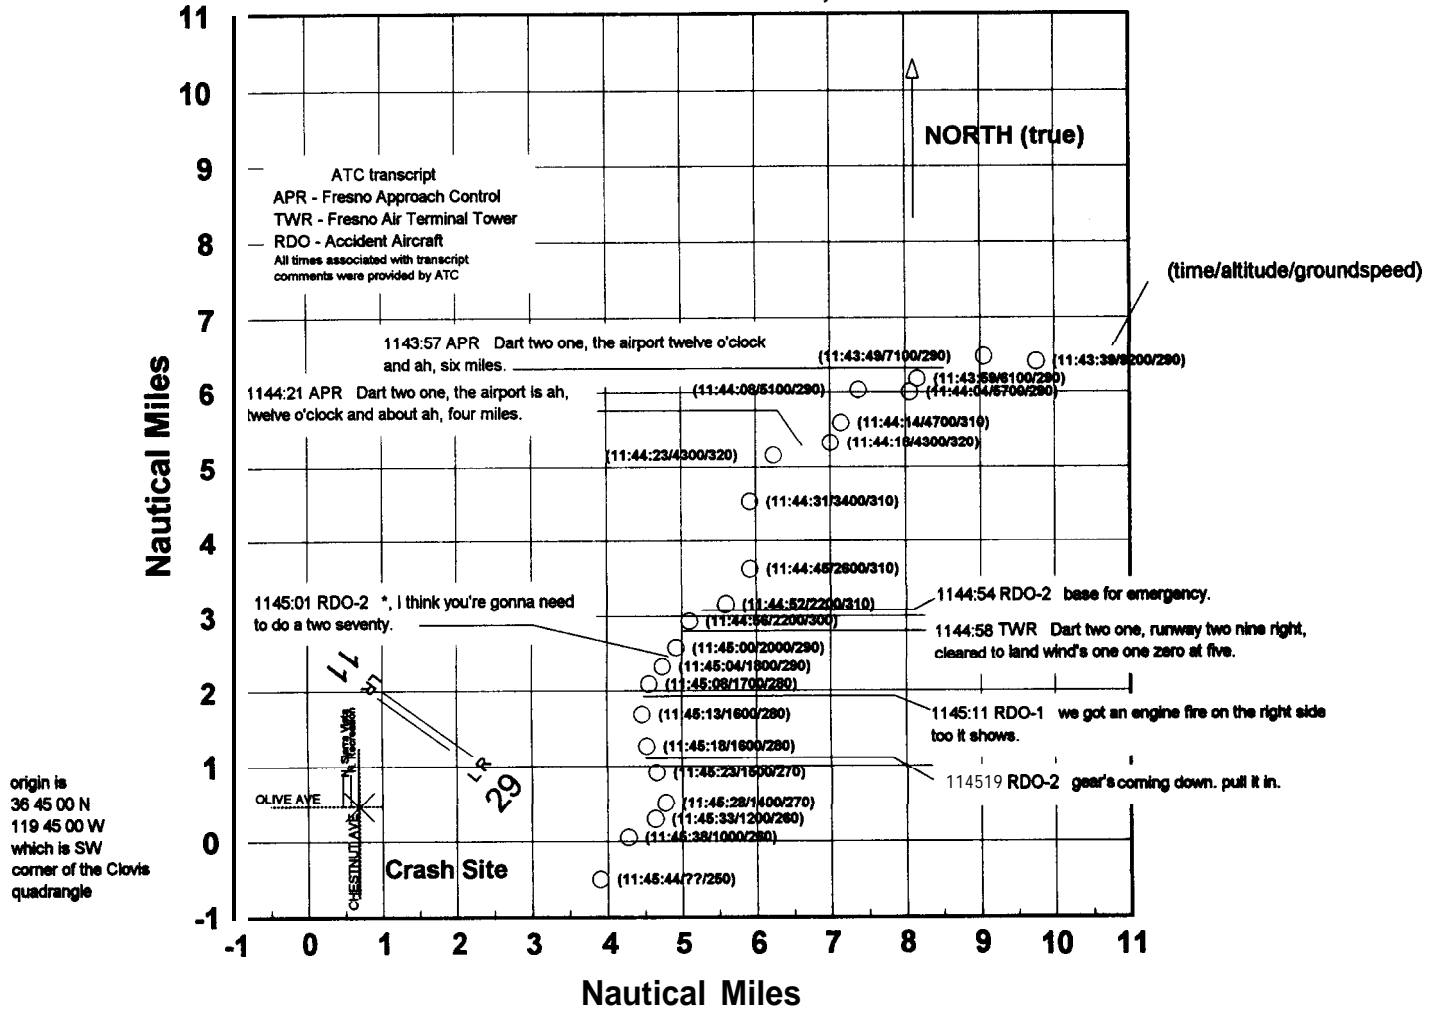
Figure 1 a.--Ground track.

About 1145:01, as Dart 21 was about 3 miles east-northeast of the approach end of 29R, on a track toward the southwest (see ground track and flight profile, from NAS Lemoore radar data and Fresno tower radio transmissions, figures 1a through 1c), the first officer stated, "I think you're gonna need to do a two seventy." At 1145:11, the captain stated, "we got an engine fire on the right side too, it shows." Radar data show that the airplane was flying at 280 knots ground speed, about 1,600 feet msl (the field elevation of FAT is 333 feet msl).

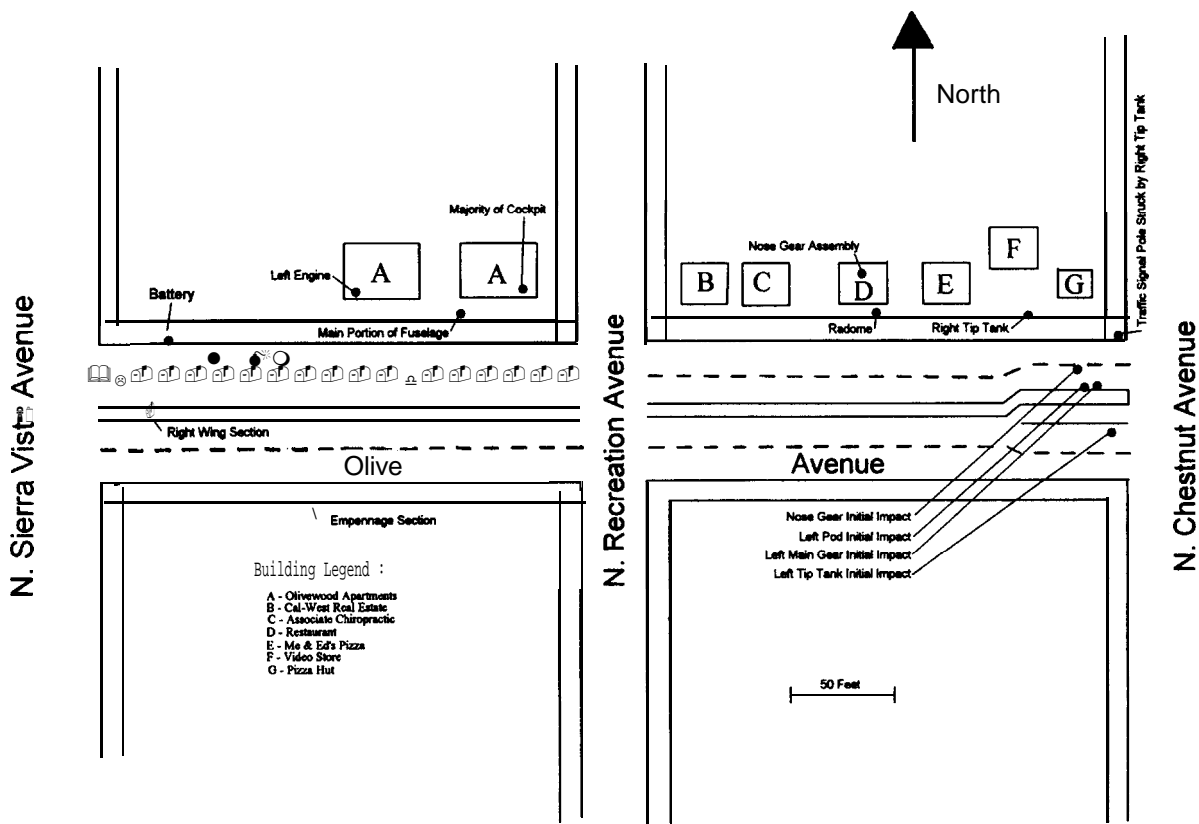
Figure 2c.--Wreckage path diagram.

observations show that the flight turned to the south, as if beginning a 270 degree turn to the left, but the flight then turned back to a southwesterly track and crossed the extended centerline about 2 miles from the approach end of 29R. Radar contact was lost about 1145:38 as the airplane descended below 1,000 feet msl at 250 knots. The airplane impacted to the west on East Olive Avenue (E. Olive) in Fresno, approximately 2 miles west-southwest of the approach end of 29R. (Figures 2a and 2b arc photographs of the accident site; and figure 2c is a wreckage path diagram.)
