AIRCRAFT ACCIDENT REPORT

**UNCONTROLLED COLLISION WITH TERRAIN
AIR TRANSPORT INTERNATIONAL
DOUGLAS DC-8-63, N782AL
KANSAS CITY INTERNATIONAL AIRPORT
KANSAS CITY, MISSOURI
FEBRUARY 16, 1995**

**Adopted: August 30, 1995
Notation 6538A**

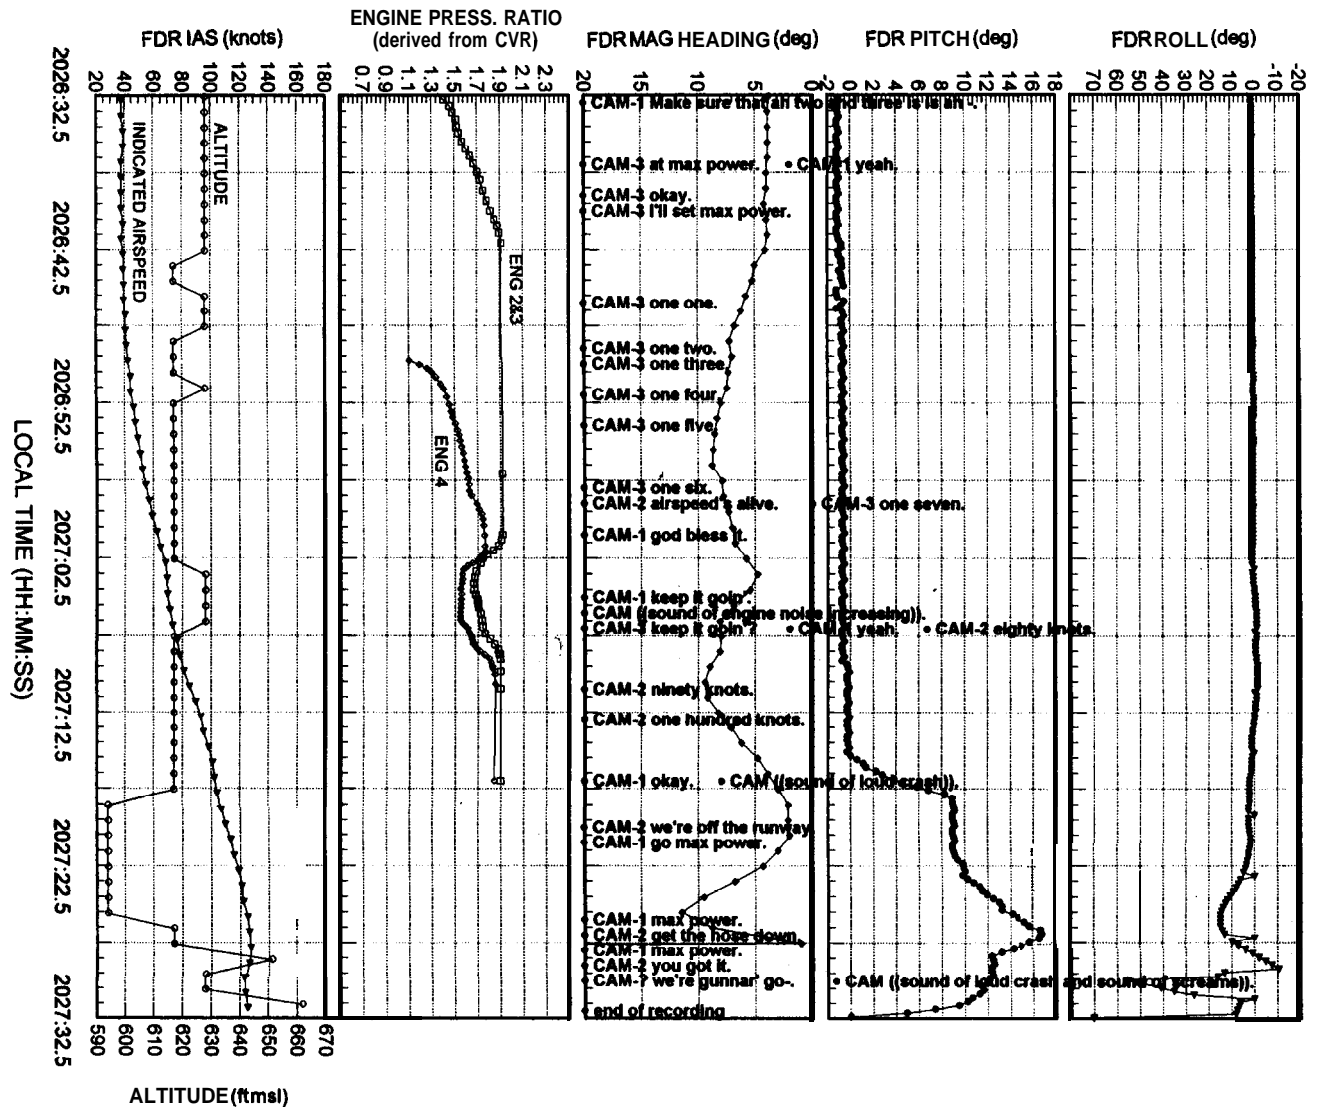
Figure 3.--FDR/CVR presentation.

The airplane was equipped with a Fairchild Model A100 cockpit voice recorder (CVR), S/N 2325, and a Sundstrand digital flight data recorder (**DFDR**), P/N **980-4100-60US**, S/N 7768. Both units were mounted in a compartment in the aft fuselage below the cargo bay floor. Both units were found separated from their mounts. Only minor dents in the outer cases were seen. There was no evidence of fire damage. DFDR information is included in figure 3, and a transcript of the CVR recording is included in Appendix B.

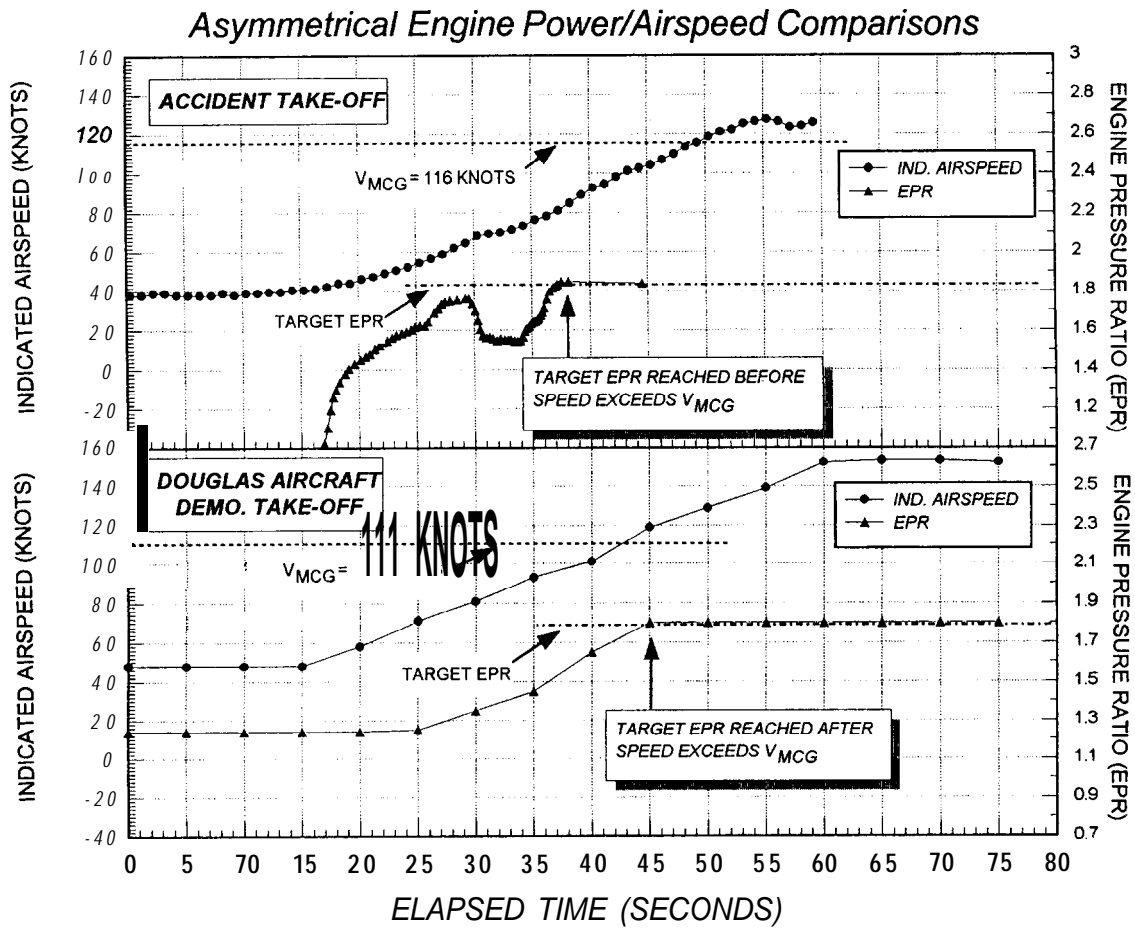
Figure 7.--No. 4 engine EPR/IAS comparison.

On the accident takeoff, the power on No. 4 engine was increased by the flight engineer at a more rapid rate than on the first takeoff. For instance, on the second takeoff, 1.6 EPR was called 1 second before the “airspeed alive” call (50 to 60 knots), whereas on the first takeoff, 1.6 EPR was called 1 second before 80 knots. See figure 7.

The accident takeoff is compared to a Douglas demonstration of an ideal three-engine takeoff in figure 7. On the accident takeoff, the power on the No. 4 engine was increased at a more rapid rate than on the first takeoff. For instance, on the second takeoff, 1.6 EPR was called 1 second before the airspeed alive call (50 to 60 knots), whereas on the first takeoff, 1.6 EPR was called 1 second before

The high rate of asymmetric throttle application by crewmembers in both the attempted takeoffs precluded successful completion of the maneuver. However, the Safety Board believes that even with the proper application of asymmetric throttle during a three-engine takeoff, the margin of safety is quite small. The procedure now calls for arriving at full takeoff power on the asymmetric engine at the computed V_{mcg} to provide for the minimum possible takeoff roll. A properly executed three-engine takeoff also entails full rudder application at the computed V_{mcg} . Any adverse crosswind condition, for instance, would place the flightcrew in a position in which they could not have full control of the airplane due to a loss of rudder authority. In addition, it is very difficult to time the throttle application to arrive at full power at exactly the computed V_{mcg} given the spool-up lag inherent in turbine engine operation.

A flightcrew, therefore, invariably reaches full asymmetric power early, and accepts a certain loss of directional control, or reaches full asymmetric power late, and accepts a longer takeoff roll. The Safety Board considers the latter to be the safer course of action, and believes that manufacturers should revise one-engine inoperative takeoff procedures to provide adequate rudder availability for correcting directional deviations during the takeoff roll compatible with the achievement of maximum asymmetric thrust at an appropriate speed greater than ground minimum control speed. Performance figures and runway requirements considering these factors should also be determined.
