NATIONAL TRANSPORTATION SAFETY BOARD

AIRCRAFT ACCIDENT REPORT

WHEELS-UP LANDING
CONTINENTAL AIRLINES FLIGHT 1943
DOUGLAS DC-9 N10556
HOUSTON, TEXAS
FEBRUARY 19, 1996

**Adopted: February 11, 1997
Notation 6804**

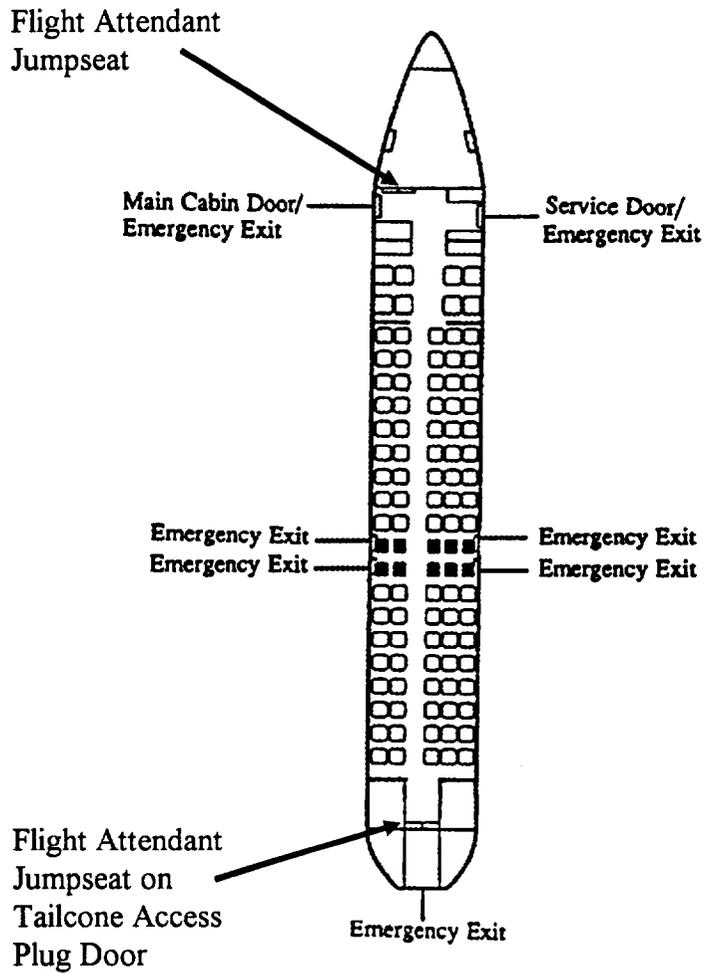
Figure 3 – Cabin configuration.

Two floor-level exits were located in the forward cabin, four overwing exits were located at seat rows 15 and 16, and a tailcone exit was located at the rear of the cabin. (See figure 3.) Access to the tailcone was provided by a plug-type door in the center of the aft cabin bulkhead.²⁹ With this type tailcone access door, the shoulder harnesses for the flight attendants occupying the aft jumpseat are mounted to the plug door, and the flight attendant lap belts are attached to the aft cabin bulkhead. If one or more of the jumpseat shoulder harness straps are buckled to the lap belt, this ties the plug door to the bulkhead and interferes with the removal of the door during an emergency evacuation.

Subsequent to the accident, on September 16, 1996, COA issued “Inflight Safety Bulletin #96-07” to all flight attendants. The subject of the bulletin was the “Aft Jumpseat Harness on DC-9 Ship #557 (Plug Door).” The bulletin provided information on how to prevent blocking a useable exit during an evacuation. It emphasized the need to fully rotate the release knob when unfastening the jumpseat restraining harness to ensure that the shoulder straps release and cautioned flight attendants never to leave the shoulder harness attached to the seat belt. On October 16, 1996, COA issued a revision to the Inflight Manual that included the following note concerning the plug door:
