STUDY OF LESSONS TO BE LEARNED FROM ACCIDENTS ATTRIBUTED TO TURBULENCE

NATIONAL TRANSPORTATION SAFETY BOARD,
WASHINGTON, D.C.

15 DEC 1971

Doc
NTSB
AAS
71
01

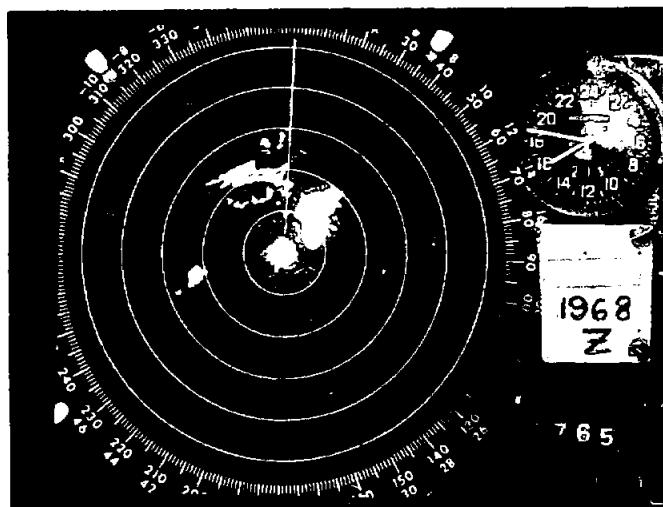
Figure 1

The turbulence was encountered between about 1545 and 1552 G.m.t. within approximately 50 nautical miles of an operating WSR-57, long range, ground-based weather radar, whose operator was photographing the Plan Position Indicator (PPI) scope. Figs. 1, 2, and 3, are enlargements of several of those photographs. In all three photographs, the radar was on the 250-mile range and the range markers were at 50-mile intervals. In Fig. 1 and 2, which were taken during the turbulence encounter, there was 1/2 degree antenna uptilt; while in Fig. 3, taken shortly after the encounter, the antenna uptilt was 3°. Cell penetration is estimated to have occurred at about the 50-mile range marker east-northeast of the antenna. Tops in that cell at the time of the encounter
