SPECIAL STUDY OF THE CARRIAGE OF RADIOACTIVE MATERIALS BY AIR

Adopted: April 26, 1972

NATIONAL TRANSPORTATION SAFETY BOARD Washington, D. C. 20591 REPORT NUMBER: NTSB- AAS-72-4 TECHNICAL REPORT STANDARD TITLE PAGE

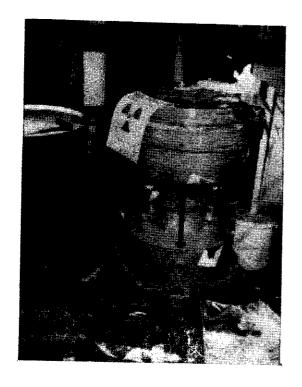
ATTACHMENT A-1-2

Typical PRIMARY CONTAINER
Polyethylene bottle

SECONDARY CONTAINER "PIG" Stainless steel/lead lined Bio-Nuclear package # 40
