# SPECIAL STUDY **TURBINE ENGINE ROTOR DISK FAILURES**

ADOPTED: DECEMBER 18, 1974

NATIONAL TRANSPORTATION SAFETY BOARD Washington, D.C. 20594

REPORT NUMBER: NTSB-AAS-74-4

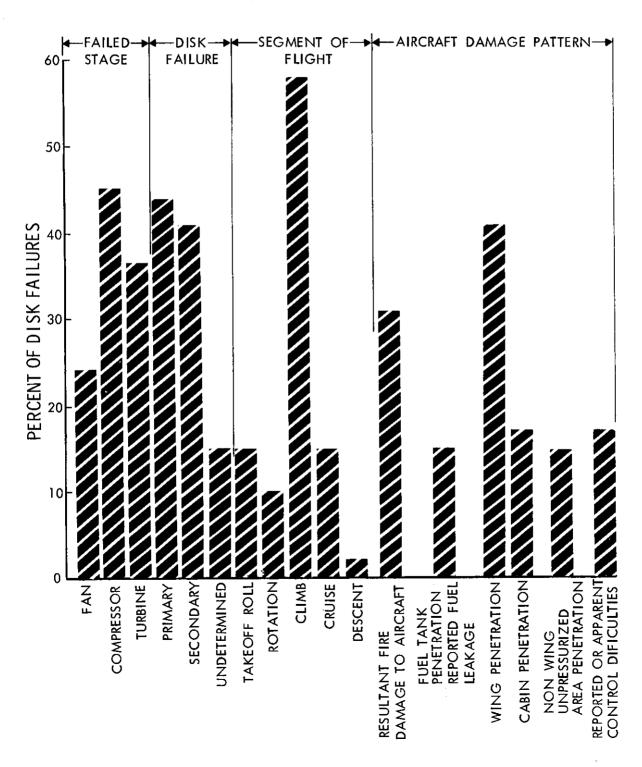
# ANALYSIS OF DISK FAILURE DATA Graphic Analytical Summation Operational Information

The segment of flight section incorporated in Table 1 shows that there were six failures during the takeoff roll, or 15 percent of the total failures. The number of failures during aircraft rotation speed (VR) and takeoff safety speed (V2) was four, which comprised 10 percent of the total failures. The time period beginning during the latter stages of the takeoff roll through V2 is considered to be the most hazardous time for a disk failure to occur. Thus, the combined failure rates during the takeoff roll through V2 are considered quite high in view of the hazard potential to the aircraft. The climb segment of the flight was more prone to disk failures; 58 percent occurred during this segment of flight. Two of these failures occurred during an en route climb from the affected aircraft's assigned altitude. Only one disk failure occurred during descent or 2 percent of the total segment of flight failures. aircraft damage pattern incorporated in Table 1 shows that fire and wing penetration had the highest failure incidence. There were 17 wing penetrations and 13 instances of fire damage to the aircraft, giving failure rates of 41 and 31 percent, respectively. The remaining parameters of fuel tank penetration and reported fuel leakage, cabin penetration, nonwing unpressurized area penetrations, and control difficulties occurred at about the same levels of incidence. There were six fuel tank penetrations and reported fuel leakage and six nonwing unpressurized area penetrations, which was equal to a 6-percent failure rate. Seven cabin penetrations and seven reported or apparent control difficulties occurred as a result of disk failures. This equated to a 17 percent failure rate.

It should be noted that the aircraft damage pattern may have involved one or more damage pattern parameters. The above data is also in the bar graph on page 14 and depicts the percent of disk failures for each operational parameter.

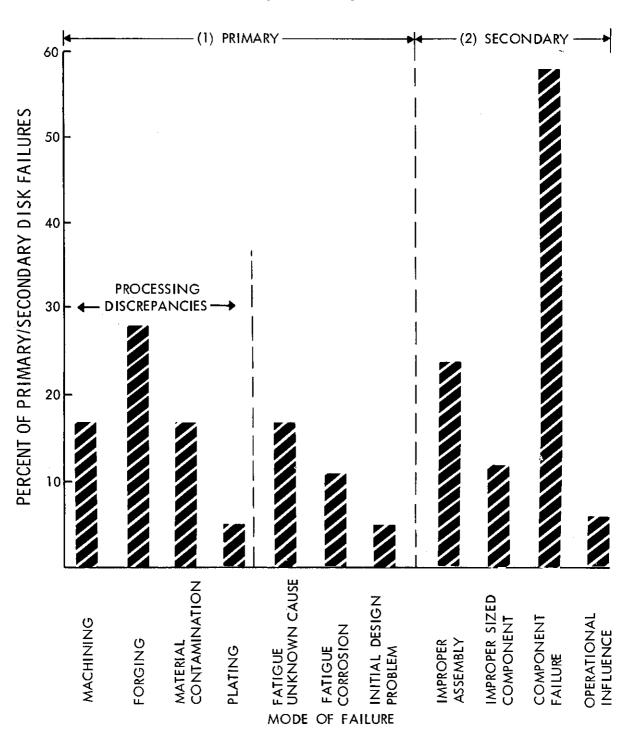
### ANALYSIS OF DISK FAILURE DATA Graphic Analytical Summation Primary/Secondary Failures

Of the 41 case histories that are shown in Table 1, it was determined that there were 18 primary, 17 secondary, and 8 unknown types of failures. Using a baseline figure of 41 cases, it was determined that there were 44 percent primary failures, 41 percent secondary failures and 15 percent unknown causes or types of failures. These data are also shown in bar graph form on page 15.
