# NATIONAL TRANSPORTATION SAFETY BOARD

**CABIN SAFETY IN LARGE  
TRANSPORT AIRCRAFT**

NTSB-AAS-81-2

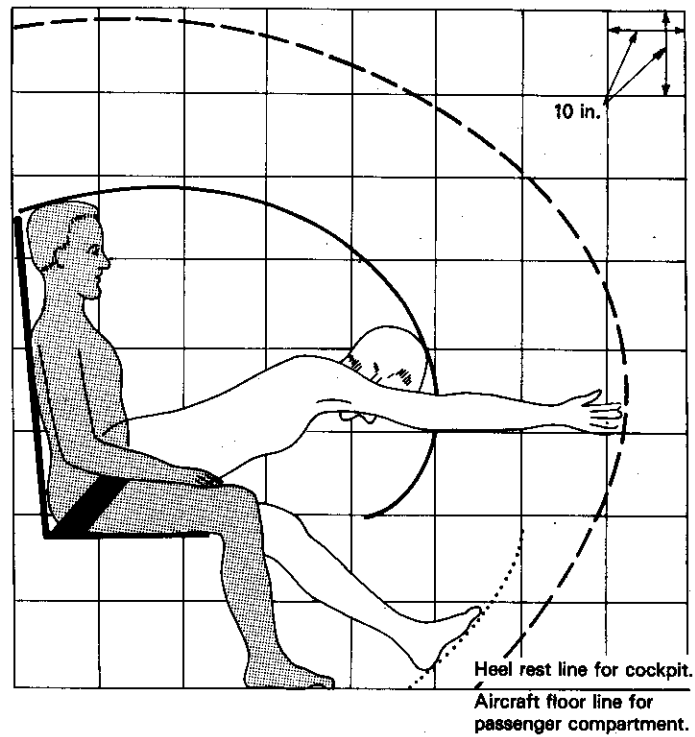
Figure 15 shows the strike envelope of a 95th percentile army aviator, restrained by lap belt only. Although the body measurements are not representative of the airline

passenger population as a whole, they probably represent at least part of the upper percentiles of the aircraft passenger population in terms of size and weight. In this case, the head will travel through an arc where maximum extension is about 45 to 50 inches forward of the seat back. The seat pitch (the distance between similar points on seats in the next row forward or behind, measured horizontally) in air transport aircraft averages about 32 inches. Figure 16 shows the relationship of the strike envelope to seat position in this case. With a lap belt only, the seats become injurious objects within the head strike envelope. This would also be true for individuals whose statures are less than that of the 95th percentile model. Notice also the flailing envelope of the arms and legs. Injuries to these extremities incapacitate occupants so that they are unable to easily release their seatbelts because of arm and hand injuries, or to evacuate the aircraft because of leg and foot injuries. Flailing body extremities which contact other seats also contribute to the loads acting on those seats, increasing the chances of the seats failing. 11/

Figure 15.--Lap-belt-only extremity strike envelope-side view.  
(From Crash Survival Design Guide, USARTL-TR-79-22.)

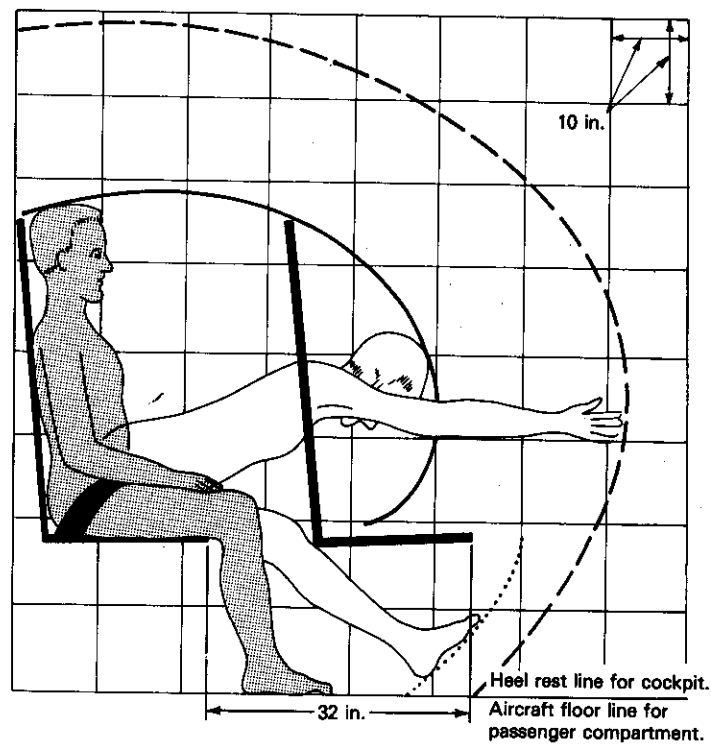
Figure 16.--Lap-belt-only extremity strike envelope-side view.  
(From Crash Survival Design Guide, USARTL-TR-79-22.)

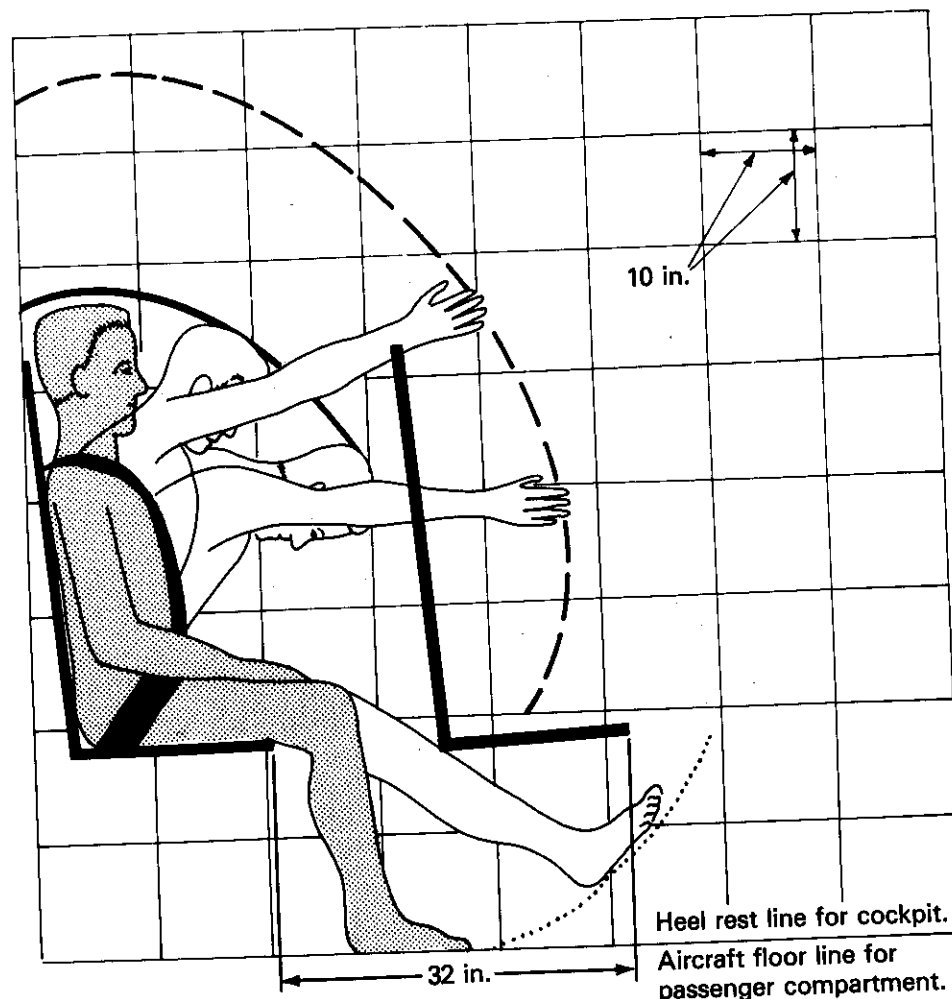
An individual is much better protected from head injury with the shoulder harness, even with a reduced seat pitch. (See figure 17.) In addition, the occupant's tolerance to forward acceleration would be increased greatly.

Figure 17.--Full-restraint extremity strike envelope-side view.  
(From Crash Survival Design Guide.)
