*Accident
on 25 July 2000
at "La Patte d'Oie"
in Gonesse (95),
to the Concorde,
registered F-BTSC,
operated by Air France*

INTERIM REPORT (15/12/2000)

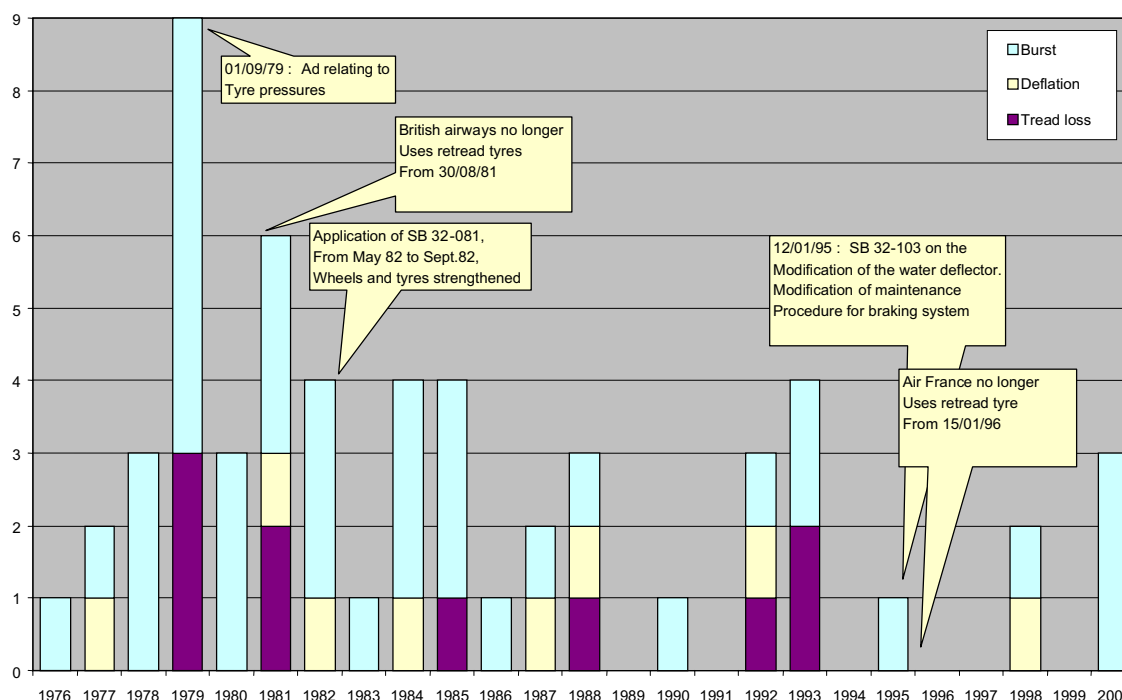
History of events involving tyres on Concorde (AFR ; BA ; confirmed)

- Twelve of these events had structural consequences on the wings and/or the tanks, of which six led to penetration of the tanks.
- Nineteen of the tyre bursts/deflations were caused by foreign objects.
- Twenty-two events occurred during takeoff.
- Only one case of tank penetration by a piece of tyre was noted.
- None of the events identified showed any rupture of a tank or a fire, whether leading or not to a significant simultaneous loss of power on two engines.

Twenty-one other events were notified by a single source, but no reports or detailed information exist for them. No mention was made of damage to the structure or the wings in any of them.

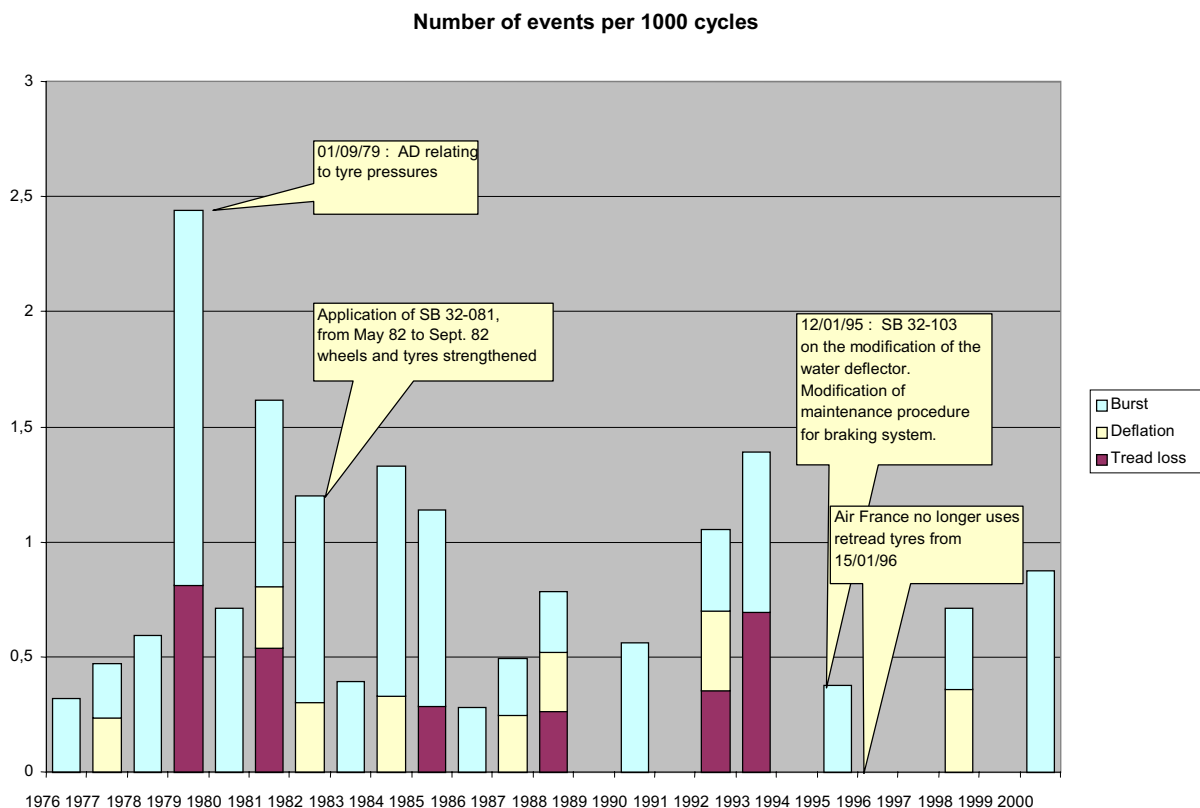
Reduced to the number of cycles, the evolution in the number of events is represented hereafter :

Note : bearing in mind the small number of events taken into account in this statistical approach, evolutions shown in this graph can only give an overall qualitative idea .
