*Accident
on 25 July 2000
at “La Patte d’Oie”
in Gonesse (95)
to the Concorde
registered F-BTSC
operated by Air France*

Interim report (10/07/2001)
f-sc000725ae2

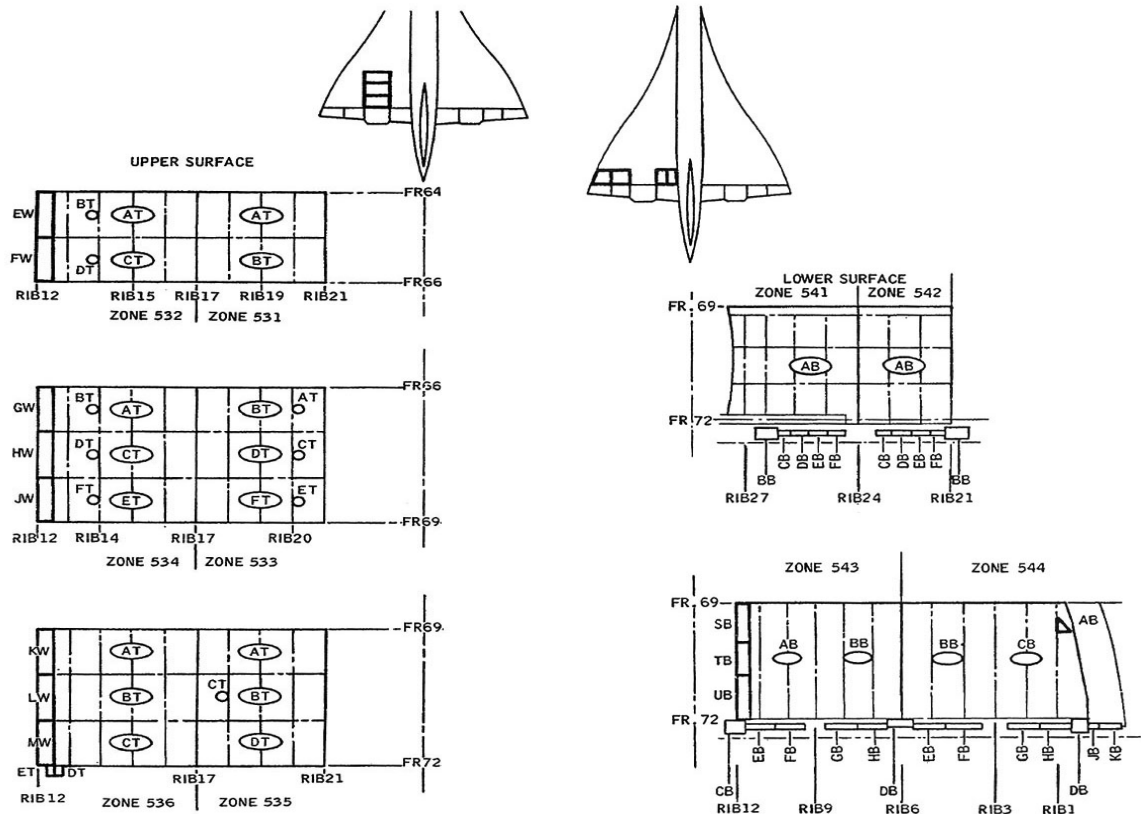
Figure 16: Dry bays

The dry bay located above engines 1 and 2 was examined by the technical investigators and their advisors. At the time of impact, it was broken off between ribs 12 and 21. All of the lateral partitions were destroyed. The heat shield was generally intact except for an indentation on impact at the level of the engine 2 nacelle.

Door 531BT was still attached to the upper surface of the bay. Door 532CT was found melted into its housing. These two doors provide access to the forward part of the dry bay. This bore no signs of overpressure, there were no traces of flames inside and the partition separating them from the aft part was generally intact. Only the tank 2 LP fuel supply valves were found there.

Eight doors located on the upper surface and providing access to the aft part of the dry bay were found under the path of the aircraft on the runway centreline extension. None of the doors bore any traces of fire. Two of the doors were equipped with an overpressure valve which opens at a pressure estimated at 200 mbar. The two valves were closed and door 535AT was bulged out as a result of overpressure directed from the inside to the outside. The valve opening rods had buckled under the effect of the distortion, which shows that the valves had no time to open. Lower surface door 541AB, which communicates with the aft part of the dry bay, was also found in the runway extension area. The section of the wing surrounding this door was found at the crash site. Both parts bore traces of soot clearly indicating the passage of the flame over the lower surface of the wing.

Examinations showed that the aft part of the dry bay as well as the communicating areas suffered a very violent overpressure after takeoff, leaving no time for the overpressure valves to open. The door latches broke off as a result of this overpressure. The manufacturer estimates that a pressure of about 450 mbar on a door could lead to the rupture of the most loaded axis. Combustion of an air/kerosene mixture in the enclosed space of the dry bay could generate an overpressure which could reach a few bars in a few tenths of a second (stoichiometric mixture). Transition from combustion to detonation (propagation of a wave of combustion at supersonic speed) can generate a shock wave equivalent to pressure rise of several dozen bars.

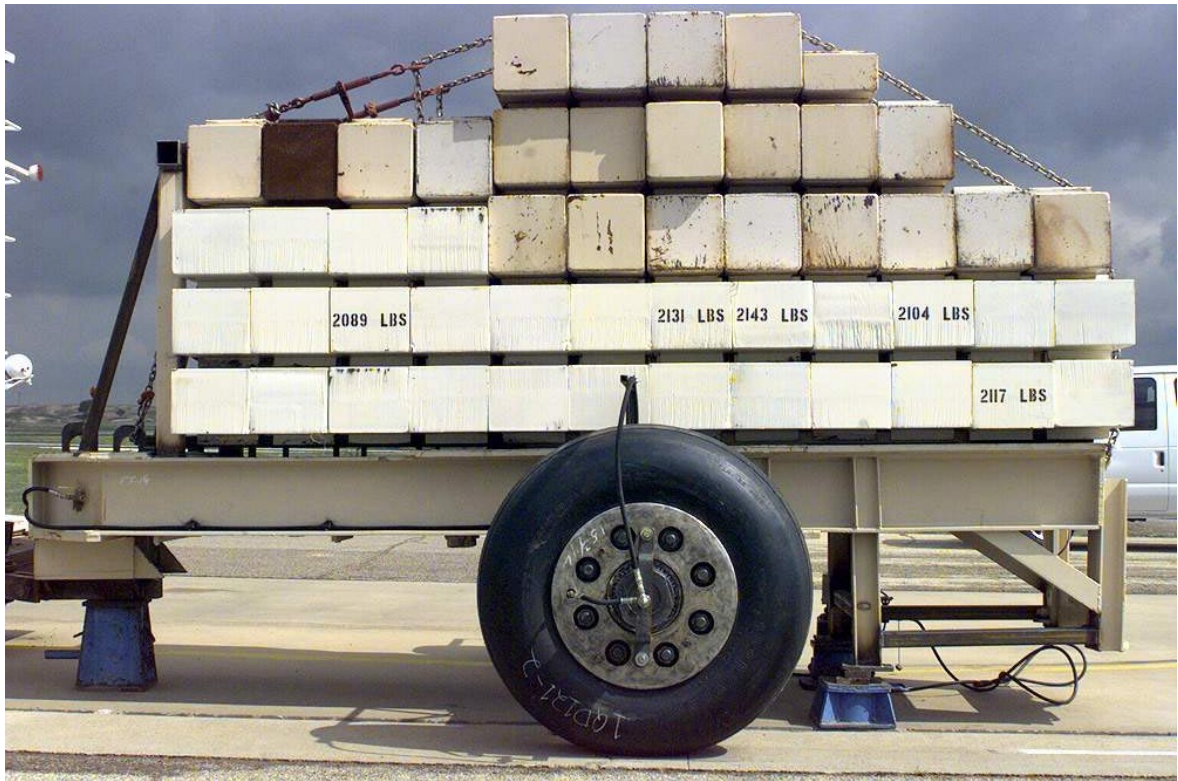
Figure 22: Tyre Test Installation

Two Concorde tyres were used for these tests. One of the strips used was made of titanium, the others made of a stainless steel whose mechanical resistance characteristics are similar to titanium.

The tyres were installed on the side of a trolley towed by a truck. The load spread out on the trolley allowed each tyre to bear a load of about twenty-five tons, equivalent to that on each main landing gear tyre on Concorde. Taking into account the test equipment and the load, the speed of the truck was around 10 km/h.

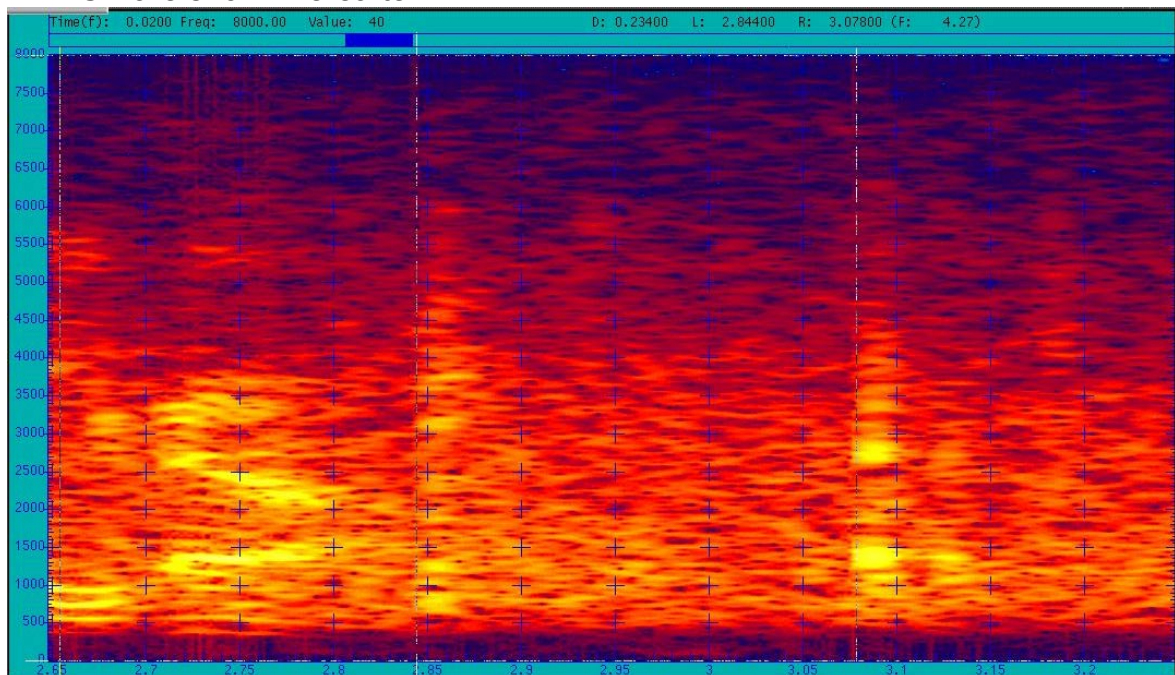
Noise of selector on F-BTSC (234 ms)

- Noise of selector at 14 h 43 min 21.3 s

The rate and auditory perception, as well as application of procedures, enabled this noise to be identified as being that of the movement of the TCU selector from “main” to “alternate”. The time-frequency analyses of the noise on F-BTSC and on F-BTSD are shown hereafter.

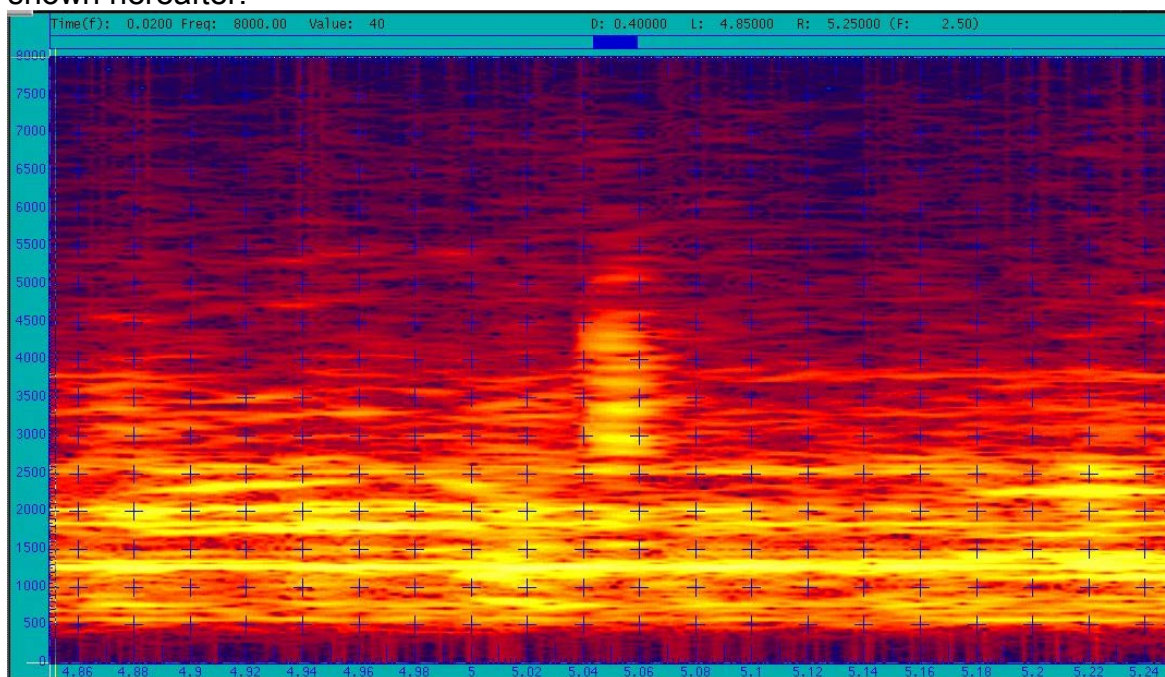
Noise of selector on F-BTSC

- Noise of selector at 14 h 43 min 26.2 s

On the FDR a decrease in engine speed is noted after this selector noise. There were four hypotheses to explain this decrease in speed. The first was independent of crew action in the cockpit, the three others were respectively an action on the thrust lever, a cut through movement of the HP fuel cock or a de-selection of auto-thrust. The spectral representation is very close to that of a thrust lever reduction or a HP fuel cock shutoff, though it is impossible to distinguish between them. The time-frequency analyses of the noise on F-BTSC and on F-BTSD are shown hereafter.

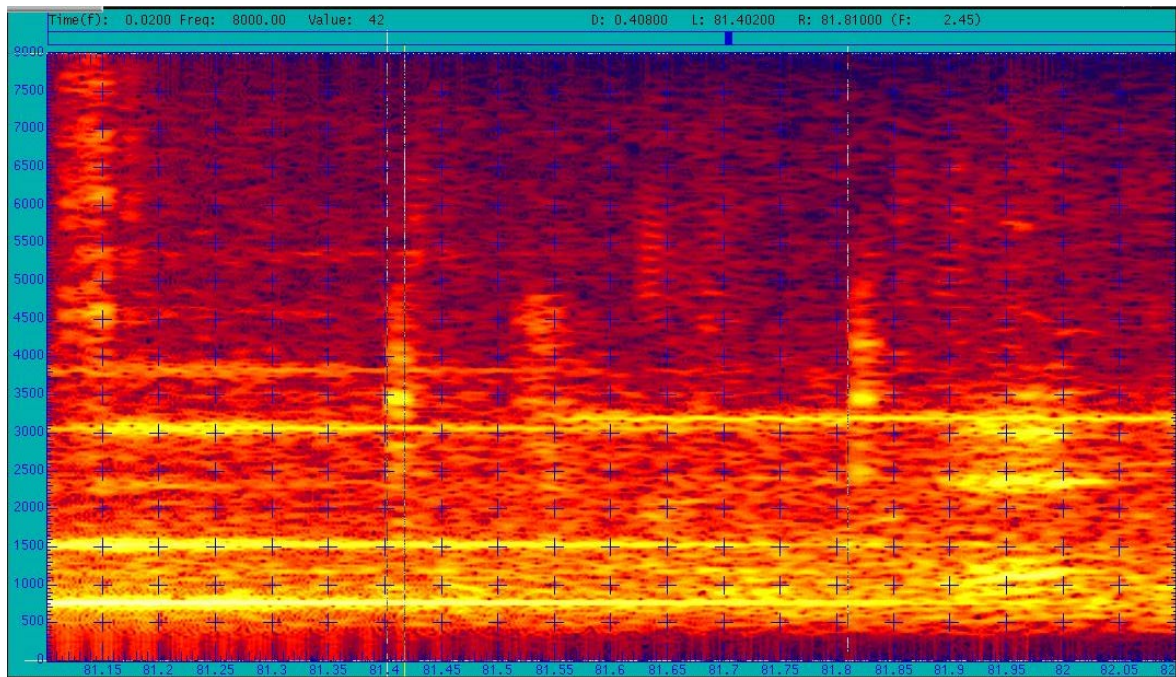
Noise on F-BTSC (408 ms)

- Noise of selector at 14 h 43 min 44.7 s

This noise is similar to activation of the “first shot” pushbutton which corresponds to the firing of the extinguishers in the engines. This action can only be taken if the fire handle has been pulled. The rate between the two energy peaks which make up this noise is characteristic of action on this button or, more exactly, of the destruction of the glass which covers this button. In the three time-frequency analyses that are shown hereafter, this time is between 0.35 and 0.4 s.
