Aviation Investigation Report

In-Flight Fire Leading to Collision with Water

Swissair Transport Limited
McDonnell Douglas MD-11 HB-IWF
Peggy's Cove, Nova Scotia 5 nm SW
2 September 1998

Report Number A98H0003

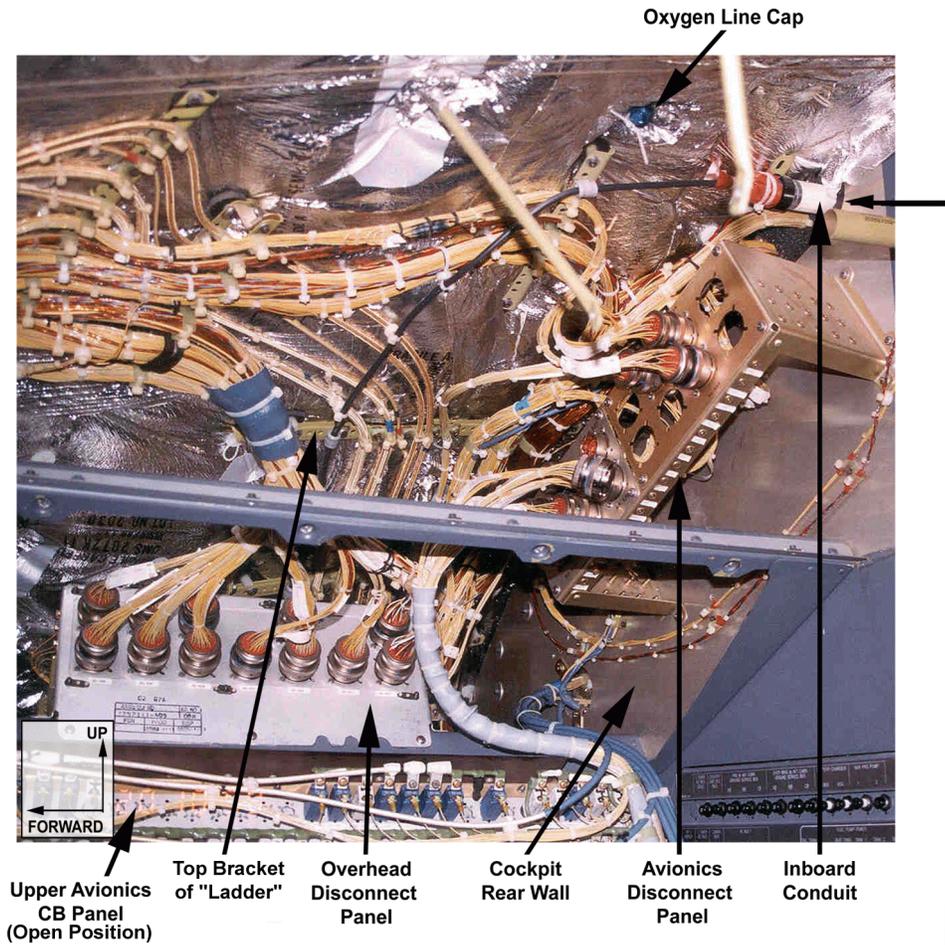
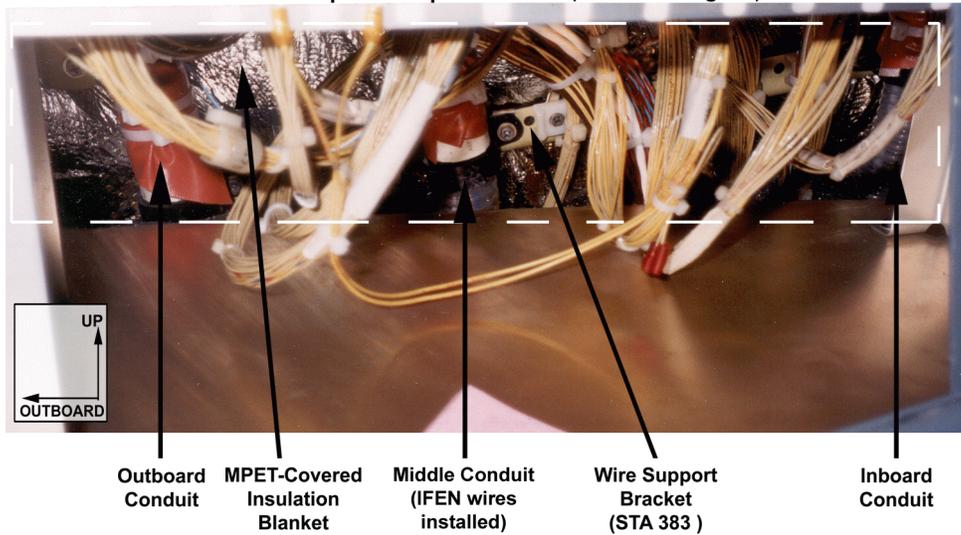
Figure 5: Cockpit attic area and cut-out above cockpit rear wall

Examination of other Swissair MD-11 aircraft in the Swissair fleet disclosed that openings existed in the smoke barriers, and in areas adjacent to the barrier. Some of these openings were located at conduit and wire run locations that pass through or above the cockpit rear wall. The top edge of the rear, right cockpit wall near STA 383 has a cut-out in it to permit the passage of wire bundles and conduits. (See Figures 4 and 5.)

Three 102-centimetre (cm) (40-inch) long conduits¹⁴ and five wire bundles pass over the cockpit rear wall at this point, and continue aft over the top of Galley 2 between STA 383 and STA 420. (See Figures 3, 4, 5, and 7.) The ends of the conduits were not required to be sealed and were found unsealed in other MD-11 aircraft that were examined. These conduits and wire bundles are attached by straps to a series of wire support brackets located at STA 383, 392, 401, 410, and 420. The wire bracket positioned at STA 383 is at a slight angle relative to the cockpit wall, which is directly below it. The top edge of this bracket, and attached wire bundles, are in contact with the metallized polyethylene terephthalate (MPET)-covered insulation blanket. Each of the conduits protrude forward of the cockpit wall by varying amounts because of the angle of the wall to the bracket.

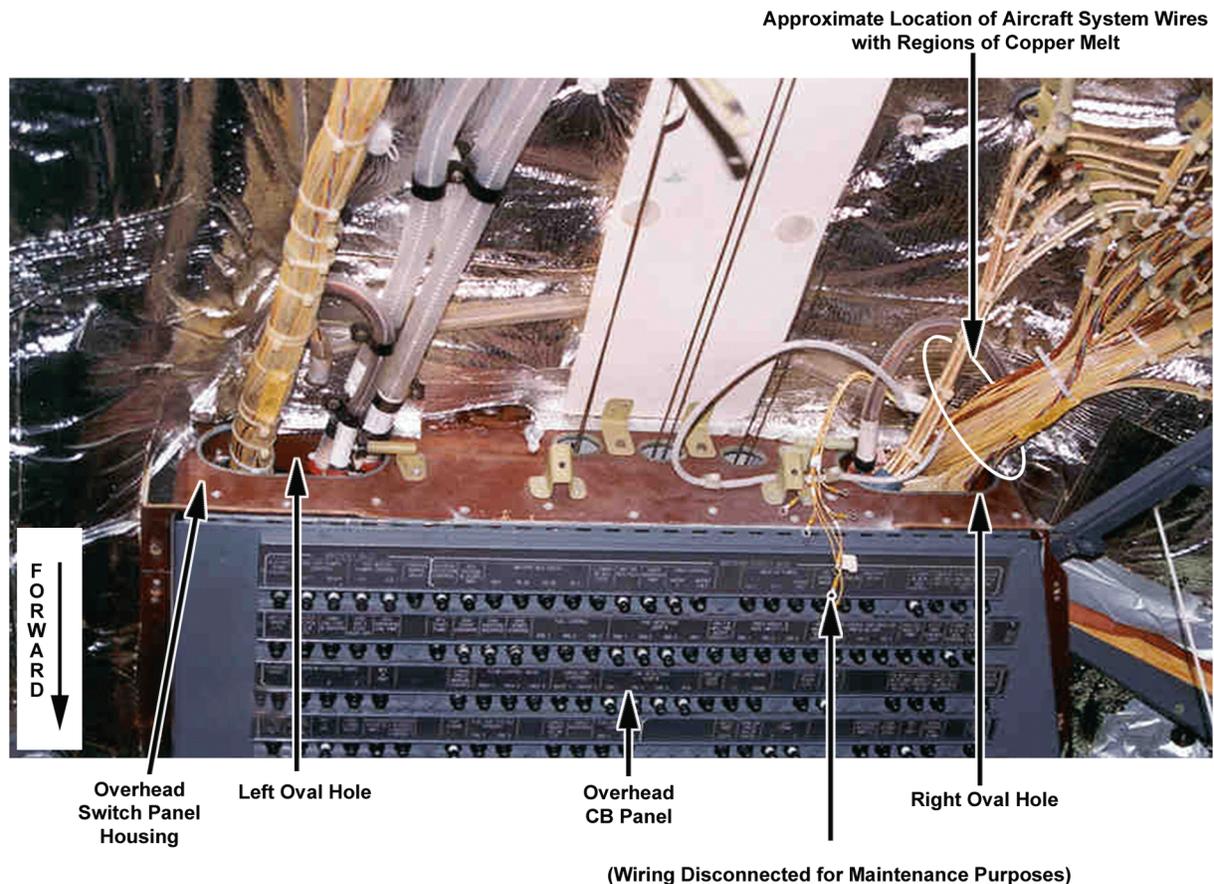
Figure 23: Location of identified aircraft wires with regions of copper melt

There was a 2-cm (0.8-inch) long section of resolidified copper located about 97 cm (38 inches) from the flag lugs. The nickel coating was missing from the conductor, for about 6 cm (2.4 inches) on either side of the melted area. The outer surface of the resolidified copper was smooth and did not exhibit any of the normal characteristics associated with an arcing event, such as surface porosity or irregular surface structure. Radiographs of this area showed it to be a solid mass, without voids. This was the only nickel-coated wire segment that exhibited melting of the nickel coating beyond the area of the resolidified copper. This melted copper was considered to have been the direct result of a welding operation during the manufacturing process of the wire.⁵⁷

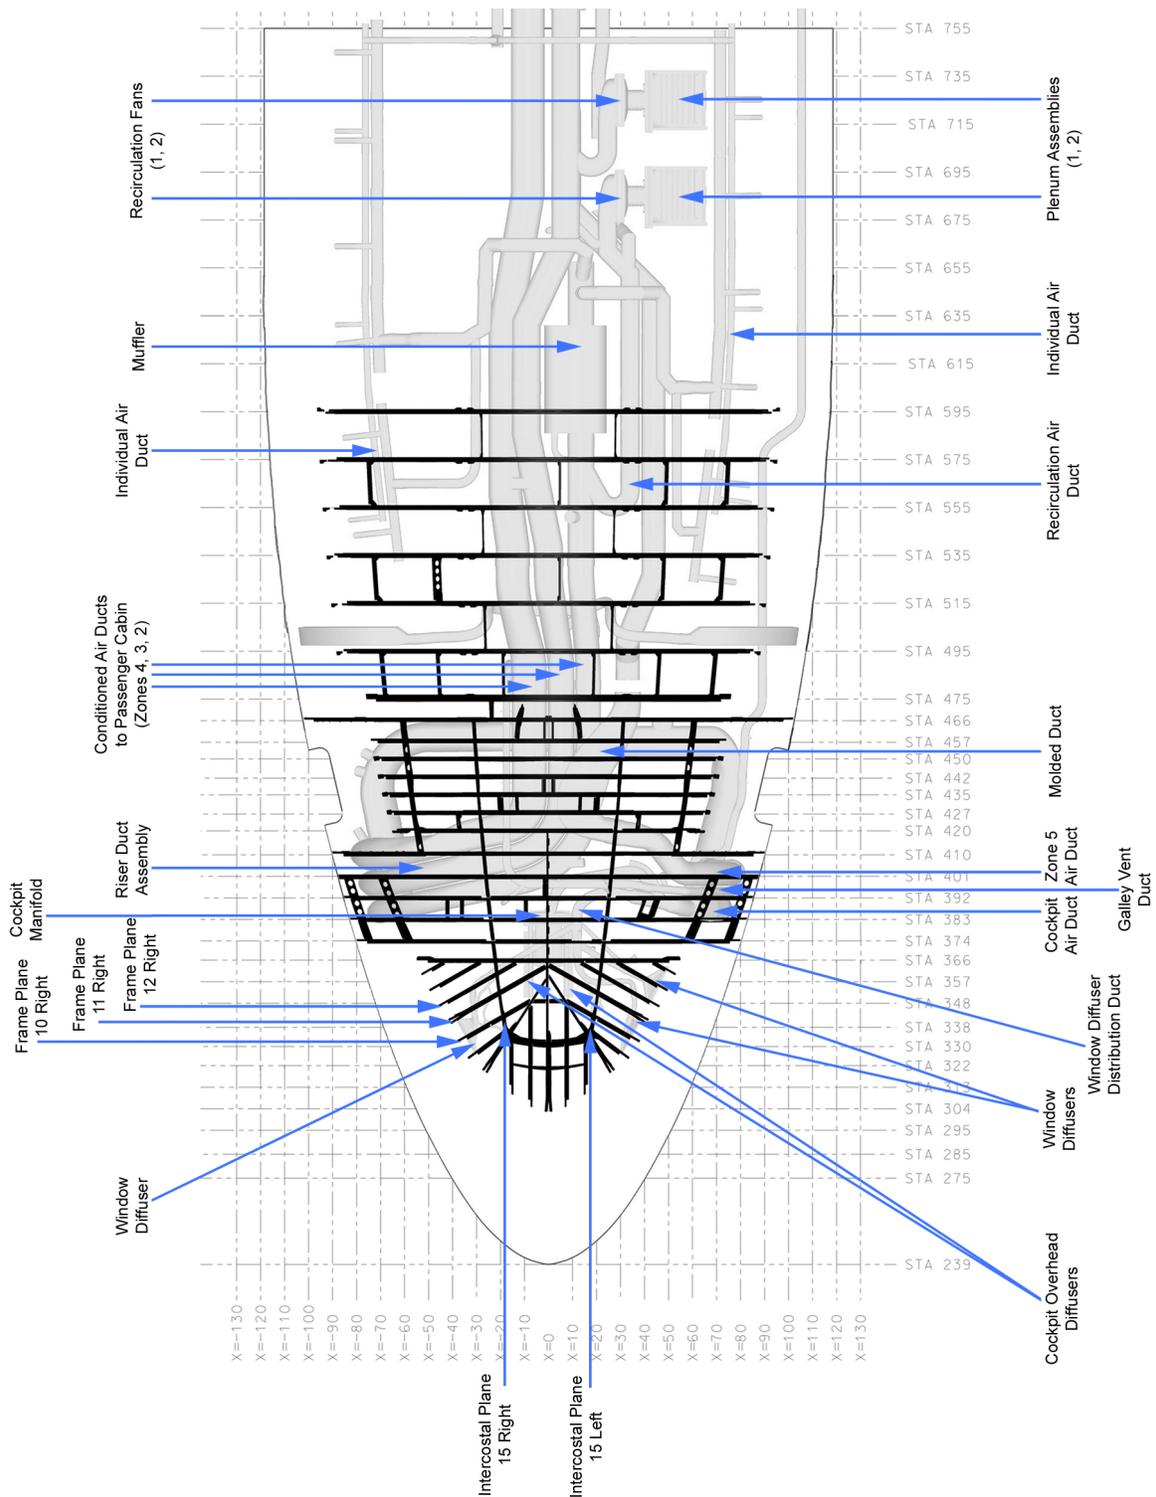
Figure 24: Airframe structure and air distribution system

There was bare-metal heat damage on the ducts behind the cockpit air diffusers from STA 350 aft to STA 402, primarily between the plane 15 left and right intercostals. The exception was the window diffuser distribution duct, which had bare-metal heat damage along STA 392 to $X = 32$. The heat damage to the recovered portions of the diffusers varied, with higher heat on the upper surfaces and lower heat on the lower surfaces adjacent to the cockpit ceiling liner.

Damage to the riser duct assembly ranged from no heat damage to bare-metal heat damage. The vertical portion of this assembly had no heat damage. The first area of bare-metal damage to the riser duct assembly started at intercostal plane 15 right, where the lower surface had a region of bare-metal heat damage from $X = -30$ inboard to the joint at $X = -20$. This was in the vicinity of the Galley 2 vent end cap. There was bare-metal damage from approximately STA 395 to STA 442 between $X = 25$ and $X = -10$. A section of molded duct was installed in that area from STA 420 to STA 442 between $X = 5$ and $X = 25$. No portions of this molded duct were identified in the wreckage.

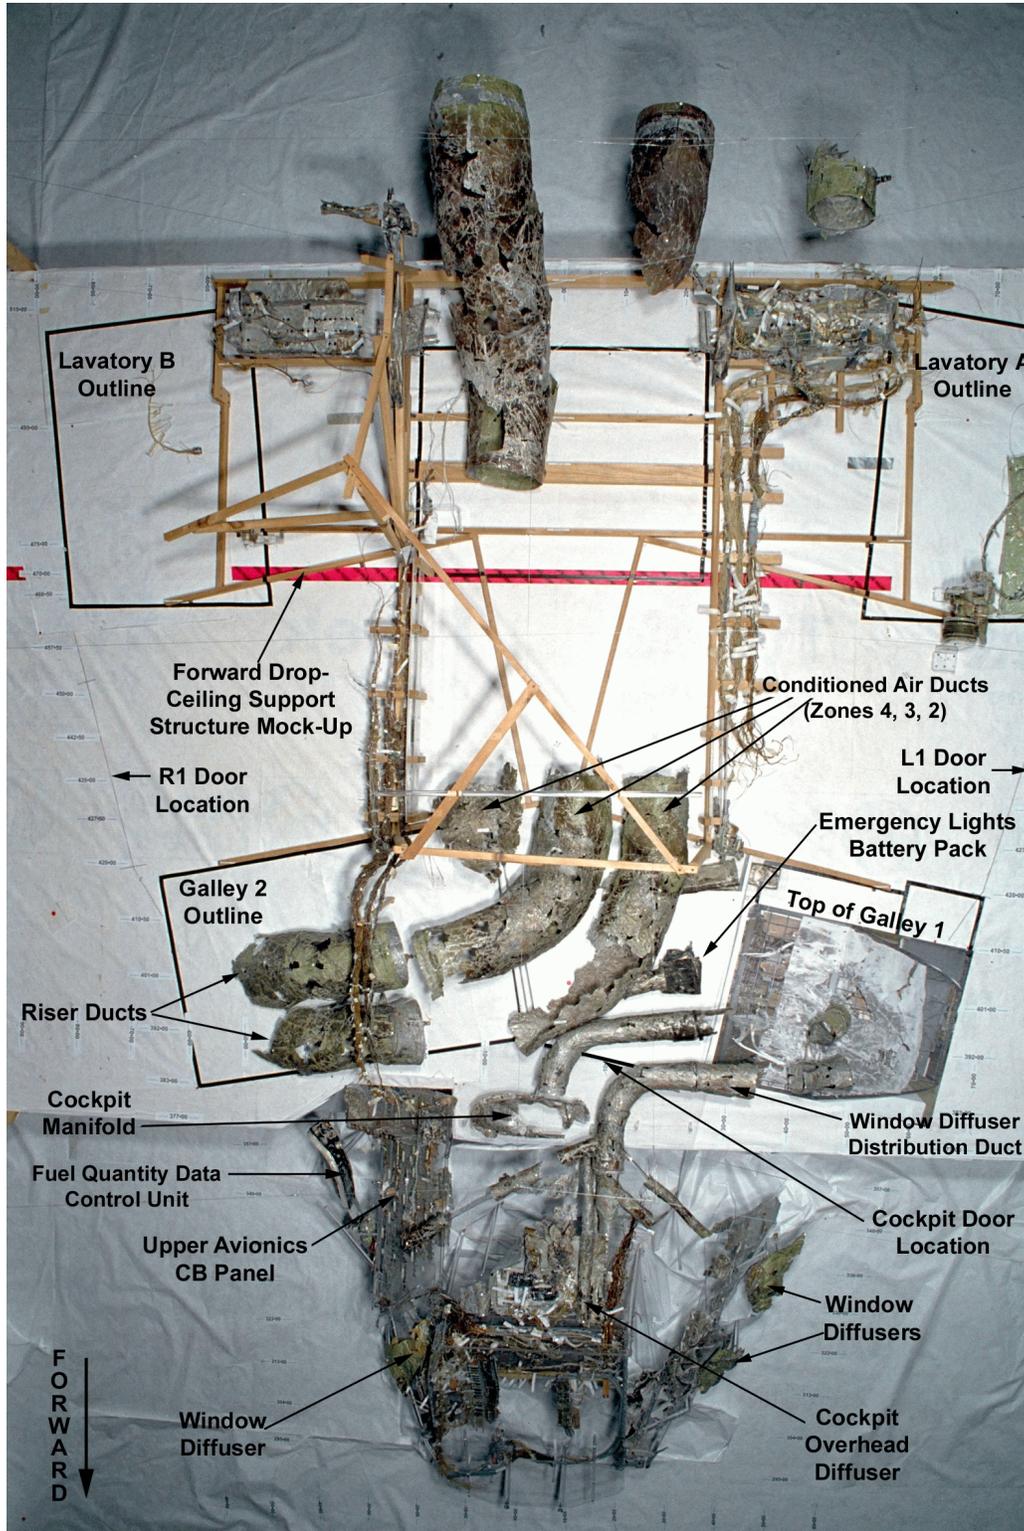
Figure 27: Cockpit attic and forward cabin drop-ceiling areas mock-up

Galley 1, which was installed on the left side of the cabin between the cockpit aft wall and the L1 door, had heavy soot accumulation and heat damage on the top outer surface (see Figure 27). Other components of Galley 1 had varying degrees of soot accumulation, particularly near the top of the unit where it had been exposed to the fire environment. The electrical equipment in the forward upper compartment of Galley 1 did not show any fire or soot damage. Wires installed inside the galley were not affected by the fire. A four-wire harness, which was routed through an access hole in the top of the galley, had a length of white spiral wrap that had localized soot accumulation. The wires in the harness had localized light-brown discoloration.

The Lavatory A module was installed on the left side of the aircraft forward cabin between approximately STA 465 and STA 495, immediately aft of the L1 door. A portion of the top of Lavatory A was recovered with a wire harness still attached (see Figure 27). Localized soot accumulations were noted on both the attic and cabin facing surfaces of the portions recovered. The attached wire harness was also sooted. Few additional pieces of this lavatory module were recovered and identified. Of those that were identified, there were no signs of heat damage.

About 75 per cent of the upper and lower CB panels were identified, reconstructed, and placed in the reconstruction mock-up (see Figures 27 and 28). The most forward sections of the upper and lower CB panels were not recovered. The upper avionics CB panel had been exposed to heat coming from both the front and back sides. The lower CB panel did not show any heat damage. The heat damage pattern on the front face of the upper CB panel was shown by the change in colour of the paint. Parts of the panel displayed damage consistent with temperature reference exemplar coupons exposed to temperatures from 430°C to 620°C (800°F to 1 150°F) for 10 minutes.⁶⁷ Discolouration and heat damage was present on the back side of this panel on some electrical components and on some bare-metal surfaces. Although there were similarities at some locations, the damage pattern on the back side was less than on the front

side, particularly on those pieces near the forward end of the panel where the front side of the panel showed considerably more heat damage than the back side. Individual CBs showed soot on the white indicator ring; soot could only have been deposited if the CB had tripped and subsequently been exposed to combustion by-products. Details concerning the CBs on the avionics CB panel and wiring in the vicinity are included in separate sections of this report.

It was noted that the heat damage on parts of the upper avionics CB panel was consistent with damage seen on temperature reference coupons that were exposed to temperatures from 427°C to 620°C (800°F to 1 150°F) for 10 minutes.⁶⁸

Most of the CB panel was identified, reconstructed, and placed in the reconstruction mock-up (see Figures 27 and 29). On the cockpit-facing surface, approximately two thirds of the polycarbonate lightplate base on Row A had been melted and folded back over onto itself, forming a fused mass of material near the top right corner of the panel. Part of the right end of the lightplate base on Row B was also melted and fused into this mass. The top right corner of the panel where the paint was missing had heat damage consistent with temperature reference coupons that were exposed to temperatures from 427°C to 621°C (800°F to 1 150°F) for 10 minutes, and the area where the paint was discoloured had heat damage consistent with temperature reference coupons that were exposed to temperatures from 343°C to 398°C (650°F to 750°F) for 10 minutes. The rear surface of the panel also showed signs of localized high-heat damage at the top right corner.

Examination of the battery pack showed that, although it was extensively heat damaged, the heat occurred from the outside in (see Figure 27). This indicates that the fire did not start from a heat condition, such as thermal heating, within the battery pack.
