PB92-917007
NTSB/SIR-92/03

SPECIAL INVESTIGATION REPORT

PIPER AIRCRAFT CORPORATION
PA-46 MALIBU/MIRAGE
ACCIDENTS/INCIDENT
MAY 31, 1989 TO MARCH 17, 1991

Adopted: July 21, 1992
Notation 5803

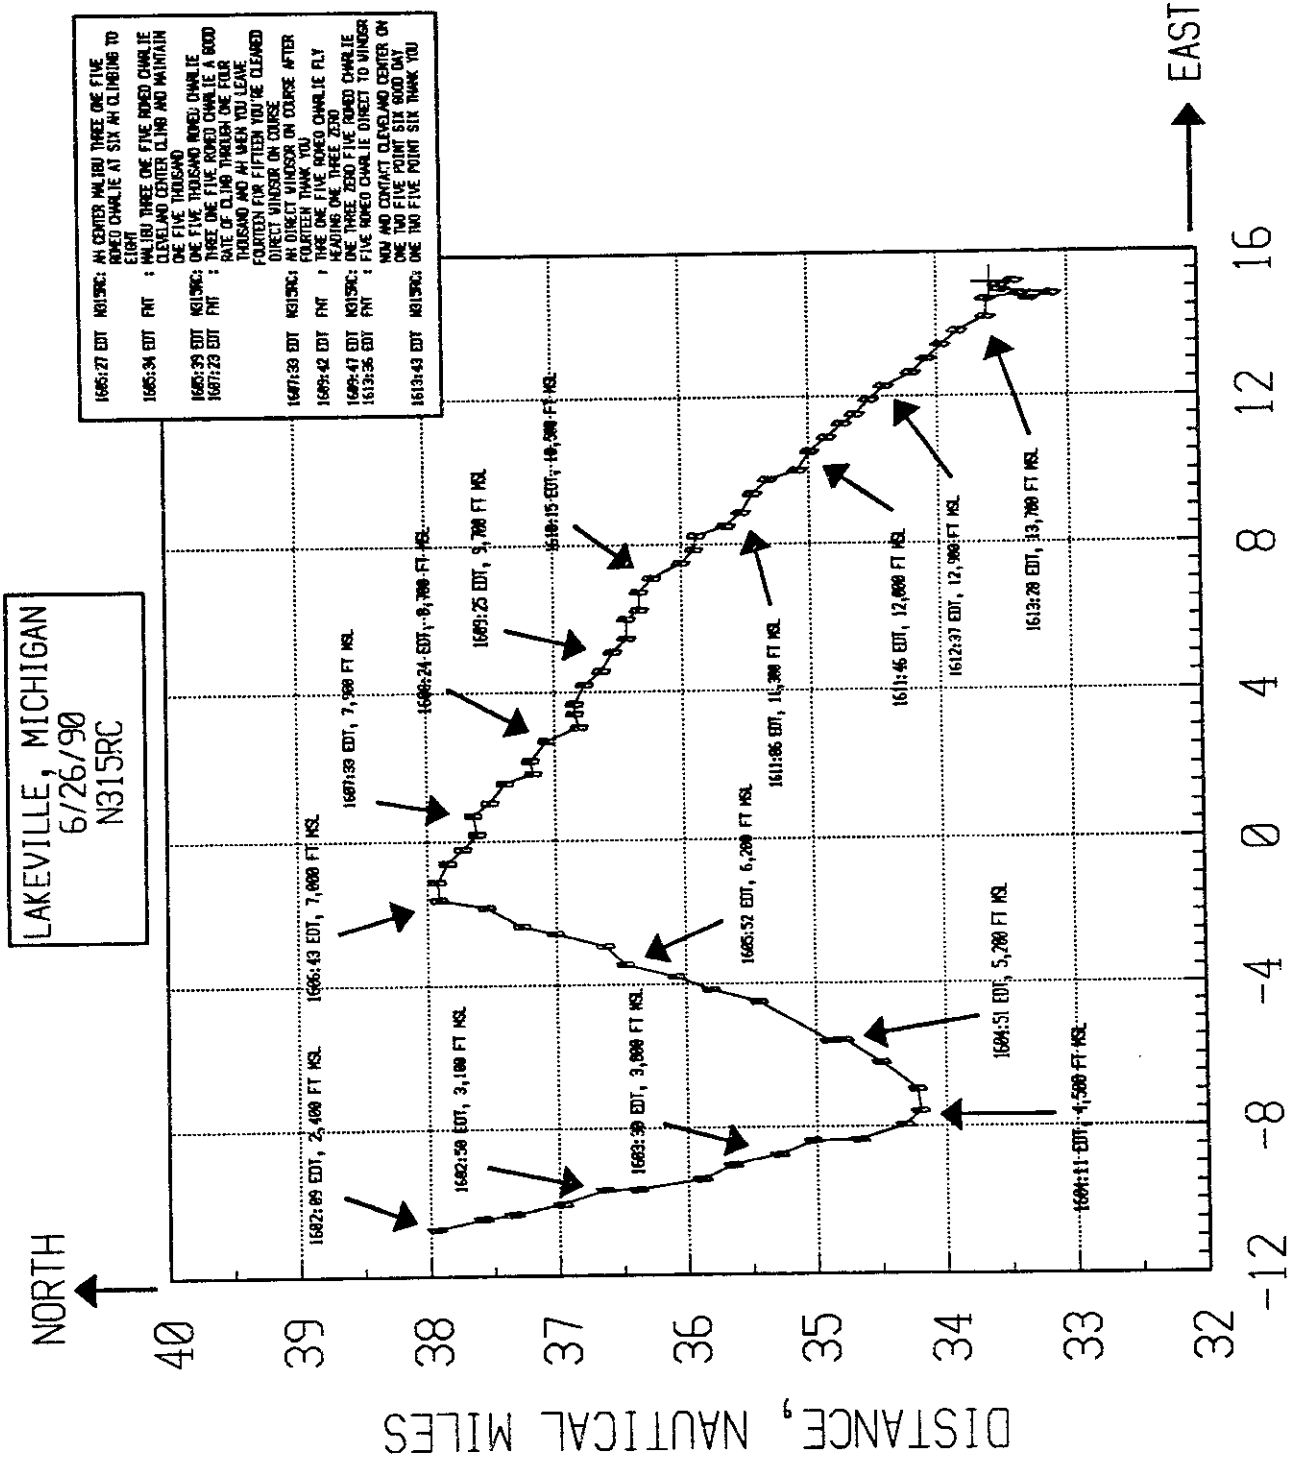
DISTANCE, NAUTICAL MILES
FIGURE 8

A flightpath study of ATC radar data (See Figures 8, 9 and 10) was conducted for the accident by Safety Board airplane performance engineers. The study revealed that the airplane climbed at a steady rate of about 1,000 fpm during the climb phase of the flight, and the indicated airspeed decreased from about 120 KIAS to 110 KIAS near 13,300 feet. Near 13,900 feet, the airspeed decreased to less than 80 KIAS, and the airplane made a shallow turn to the left followed by a steeper turn to the right. The airplane then entered a rapid descent with some maneuvering as the airspeed rapidly increased. According to the airplane flight manual for the PA-46-310P, the maximum rate of climb expected at 14,000 feet with an indicated airspeed of 110 knots, and at the assumed weight of the accident airplane, was about 1,200 fpm if the engine was operated at normal climb power. A trajectory study based on the radar data and wreckage scatter indicates that the airplane broke apart in a rapid descent between 9,000 feet and 6,000 feet.

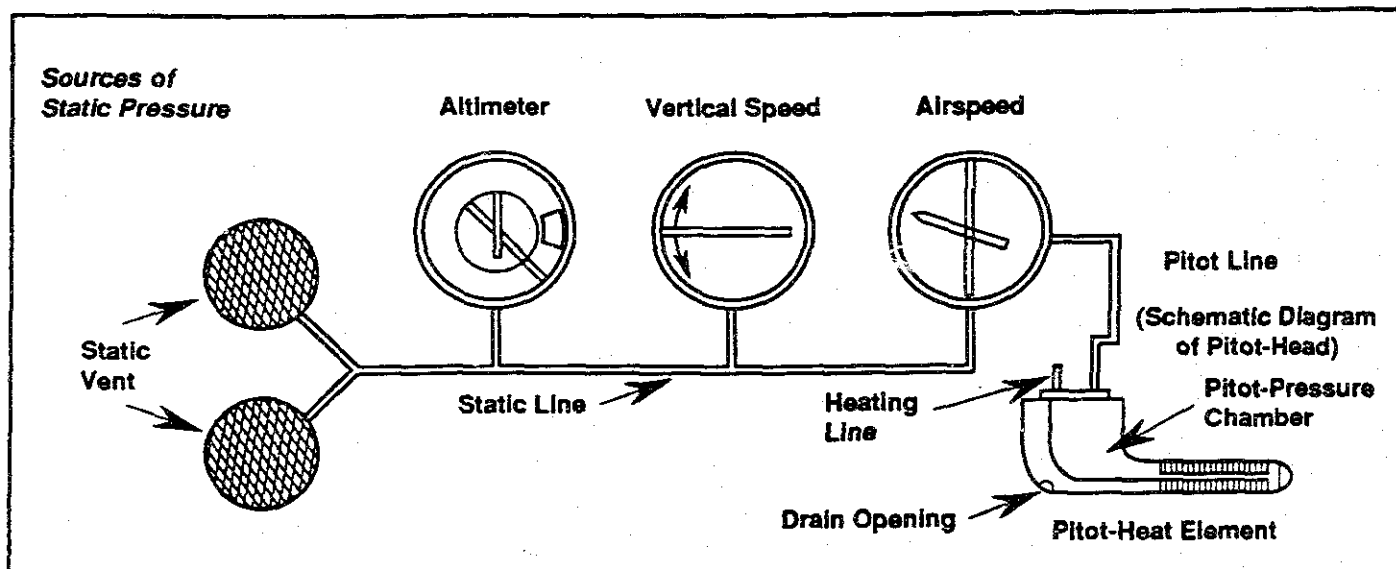
Figure 16.
Typical Pitot Static System for General Aviation Aircraft

In an aircraft airspeed measuring system, the total pressure is measured by the pitot head and is transmitted through the pitot system plumbing to one side of a differential pressure measuring instrument (airspeed indicator). The ambient static pressure is measured at static ports, which are mounted in an area that is not significantly influenced by the moving air stream. The static pressure measured at these ports is transmitted to the opposite side of the differential pressure measuring instrument. In effect, the differential pressure instrument (whether it be an airspeed indicator gage, a flight data recorder pressure transmitter, or a component within an air data computer) subtracts the ambient static pressure measured by the static system from the total pressure measured by the pitot system. The resultant dynamic pressure is a direct measurement of indicated airspeed. (See figure 16 and 17).

In the event of a blocked pitot or static system, the direction of the indicated airspeed error would depend on the part of the system that is blocked and the direction of change in the ambient static pressure. Under conditions in which the pressure in the static system increases with respect to the pressure in the pitot system, the indicated airspeed will read low erroneously. For the opposite condition, in which the pressure in the static system decreases with respect to the pressure in the pitot system, the indicated airspeed will read high erroneously. The latter would exist if the pitot head is blocked so that a constant

pressure is trapped in the pitot system while the aircraft is ascending. This is because the static system pressure would decrease and the resultant differential pressure would appear as an increase in dynamic pressure.

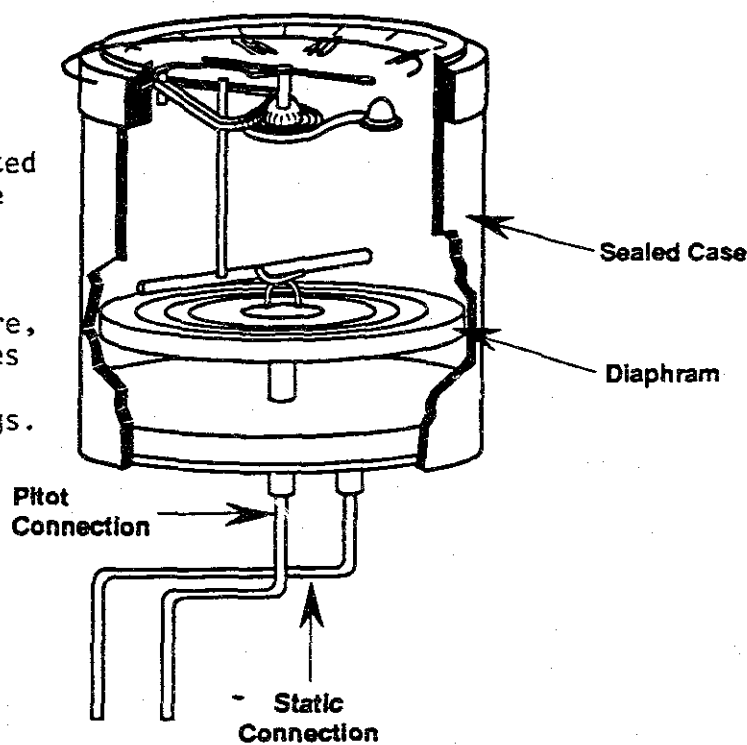
Figure 17.
Typical Airspeed Indicator for General Aviation Aircraft

The pitot pressure line is connected to one side of the diaphragm, while the inside of the sealed case is connected to the static line. As the diaphragm moves in response to increased or reduced pitot pressure, the airspeed indicator needle moves accordingly through the mechanical means of gears, levers, and springs.
