NATIONAL TRANSPORTATION SAFETY BOARD

AIRCRAFT ACCIDENT REPORT

TRANS WORLD AIRLINES, INC.,
BOEING 727-31, N840TW
NEAR SAGINAW, MICHIGAN
APRIL 4, 1979

NTSB-AAR-81-8

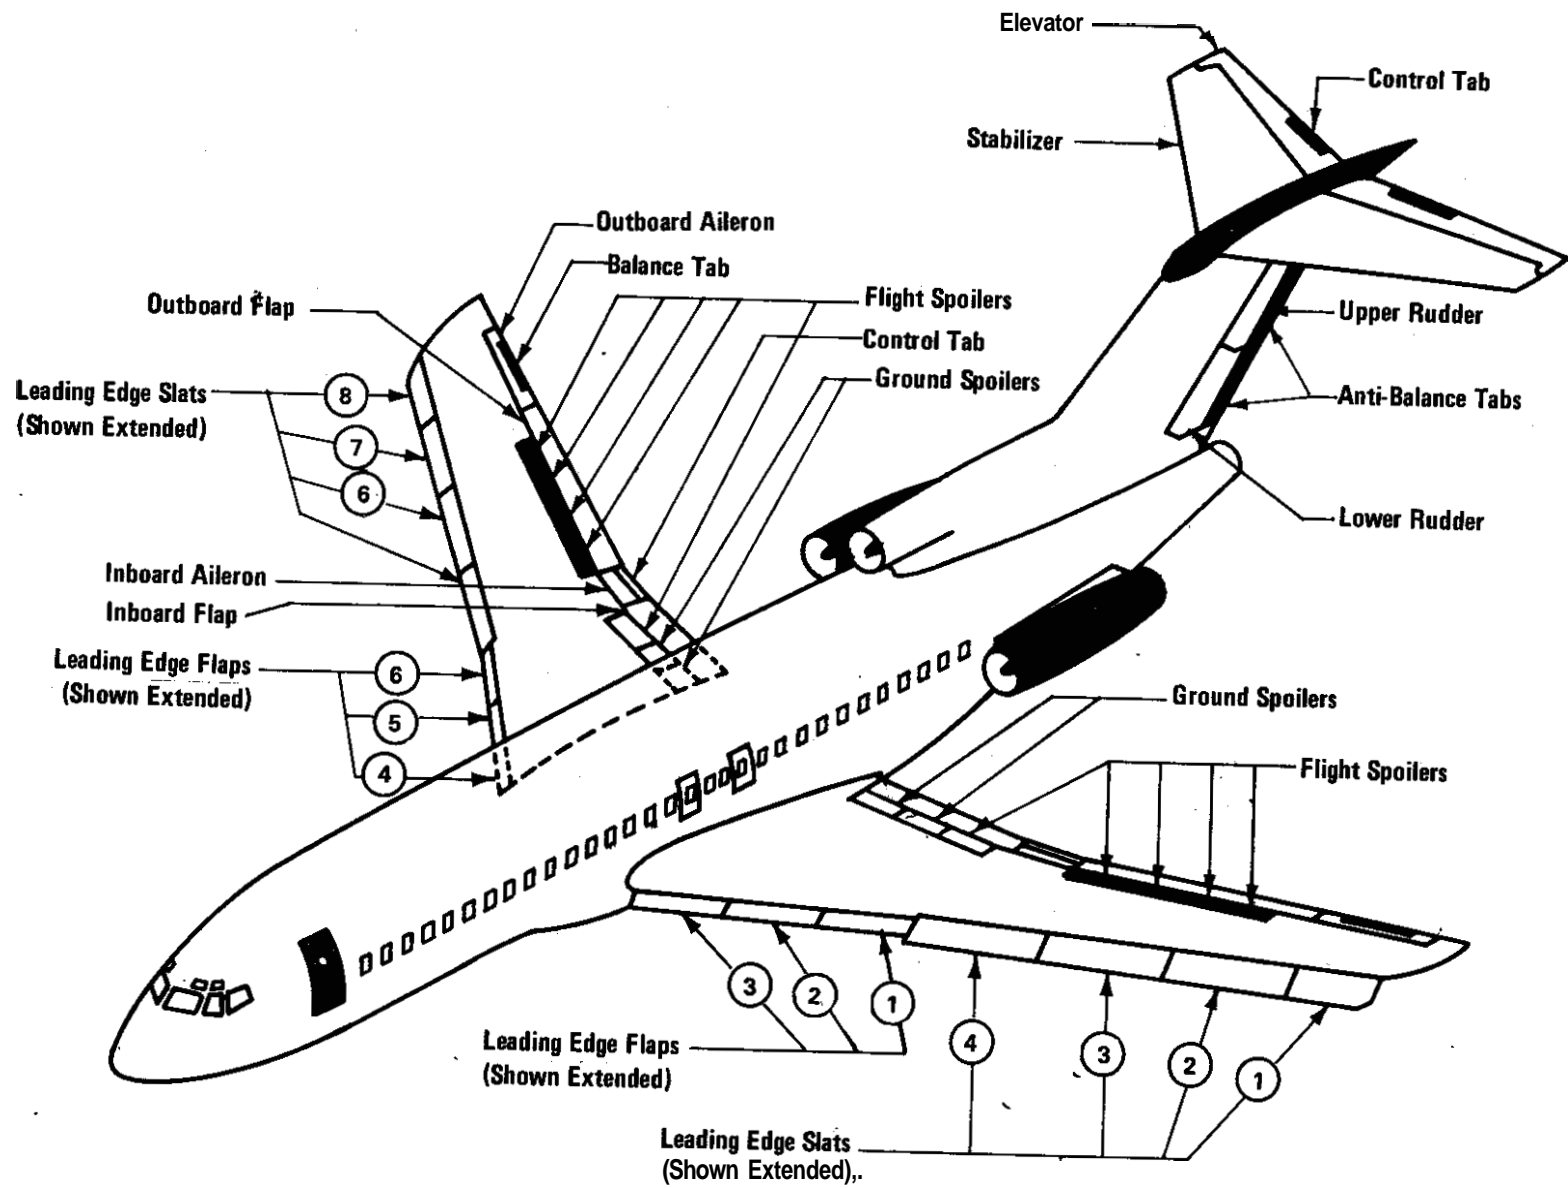
Figure 1.—B-727 flight control system surfaces.

The B-727 has eight individual leading edge **slats** and four individual leading edge flaps. The slats are mounted on the outboard positions of the wings and are numbered 1 through 4 on the left wing and 5 through 8 on the right wing. The flaps are on the inboard portion of the wings. (See figure 1.) The leading edge slats and flaps are **high lift devices** that are extended for takeoff and landing. (See figure 2.) According to the TWA Flight Handbook, the maximum speed and altitude with the leading edge devices extended are **240 knots** and **25,000 feet**, respectively, and the maximum speed for extension and retraction is **230 knots**.

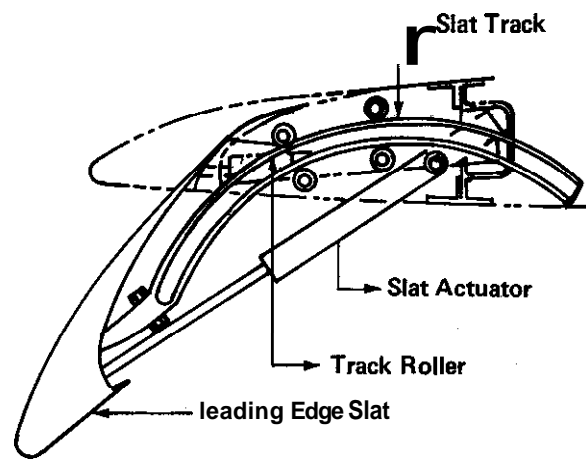
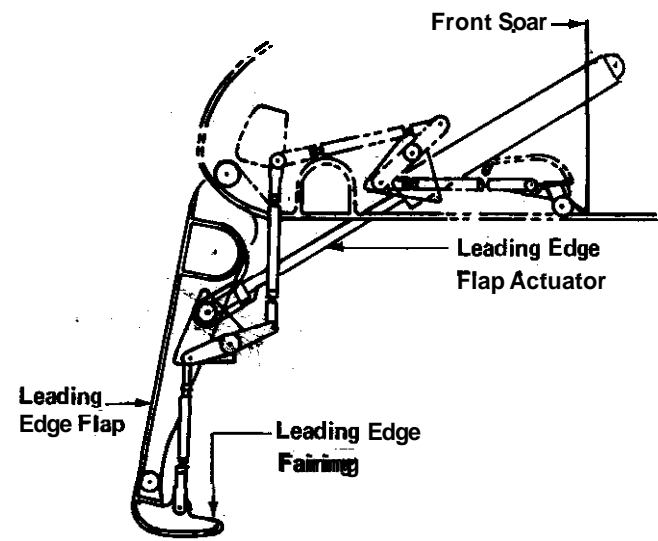
Figure 2.—B-727 wing leading edge devices.

The leading edge devices normally extend and retract in conjunction with the trailing edge flaps. The normal schedule is for extension of the **Nos. 2, 3, 6, and 7** leading edge slats in conjunction with the selection of **2°** of trailing edge flaps and extension of the **No. 1, 4, 5, and 8** slats and the six leading edge flaps in conjunction with the selection of **5°** of trailing edge flaps. The devices are retracted in the same groups in the reverse order of extension. Actual extension and retraction are initiated by the outboard trailing edge flap followup system; that is, slat extension is not initiated until the trailing edge flaps approach the **2°** and **5°** positions and slat retraction occurs when the trailing edge flaps retract from the **5°** and **2°** positions. Normal extension and retraction times for the leading edge devices is about **6** seconds.

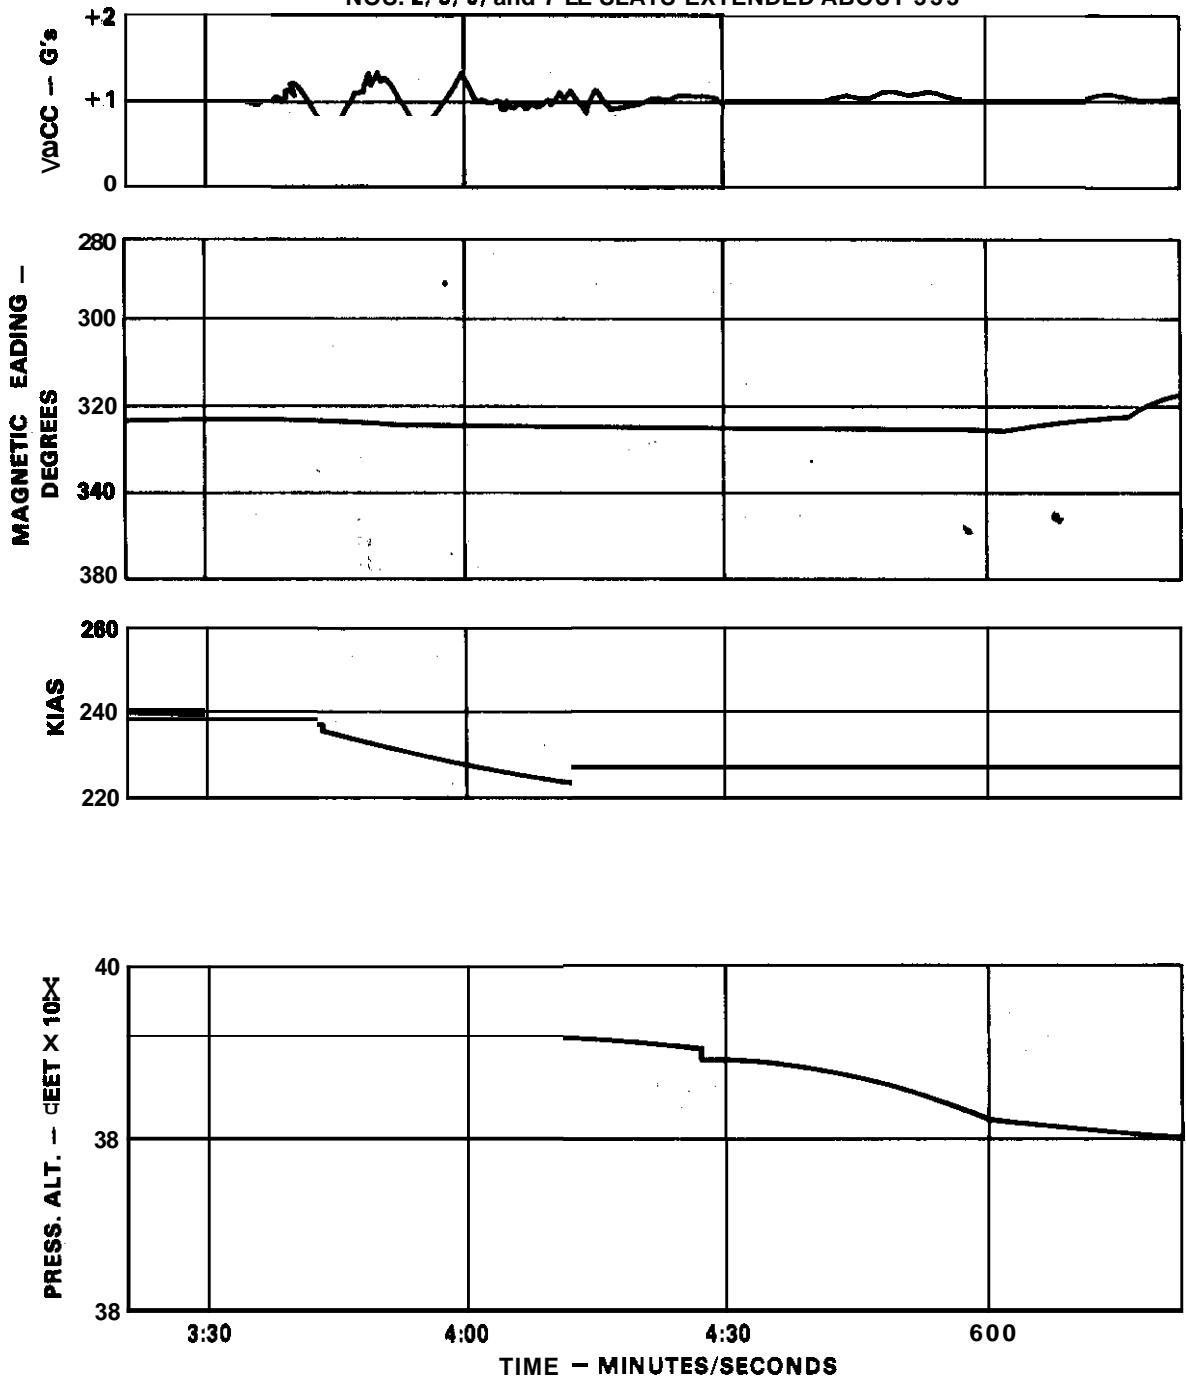
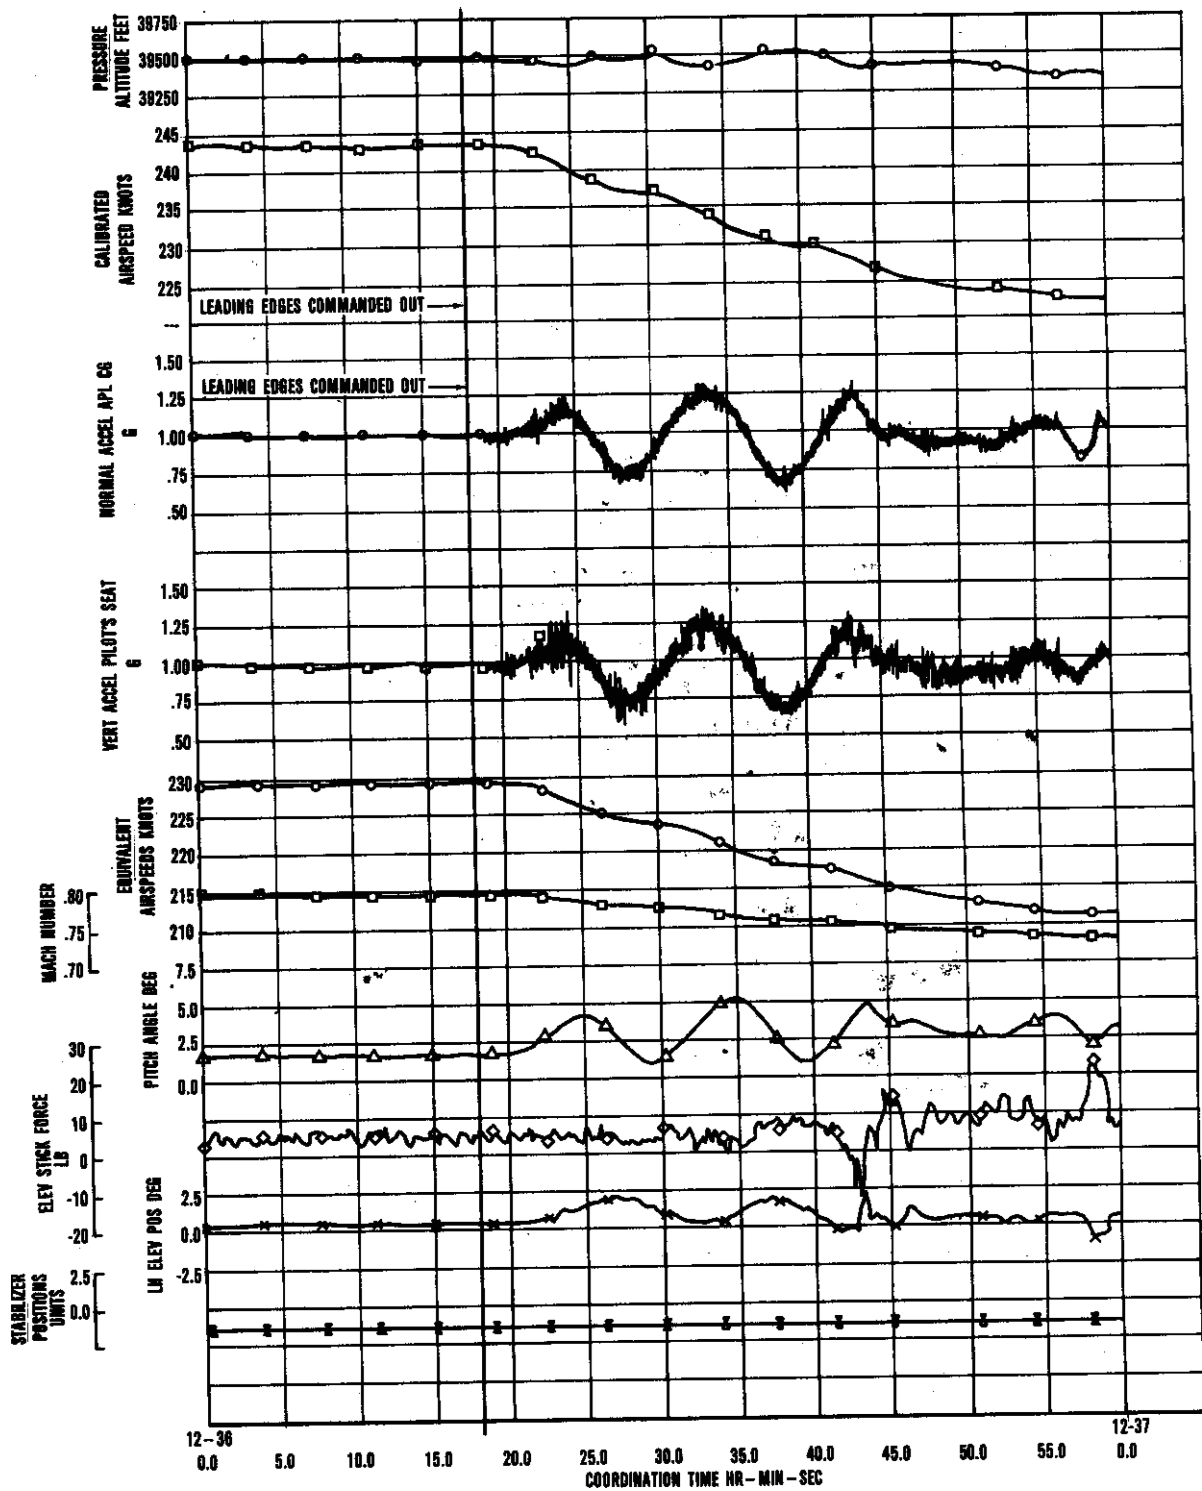
FLIGHT TEST RECORDINGS

AIRCRAFT CONFIGURATION --- TE FLAPS 2°
NOS. 2, 3, 6, and 7 LE SLATS EXTENDED ABOUT 333
