PB89-910406
NTSB/AAR-89/04

AIRCRAFT ACCIDENT REPORT

DELTA AIR LINES, INC.
BOEING 727-232, N473DA
DALLAS-FORT WORTH INTERNATIONAL
AIRPORT, TEXAS
AUGUST 31, 1988

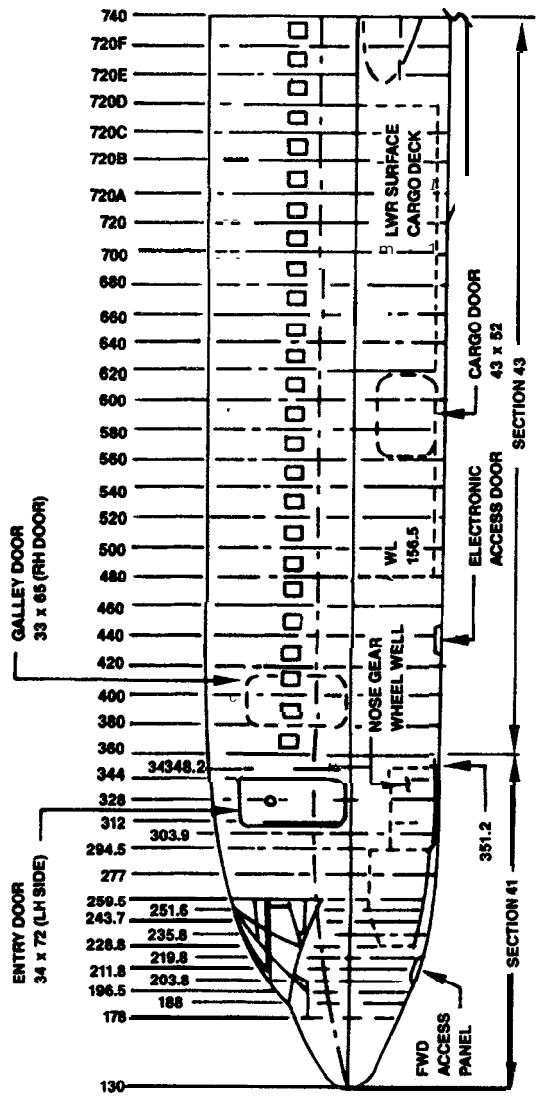
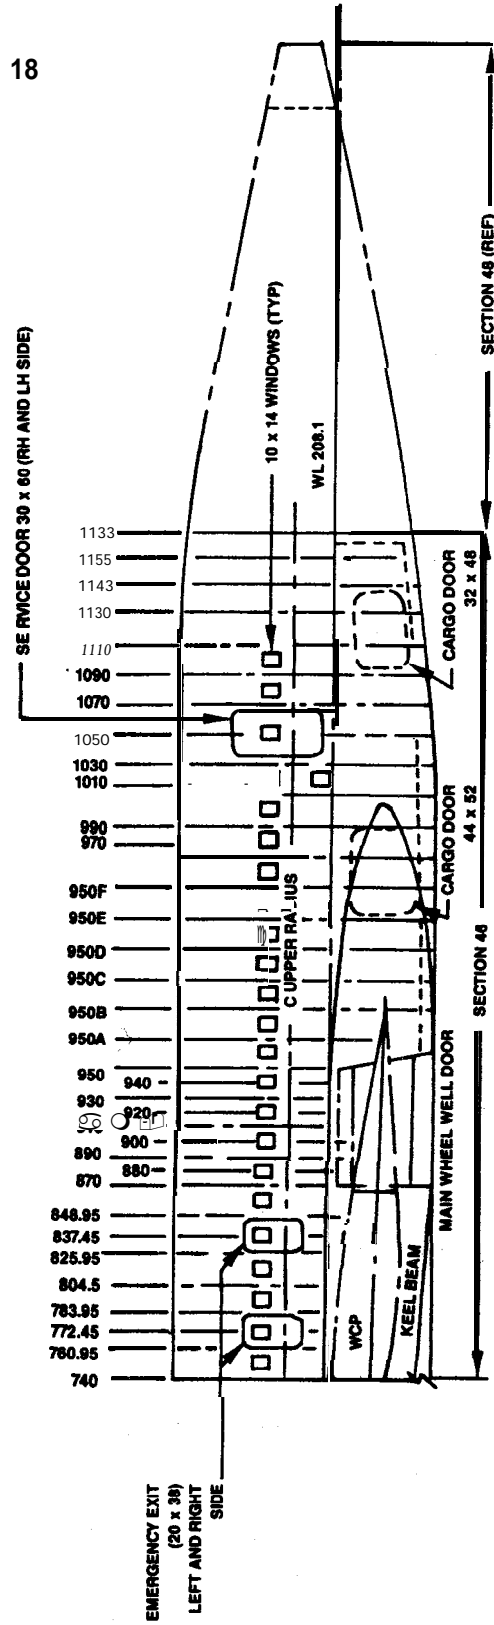
Figure 6.- station diagram.

Fuselage and Empennage.--The fuselage had separated into three major sections: (1) the forward section consisted of the nose forward of fuselage station (FS)-420 (see figure 6); (2) the center fuselage section included the body structure between FS-420 and FS-950c; and (3) the aft fuselage section extended from FS-950c aft to the end of the No. 2 engine tailpipe.

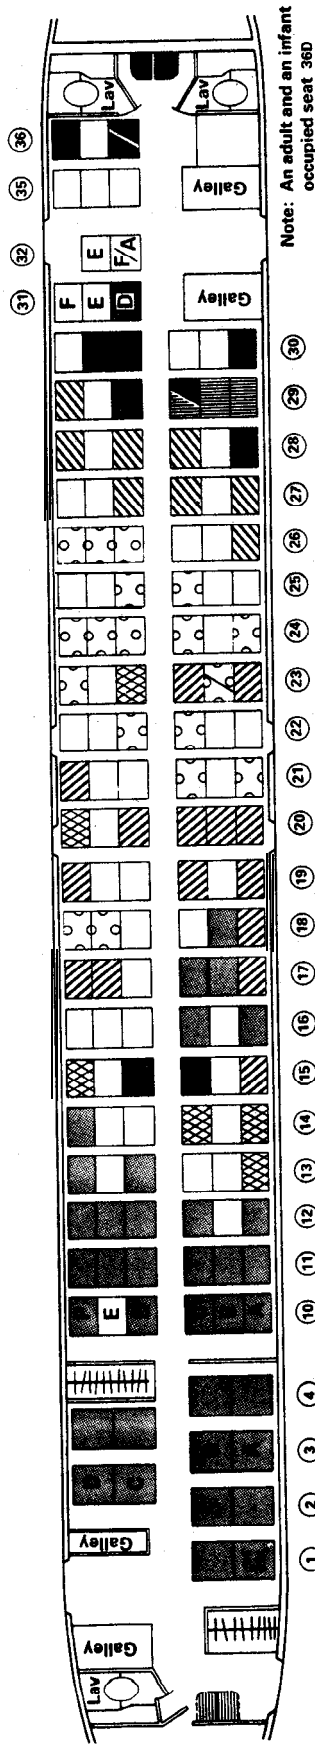
Figure 8.--Configuration of B727-232 and escape routes used.

The B-727-232 was configured for a three person flightcrew and 149 passengers (see figure 8). The passenger cabin was configured with 12 first-class passenger seats and 137 tourist class seats. A double occupancy aft facing flight attendant seat was on the aft left side of the cockpit rear bulkhead; a double-occupancy forward facing flight attendant seat was located on the ventral airstairs door. A single flight attendant seat was in row 32.

The investigation found that although the fuselage had separated in several places, the occupiable volume of the cabin was not substantially compromised. Passengers generally stated that impact forces were not severe. Further, the cause of deaths of the passengers in the aft section of the cabin were attributed to smoke inhalation and fire rather than impact injuries. Exit from the aft cabin was hampered by the fire that impinged on the right side of the airplane. Exit from the mid and forward cabin was through breaks in the fuselage and through the left side exits, except for the left aft service door which was not opened.

Note: The three flight crew members were removed by rescuers.

Note: An adult and an infant occupied seat 23B.

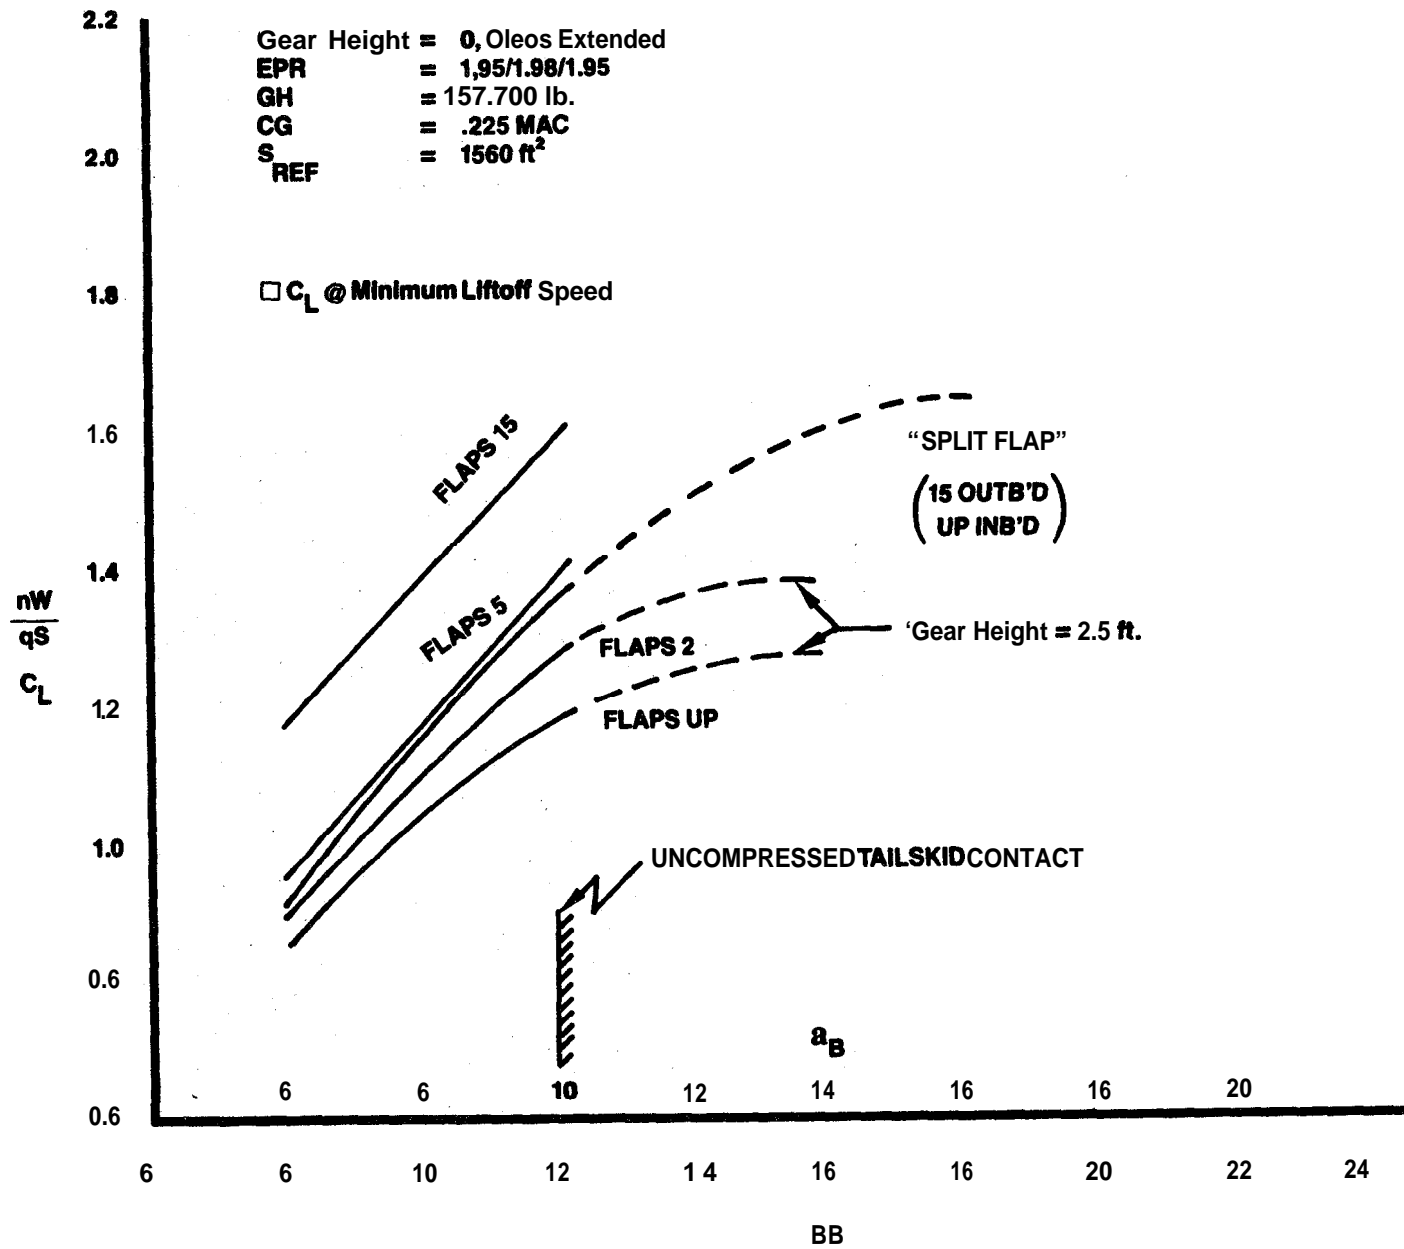
Figure 10.--Boeing 727 city curves, in ground effect zero altitude.

with a normal flap setting of 5° . The stall AOA for "split flaps" is about 9° higher than the stall AOA for flaps at 15° or 5° . (See figures 10 and 11.) The "split flaps" scenario will be discussed later in this report.

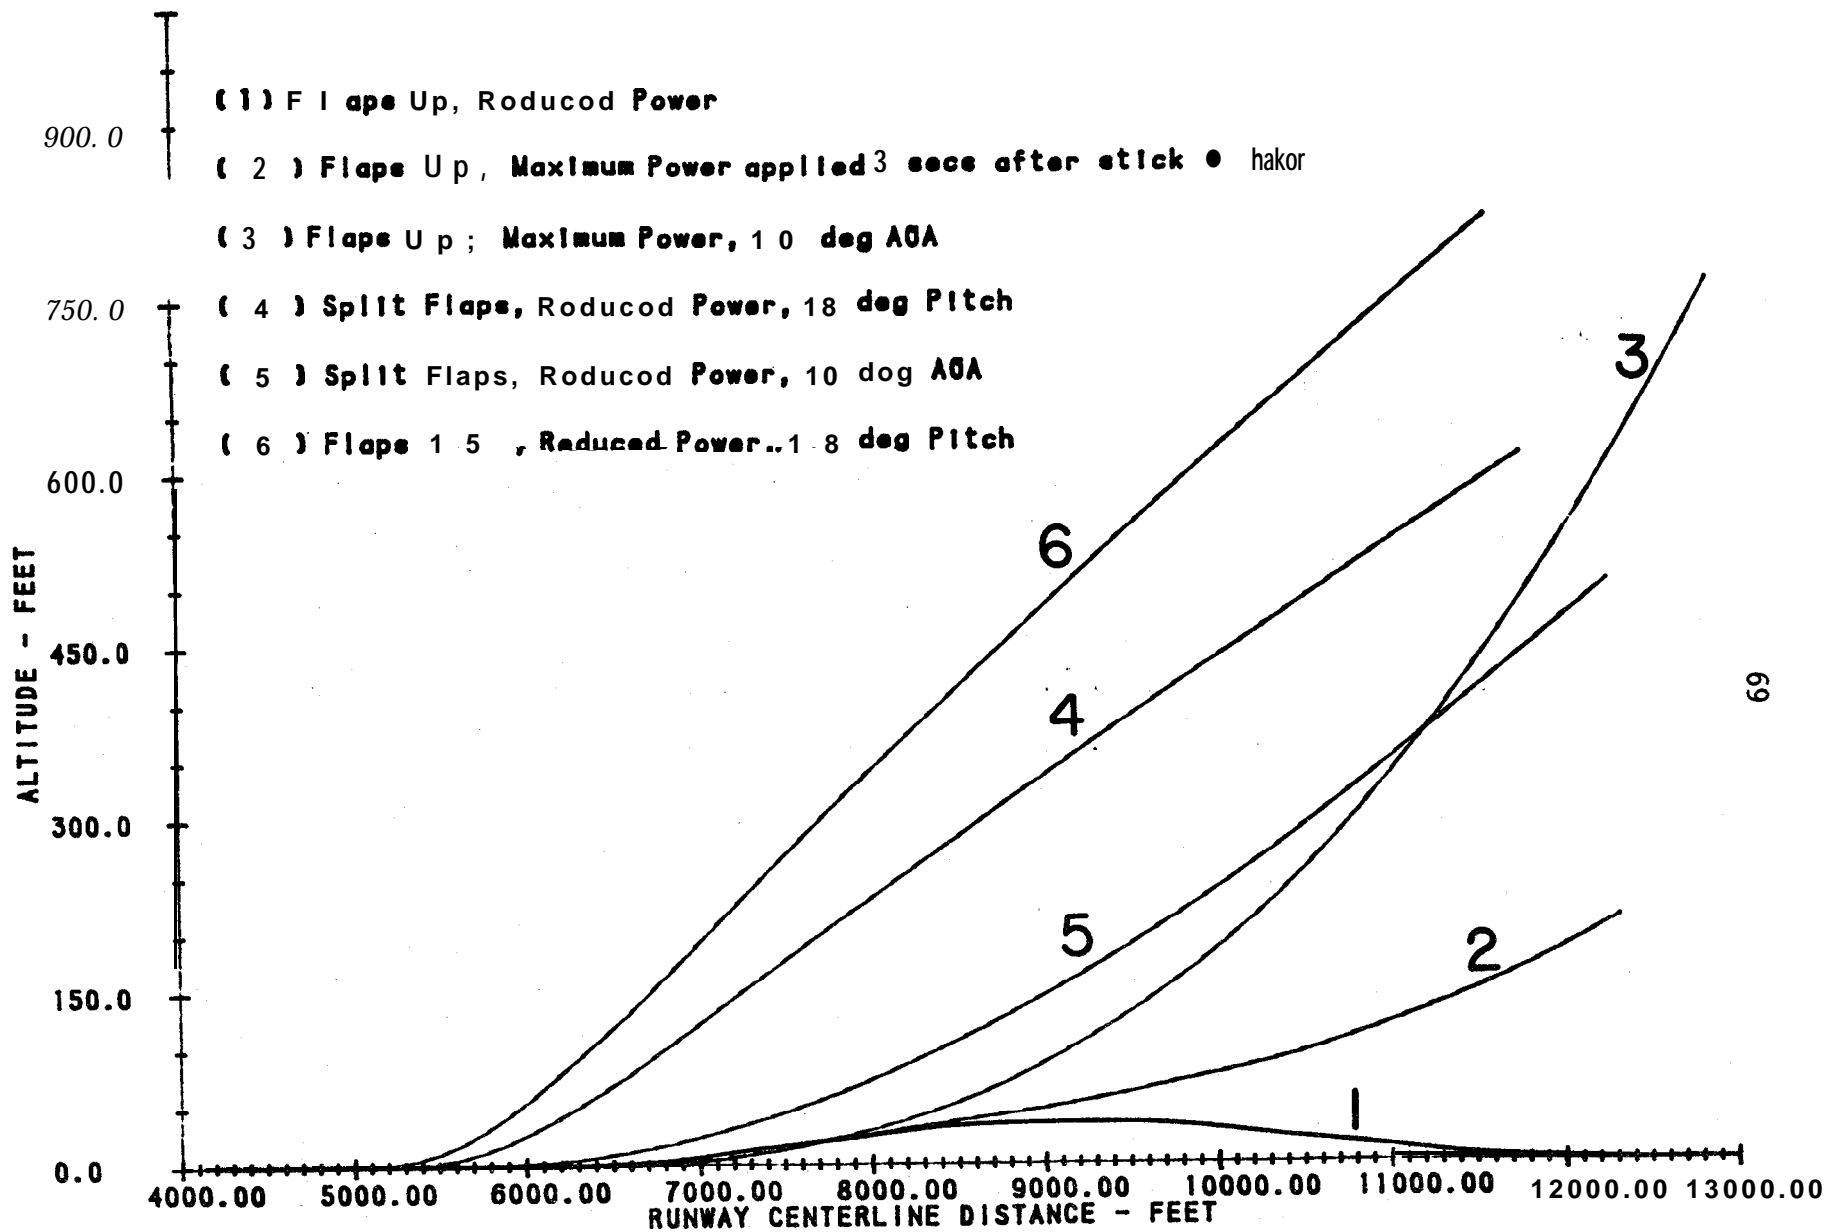
Figure 13. -- Takeoff profiles.

edge flaps retracted, the outboard trailing edge flaps extended to 15° , and the leading edge flaps and slats extended was analyzed and compared with the performance achieved by flight 1141. (See figure 13.) It is readily apparent from the calculated aerodynamic effects of trailing edge flaps and leading edge devices that the wing in the "split flap" configuration would have generated less lift at a given airspeed and AOA than it would have with all of the trailing edge flaps extended to 15° ; but it is also apparent that the AOA at which airflow separation would have occurred with "split flaps" would have been about the same (or even slightly higher on the inboard wing section) than it would have been in the normal 15° trailing edge flap configuration. The theoretical aerodynamic data provided for the split flap configuration by the Boeing Company indicate that the stall AOA is about 18° ; the data obtained from the March 23, 1989, demonstration flight indicate that an airplane under the conditions of flight 1141 maintains good flight characteristics without airflow separation (as indicated by buffet or roll instability) up to AOA greater than 15° . However, unlike the takeoff warning system, the stall warning stickshaker circuitry is predicated upon the inboard flap position and an assumption that the leading edge devices are also retracted when the inboard flaps are retracted. Thus, the stickshaker stall warning will alarm at an AOA of 11° appropriate to stall for the clean wing configuration. In the split flap configuration, the 11° AOA stickshaker warning would have provided about 16 percent airspeed and 7° AOA margin to stall. If the stickshaker warning was set at 14° AOA, the more typical 7 percent airspeed and 4° AOA margin to stall would have been available.

The performance analysis, based upon the lift versus AOA data for the split flap configuration, indicates that had flight 1141 been so configured during the takeoff roll, the airplane's tail may have contacted the runway surface as the captain rotated to the takeoff attitude. However, the airplane, with its geometry-limited 10° pitch attitude would have lifted off at about 150 KCAS instead of the actual liftoff speed of 158 KCAS. A continued rotation at a rate greater than 1.5° per second would have resulted in stickshaker activation; but there would have been considerable margin to stall when the warning occurred and the airplane would have transitioned to a climbing flightpath with a vertical acceleration in excess of 1.26. If the captain had ignored the stickshaker warning and continued to exert sufficient back force on the control column to raise the airplane's nose at a rate of 3° per second, the airplane would have achieved a 3° climbing flightpath at an AOA of about 15° within 2 seconds after liftoff. There would have been no airflow separation to explain the sudden roll of the airplane, and there would have been no engine inlet air turbulence to explain the compressor surges which were evident on the CVR. A more likely and proper flight crew reaction to the stickshaker activation would have been to relax the back force on the control column to silence the stickshaker, provided that that response would not result in a loss of critical altitude. Under such circumstances, the airplane would have continued to accelerate while developing sufficient lift force to transition to a climbing flightpath. These performance data indicate that about 10 seconds after liftoff, the airplane would have been about 100 feet above the ground and climbing at about 1,200 feet per minute. The stickshaker would have activated only momentarily.

The Safety Board concludes that the actual performance of flight 1141 is not explainable by the "split flap" theory. A possibility that one flightcrew member reacted to the delayed liftoff and stickshaker onset by intentionally or inadvertently retracting the flaps to 0° is also implausible, since the 20 seconds required for the trailing edge flaps and leading edge devices to retract with consequent effect on flight performance would place the airplane far beyond the point at which the roll instability and engine compressor surges actually occurred. If the flaps retraction sequence had started at rotation, the airplane would have had sufficient lift to climb several hundred feet prior to the flaps reaching 0°. Furthermore, each of the flightcrew members positively stated that they did not reset the flap control lever after the takeoff was initiated, and that they knew of no situation in which they would have done so.
