# NATIONAL TRANSPORTATION SAFETY BOARD

## AIRCRAFT ACCIDENT REPORT

AIR TRANSPORT INTERNATIONAL, INC., FLIGHT 805  
DOUGLAS DC-8-63, N794AL  
LOSS OF CONTROL AND CRASH  
SWANTON, OHIO  
FEBRUARY 15, 1992

**Abstract:** This report explains the loss of control and crash of Air Transport International, Inc., flight 805, a Douglas DC-8-63, near Toledo Express Airport, Ohio, after executing a second missed approach to runway 7, on February 15, 1992. The safety issues discussed in the report include unusual attitude recovery training for flightcrews, crew fatigue, and cockpit resource management.

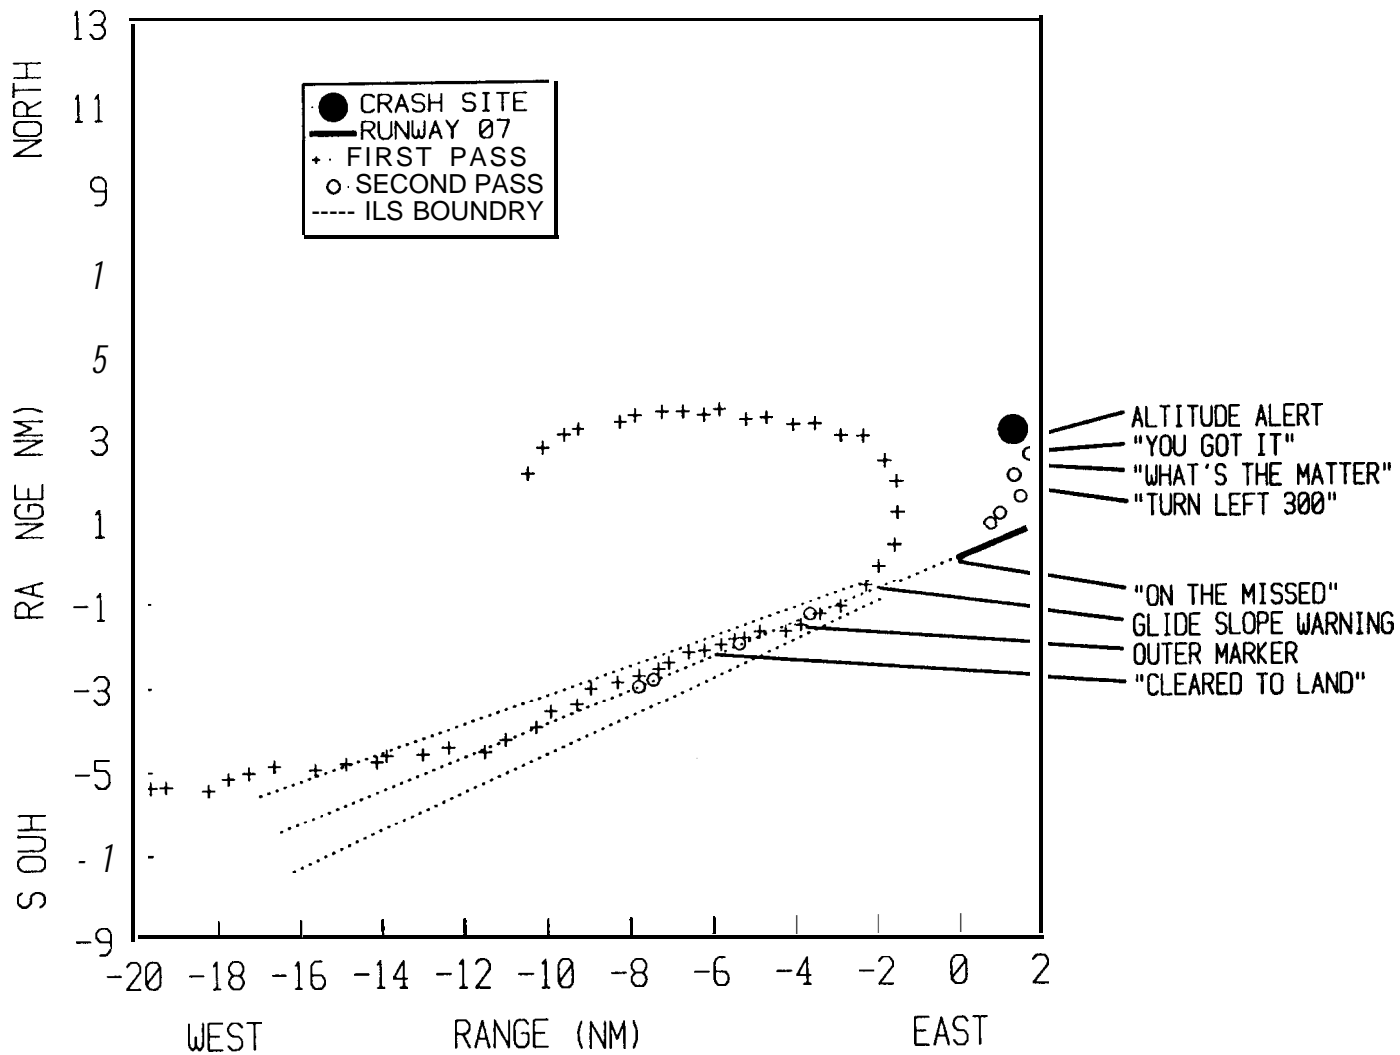
Figure 1 .--Ground track.

The aircraft crashed approximately 3 miles north-northeast of the runway. The geographical coordinates of the initial ground impact point were 41 degrees, 37.95’ north latitude, and 83 degrees, 48.07’ west longitude. The elevation of the accident site was approximately 670 feet. Figures 1 and 2 depict the ground track (plan view) and profile view of the two approaches derived from air traffic radar data.

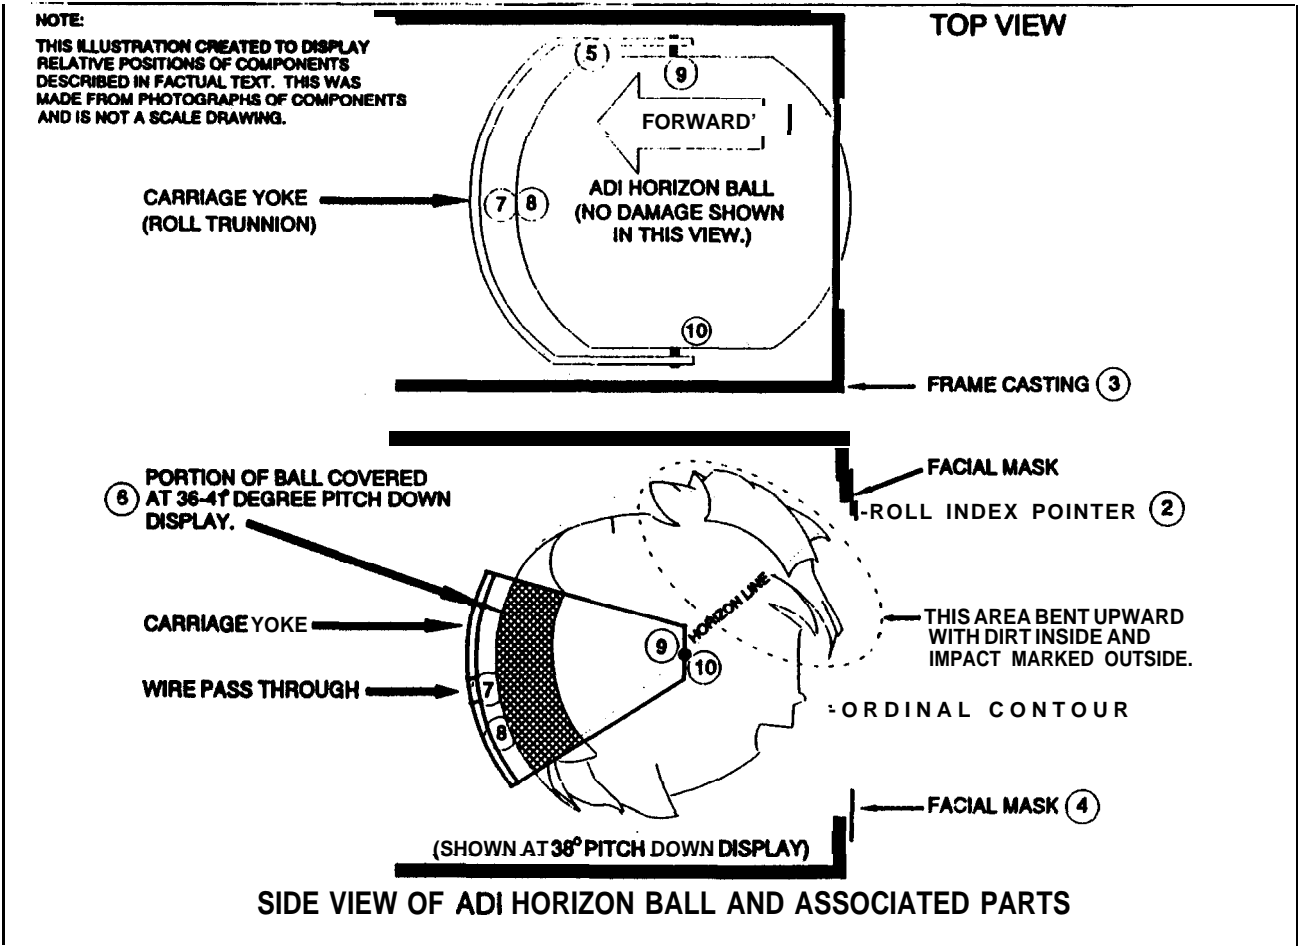
**ADI HORIZON BALL MARKINGS AND DAMAGE**  
 (AS UNWRAPPED FROM BALL SURFACE)
