## **AIRCRAFT ACCIDENT REPORT**

**IN-FLIGHT FIRE AND IMPACT WITH TERRAIN**  
**VALUJET AIRLINES FLIGHT 592**  
**DC-9-32, N904VJ**  
**EVERGLADES, NEAR MIAMI, FLORIDA**  
**MAY 11,1996**

AIRCRAFT ACCIDENT REPORT  
NTSB/AAR-97/06(PB97-910406)

**Adopted: August 19, 1997  
Notation 6704B**

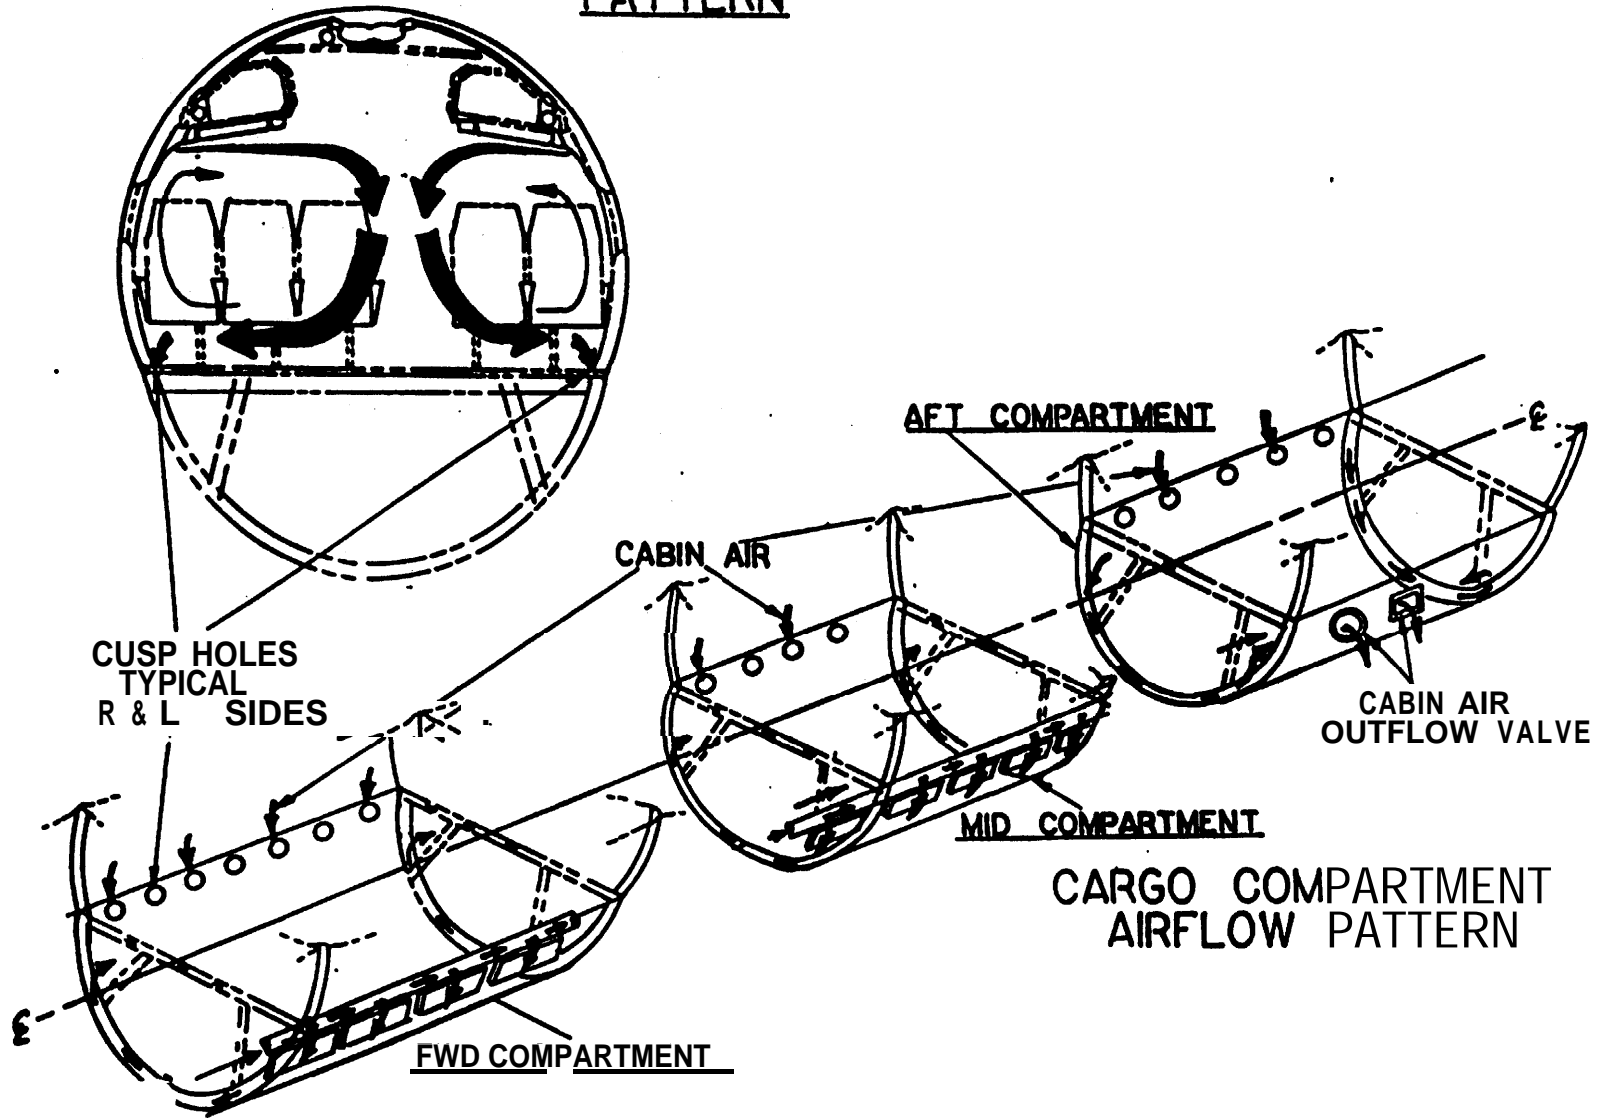
Figure 4—Cabin/cargo airflow pattern

Douglas documents for the DC-9 airplane show that the ventilation for the passenger cabin is introduced from above the passengers; the air then flows toward the center aisle, then aft and outboard. (See figure 4.) The design of the DC-9-30 series airplane allows for a complete change of cabin air 28 times per hour. Air exhausted from the cabin is directed downward from the lower outboard edges of the cabin to flow beside the lower cargo compartment, then aft toward the outflow valve.

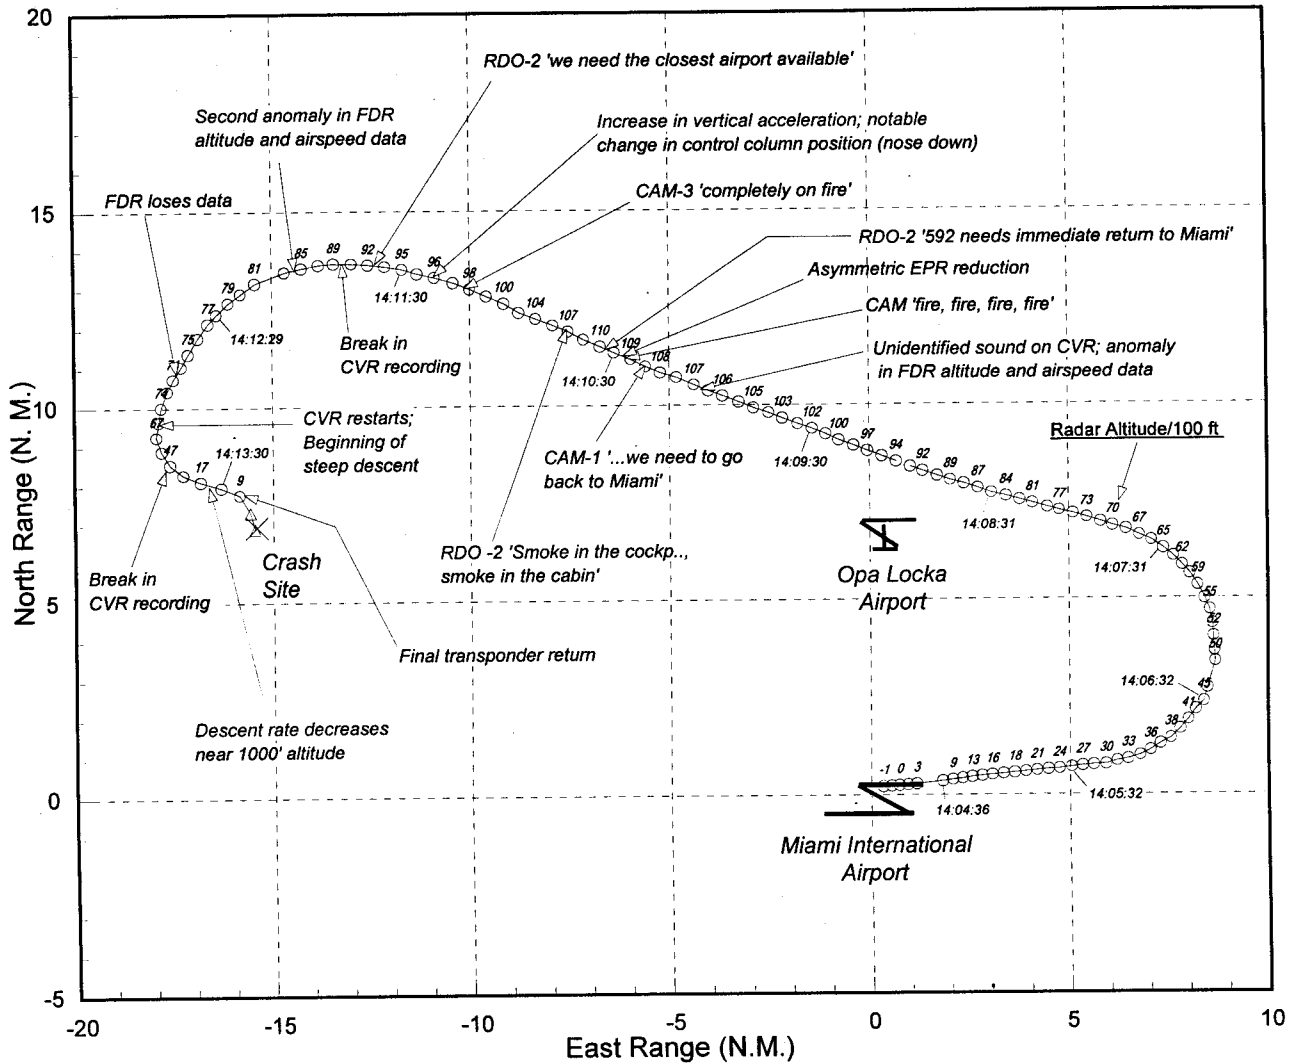
Figure 6a—Ground track of flight 592 (2-dimensional)

Recorded radar data, CVR comments and sounds, and FDR data were used to develop a time history of flight 592’s performance. (See figures 6a and 6b.) The performance of the flight was normal until 1410:03, when an unidentified sound was recorded on the CVR. According to the FDR, just before the sound, the airplane was climbing through 10,634 feet msl, 260 KIAS, and both EPRs were 1.84. Simultaneous with the noise on the CVR, the FDR recorded a 33-knot decrease in indicated airspeed and a pressure altitude drop of 817 feet. The FDR airspeed and altitude data returned to normal values within 4 seconds. An increase of 69 pounds per square foot (psf) in the static pressure sensed by a static pressure sensor on the airplane would result in an 817-foot decrease in altitude (as recorded by the FDR). Further, an increase of 69 psf in static pressure would result in a decrease in airspeed of about 40 knots and this is consistent with a curve fit of the airspeed decrease recorded on the FDR. Therefore, the recorded perturbations in altitude and airspeed at 1410:03 are consistent with a short duration increase in the static system pressure of 69 psf.

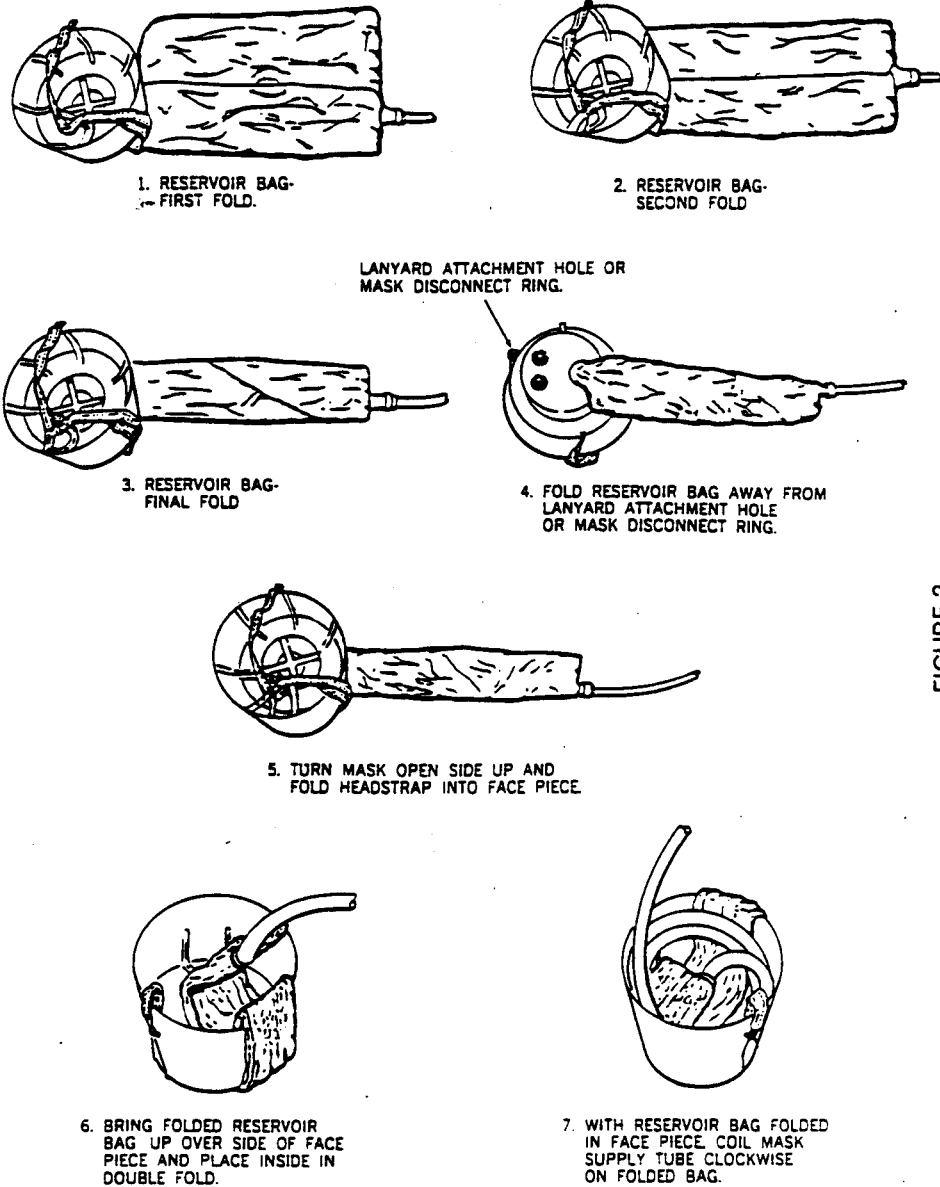
FIGURE 2

<p>F. Remove excess lanyard.</p> <p>G. If required, fold oxygen mask (Figure 2).</p> <p>H. Reset door latching mechanism by placing release lever flush with latching coil.</p> <p><b>Note:</b> As door is closed, the door mounted latch strike will engage strike retainer and will be held in place by an internal spring-loaded mechanism.</p>					Oxygen Module Location	Lanyard Length	Forward attendants console	17(±1) inches (431.8(±25.4) mm)	Aft attendants console	23 (±1) inches (584.2 mm)	Lavatory	10 inches (254.0 mm)	Lavatory (overhead)	69.00(±0.50) inches (1752.6(±12.7) mm) measuring from floor to mask attach point	Lavatory (overhead)	12.00(±0.50) inches (304.8(±12.7) mm) measuring below mask from mask attach point to streamer attach point	Intermediate attendants seat	50(±1.00) inches (1270.0(±25.4) mm) measuring from floor to mask attach point	5th attendants seat	1.00(±0.50) inch (25.4(±12.7) mm) slack
Oxygen Module Location	Lanyard Length																			
Forward attendants console	17(±1) inches (431.8(±25.4) mm)																			
Aft attendants console	23 (±1) inches (584.2 mm)																			
Lavatory	10 inches (254.0 mm)																			
Lavatory (overhead)	69.00(±0.50) inches (1752.6(±12.7) mm) measuring from floor to mask attach point																			
Lavatory (overhead)	12.00(±0.50) inches (304.8(±12.7) mm) measuring below mask from mask attach point to streamer attach point																			
Intermediate attendants seat	50(±1.00) inches (1270.0(±25.4) mm) measuring from floor to mask attach point																			
5th attendants seat	1.00(±0.50) inch (25.4(±12.7) mm) slack																			
ALL ITEMS SIGNED		EMP. NO.	DATE

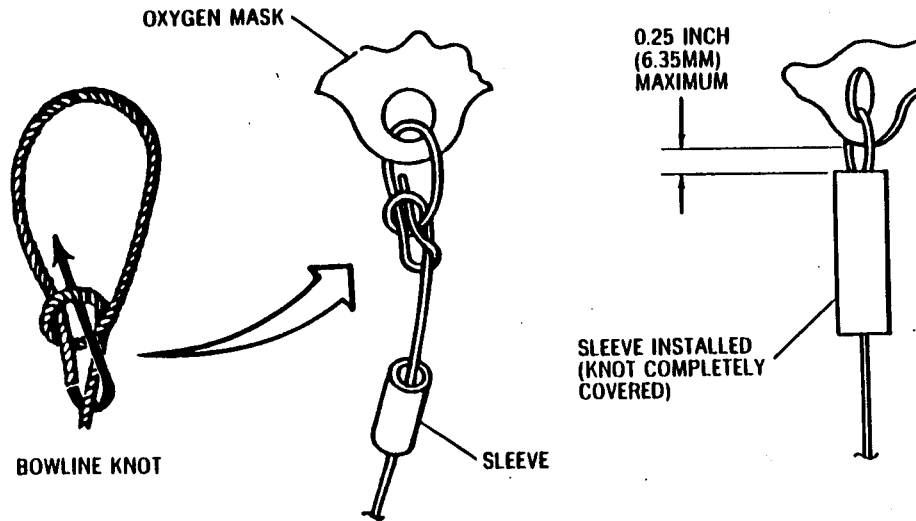
FIGURE 1

<b>ValuJet</b> <b>MD-80</b>	<b>REV. DATE</b> December 1995	<b>PAGE NO.</b> 3 of 6	<b>INSP CHK</b> 12 YRS	<b>CARD NO.</b> 0069																
	<b>ATA CHAP</b> 35	<b>AREA ZONE</b> 58	<b>INSP DATE</b>	<b>A/C NO.</b>																
<b>INSTRUCTION</b>			<b>MECH SIGNOFF</b>																	
<p>E. Connect firing pin lanyards to masks using bowline knot installation (Figures 1 and 2). With module door in open position, make certain that lanyard length is as follows:</p>
