1. Report No. FAA-AM-78-29		2. Government Accession No.		3. Recipient's Catalog No.	
4. Title and Subtitle CONSPICUITY ASSESSMENT OF SELECTED PROPELLER AND TAIL ROTOR PAINT SCHEMES				5. Report Date August 1978

CONSPICUITY ASSESSMENT OF SELECTED
PROPELLER AND TAIL ROTOR PAINT SCHEMES

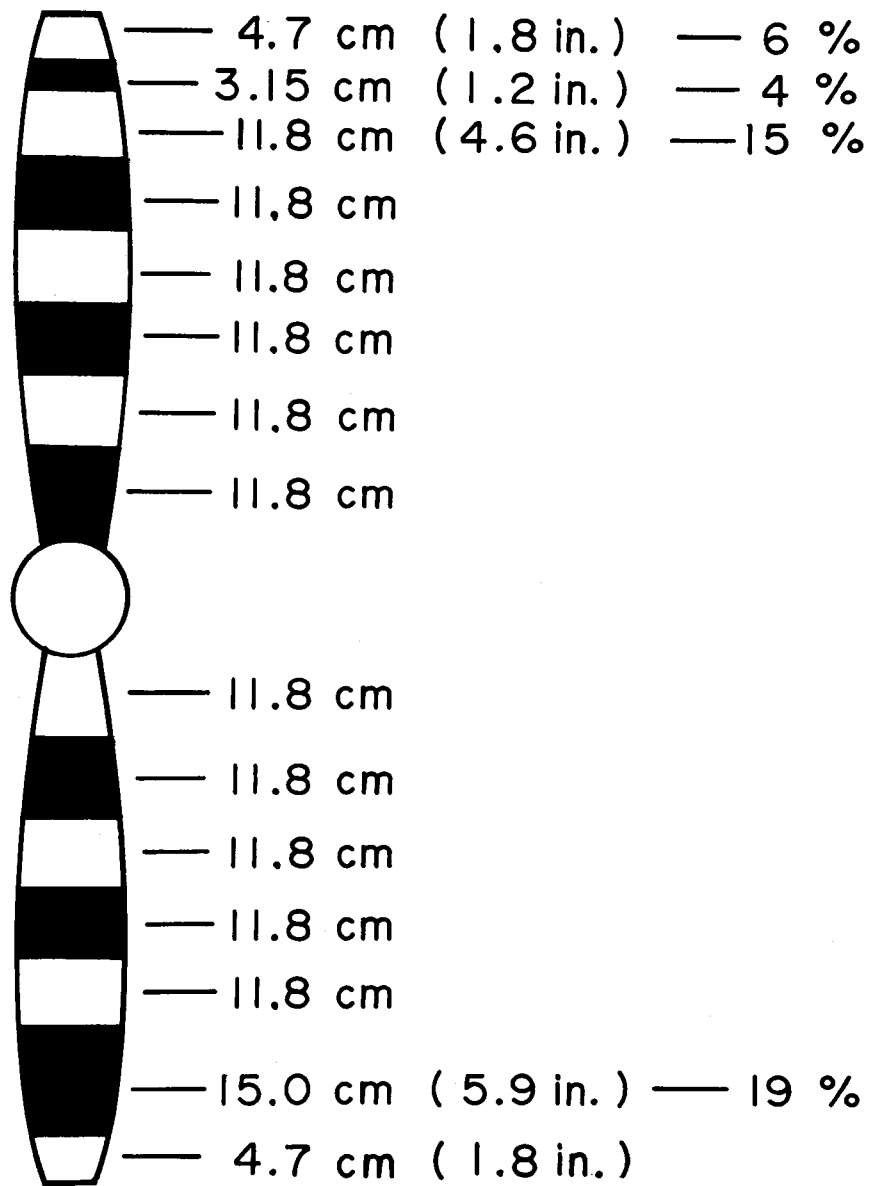
FIGURE 1. Propeller with black and white paint scheme and asymmetrical stripes taken from U.S. Army, TB-746-93-2.

Paint scheme specifications for each of three airplane propellers (Figures 1-3) were taken from: (i) U.S. Army, TB-746-93-2, (ii) U.S. Air Force, T.O. 1-1-4, and (iii) U.S. Navy, MIL-M-25047-C, (ASG). Specifications for two helicopter tail rotor blades (Figure 4) include U.S. Navy, MIL-M-25047-C, (ASG) and U.S. Army, TB-746-93-2. Propeller/tail rotor specifications recommended by the British Civil Aviation Authority

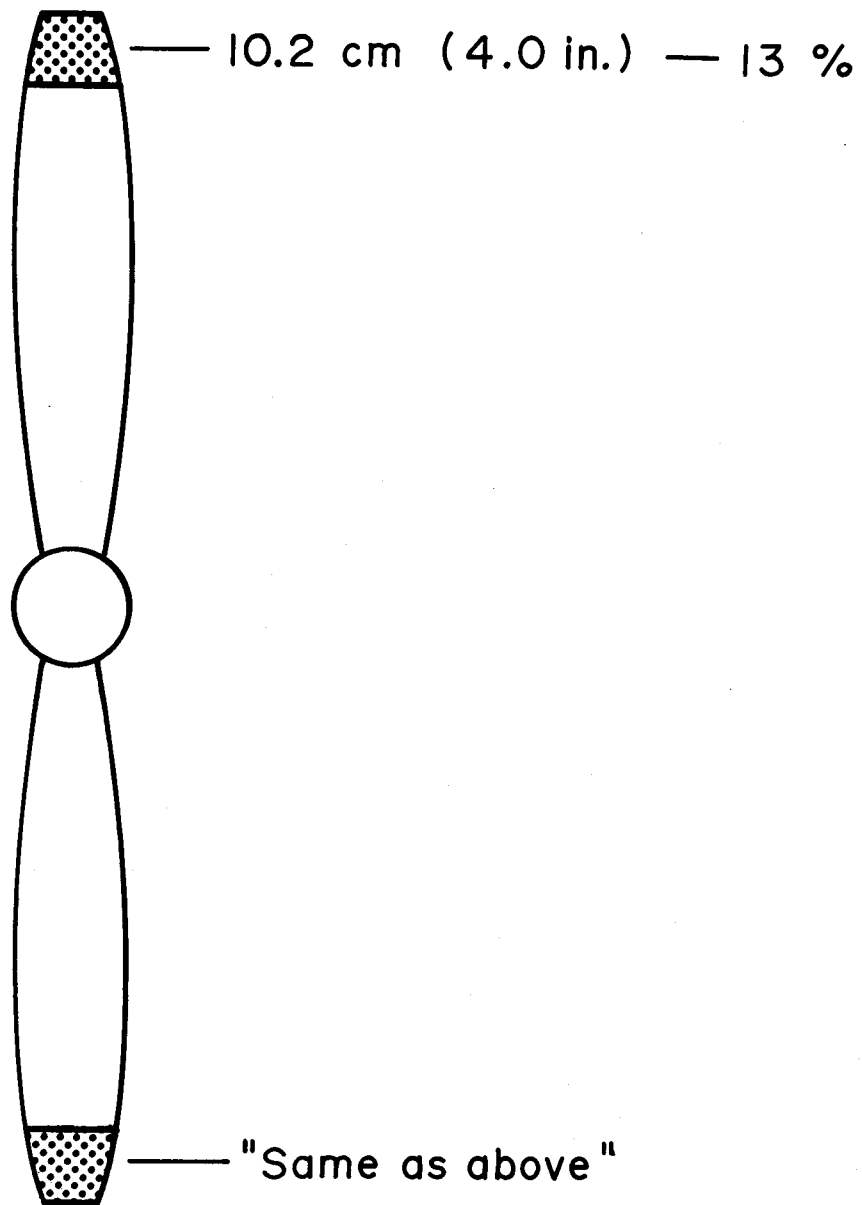
FIGURE 2. Propeller with yellow tip paint scheme (stippled area) taken from U.S. Air Force, T.O. 1-1-4.

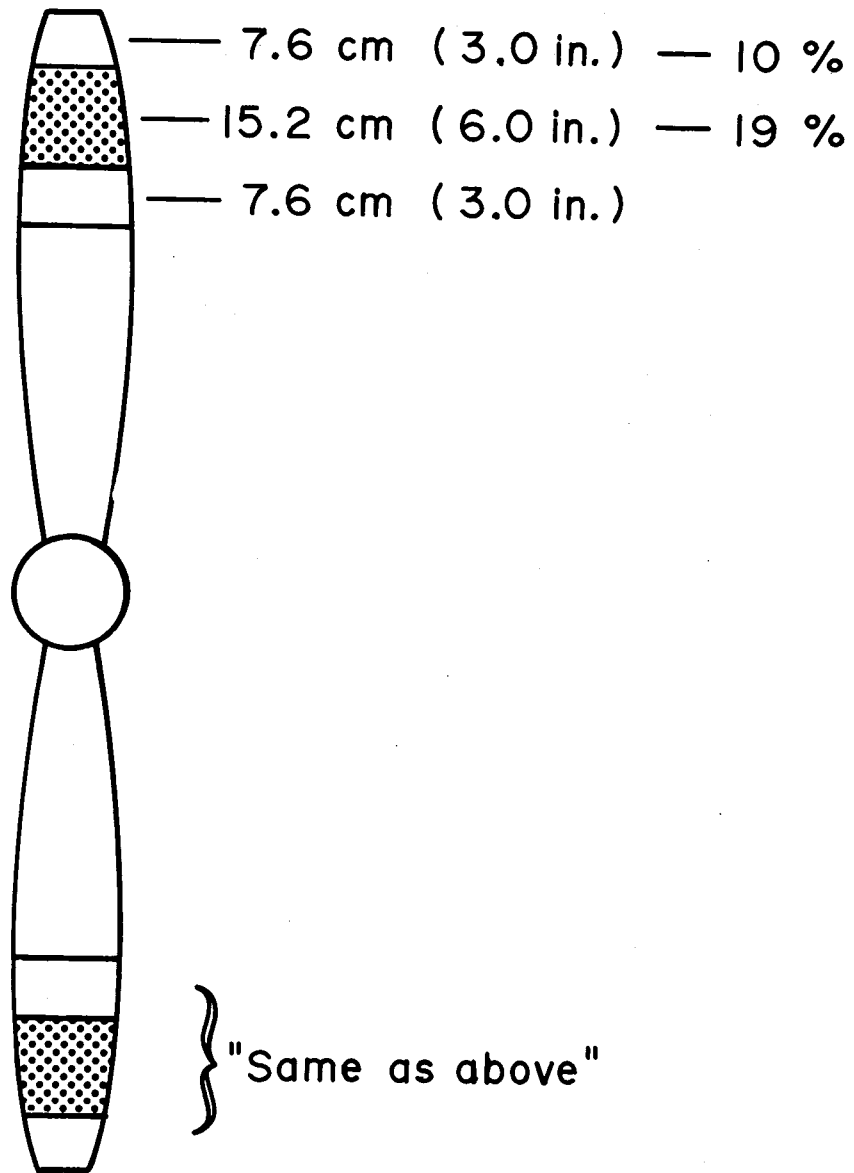
FIGURE 3. Propeller with red (stippled area) and white paint scheme taken from U.S. Navy MIL-M-25047-C (ASG).

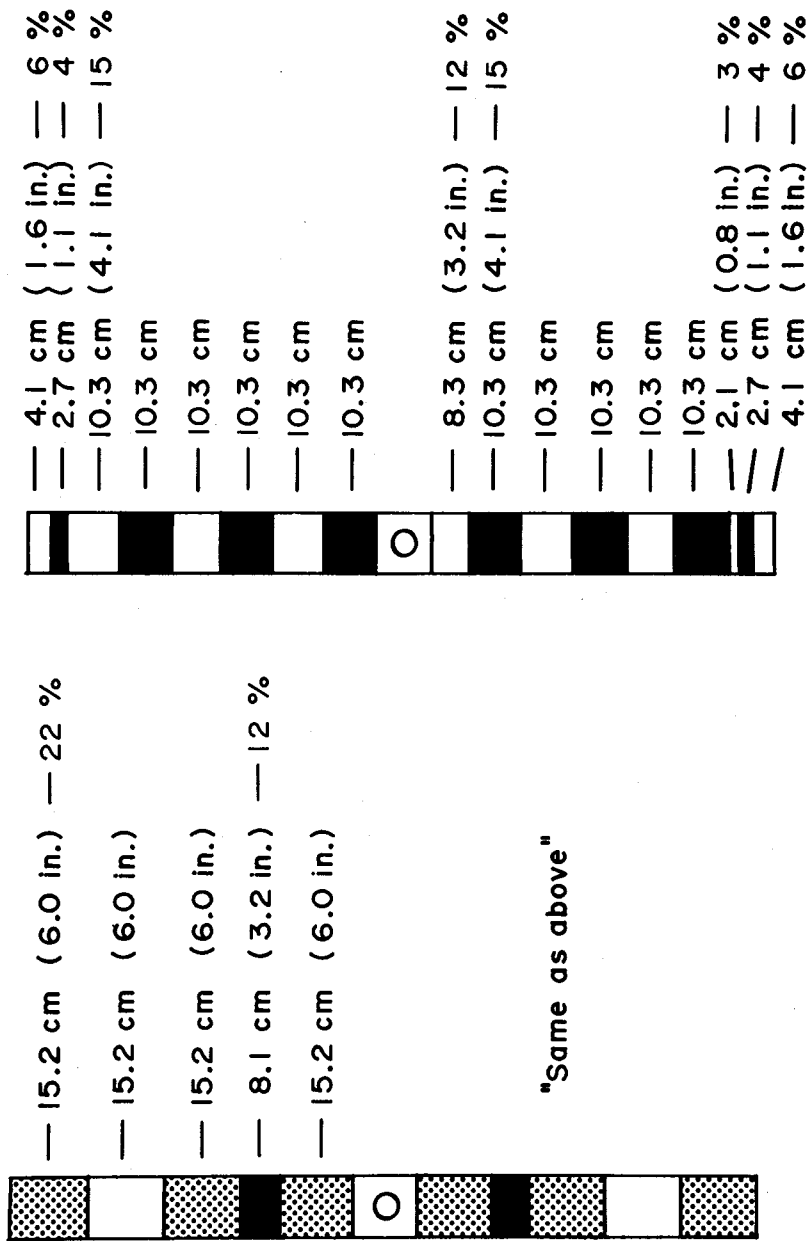
FIGURE 4. Two helicopter rotor paint schemes. (Left) U.S. Navy scheme taken from MIL-M-25047-C (ASG) with stippled area in red. (Right) U.S. Army scheme with black and white asymmetrical stripes taken from TB-746-93-2.

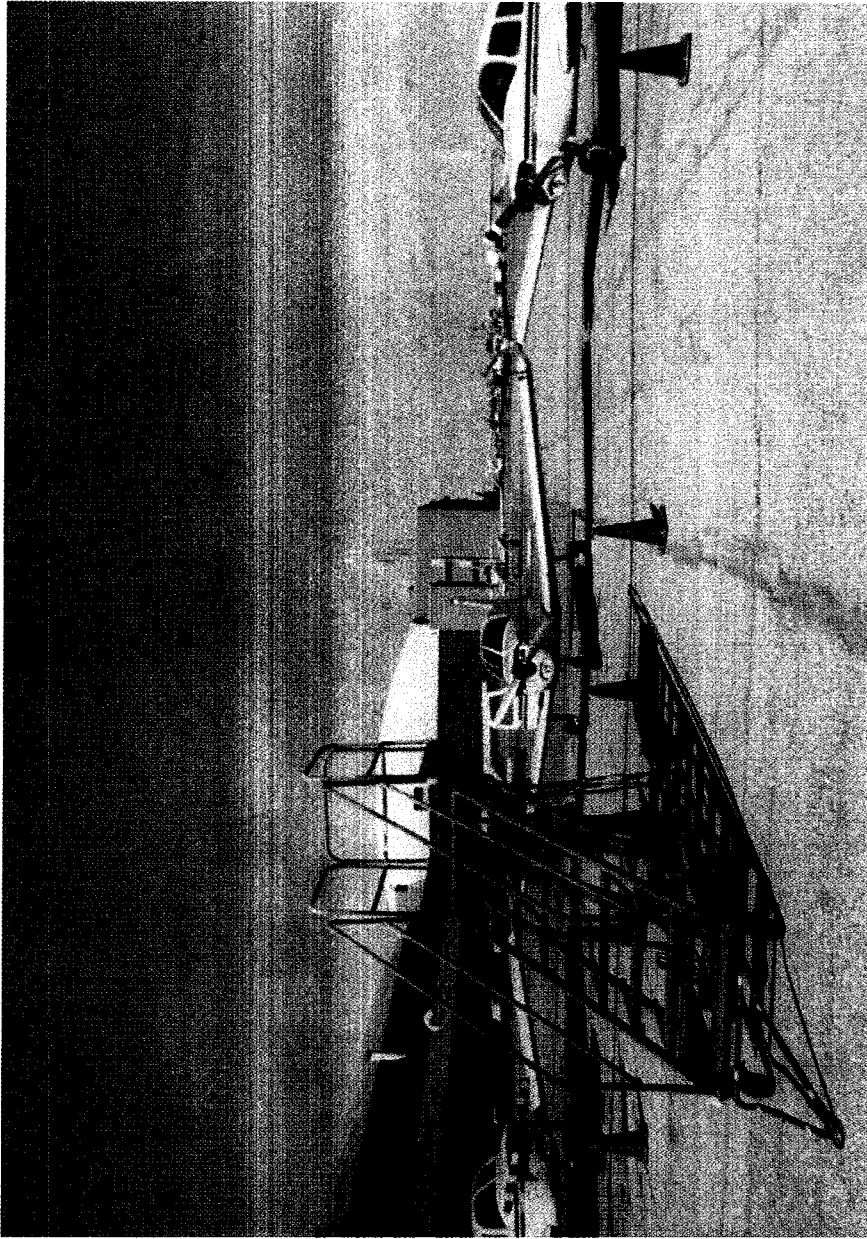
FIGURE 5. Three Piper Cherokee, Model 140, airplanes positioned in the viewing area with an elevated viewing platform.

Three Piper Cherokee airplanes (Model 140) were positioned wing-to-wing in a semicircular fashion facing a central viewing area. Two Bell helicopters (Series B47G, open tail) were positioned nose-to-tail at a distance of approximately 90 m (300 ft) from the airplanes. The viewing areas, sectioned off by pylon-type markers, were located 6.1 m (20 ft) from the airplanes and 9.1 m (30 ft) from the helicopters. A photograph of the airplane viewing area is shown in Figure 5.
