## AIRCRAFT ACCIDENT REPORT

ATLANTIC CITY AIRLINES, INC.,  
DeHAVILLAND DHC-6, TWIN OTTER, N101AC

CAPE MAY COUNTY AIRPORT, NEW JERSEY

REPORT NUMBER: NTSB-AAR-77-12

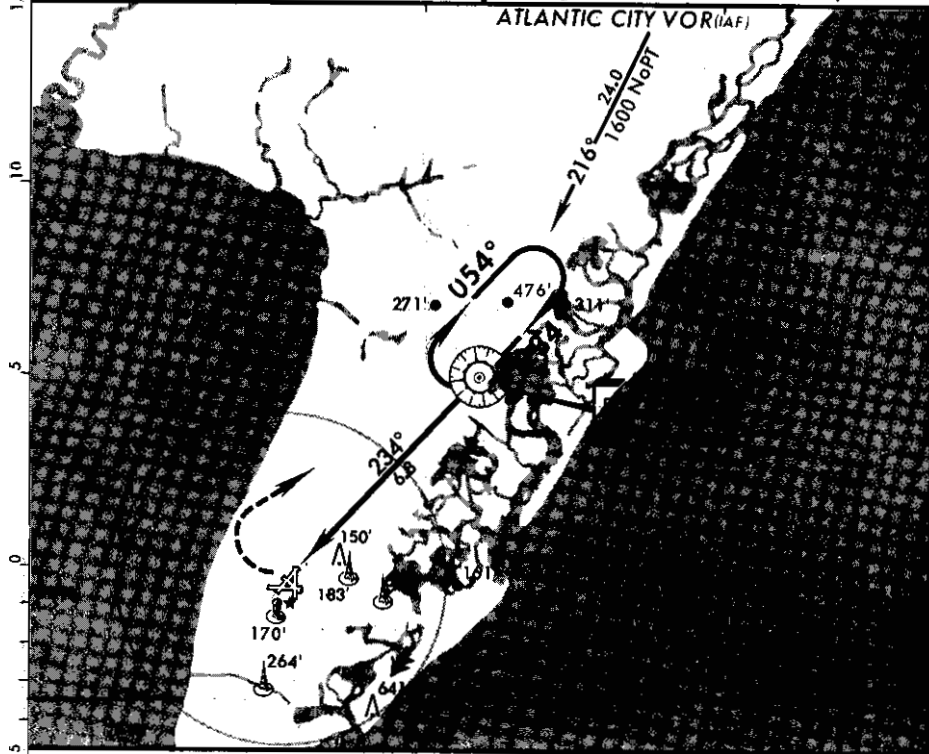
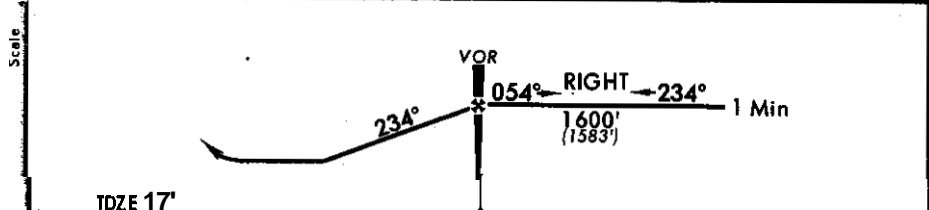
PULL UP: Climbing RIGHT turn to 1600 feet direct SIE VOR and hold NORTHEAST.

STRAIGHT-IN LANDING RWY 23		CIRCLE-IO-LAND	
MDA 440'(423') With Approved Weather Service		MDA 540'(523') With Millville Altimeter Setting	
		With Approved Weather Service	With Millville Altimeter Setting
		MDA	MDA
A		480'(458')-1	560'(538')-1
B			
C	1	500'(478')-1 1/2	580'(558')-1 1/2
D		580'(558')-2	580'(558')-2
D		1 1/4	
Gnd speed-Kts		Night NA.	
VOR to MAP 6.8			
6:48 5:06 4:05 3:24 2:55 2:33

3.1	Findings . . . . .	21
3.2	Probable Cause . . . . .	23
<b>4.</b>	Appendixes . . . . .	<b>25</b>
	Appendix A - Investigation and Hearing . . . . .	25
	Appendix B - Personnel Information . . . . .	<b>26</b>
	Appendix C - Aircraft Information . . . . .	27
	Appendix D - Instrument Approach Chart . . . . .	28

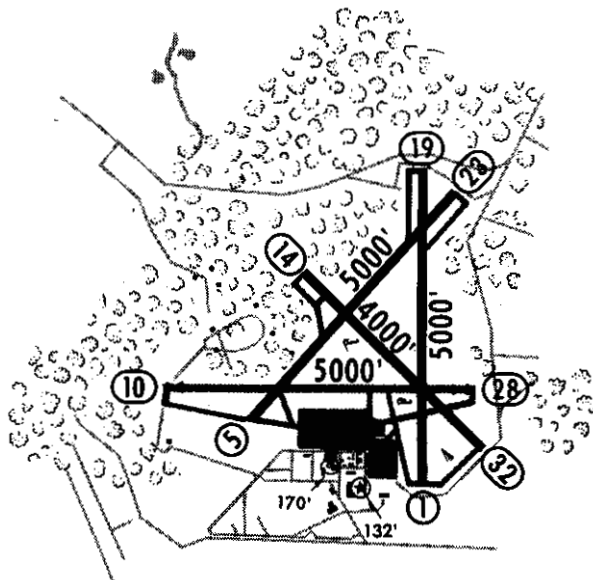
**ADDITIONAL RUNWAY INFORMATION**

RWY		USABLE LENGTHS			WIDT.
		LANDING Threshold	BEYOND Glide Slope	TAKE-OFF	
1	MIRL VASI (non-std)				150'
5	19 23				150'
10	28 MIRL				150'
14	32				150'
