AIRCRAFT ACCIDENT REPORT

UNSTABILIZED APPROACH AND
LOSS OF CONTROL

NPA, INC. dba UNITED EXPRESS FLIGHT 2415

BRITISH AEROSPACE BA-3101, N410UE

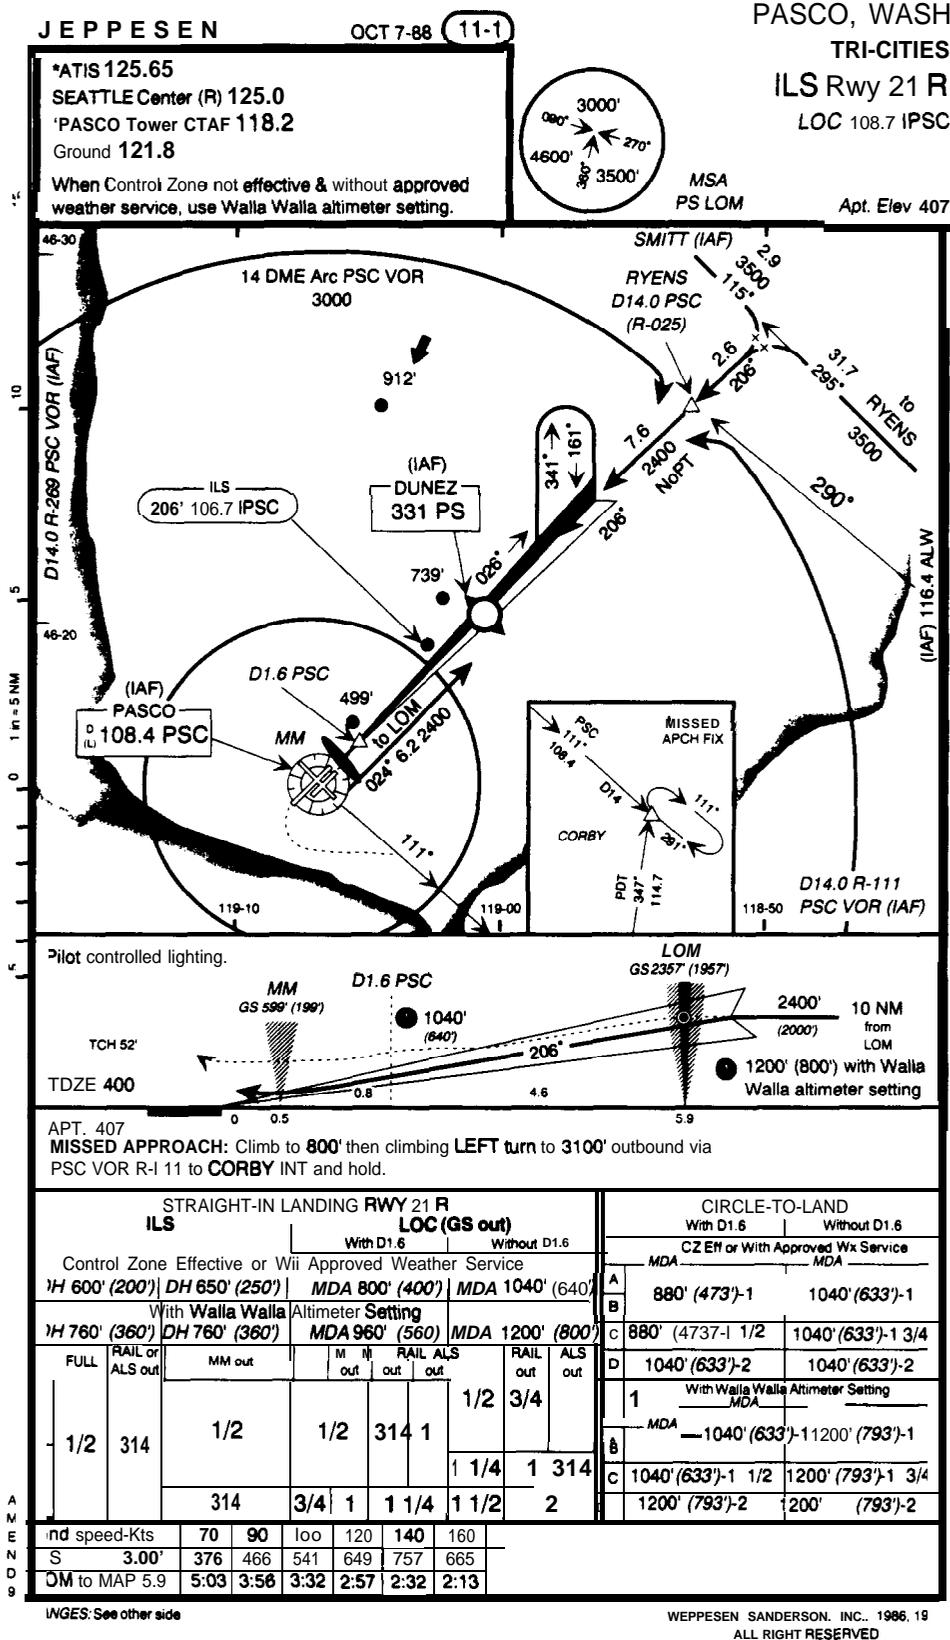
Figure 1. --ILS approach to runway 21R.

At 2226:12, the Seattle Center controller advised the flightcrew of Sundance 415, "...5 miles north of DUNEZ, turn right heading 180, maintain 3,000 until established on the localizer and you're cleared for straight-in ILS [instrument landing system] runway 21R approach." (See figure 1). The first officer responded, "Okay, you were, uh, partially broken up, uh, for Sundance 415, can you repeat that?" At 2226:27, the Seattle Center controller repeated the clearance. At 2226:35, the first officer acknowledged the approach clearance. At 2227:27, the Seattle Center controller advised the flightcrew, "...radar service is terminated, frequency change is approved, good day." This transmission was repeated 9 seconds later and, at 2227:41, the first officer responded, "Okay, we're switching to tower now, Sundance 415." The Seattle Center controller replied, "uh, tower's closed sir, you can contact, uh, flight service." At 2228:30, the first officer of Sundance 415 transmitted, "Seattle Center, Sundance 415 is, uh, doing a missed approach out of Pasco, we'd like, uh, vectors for another one, please."

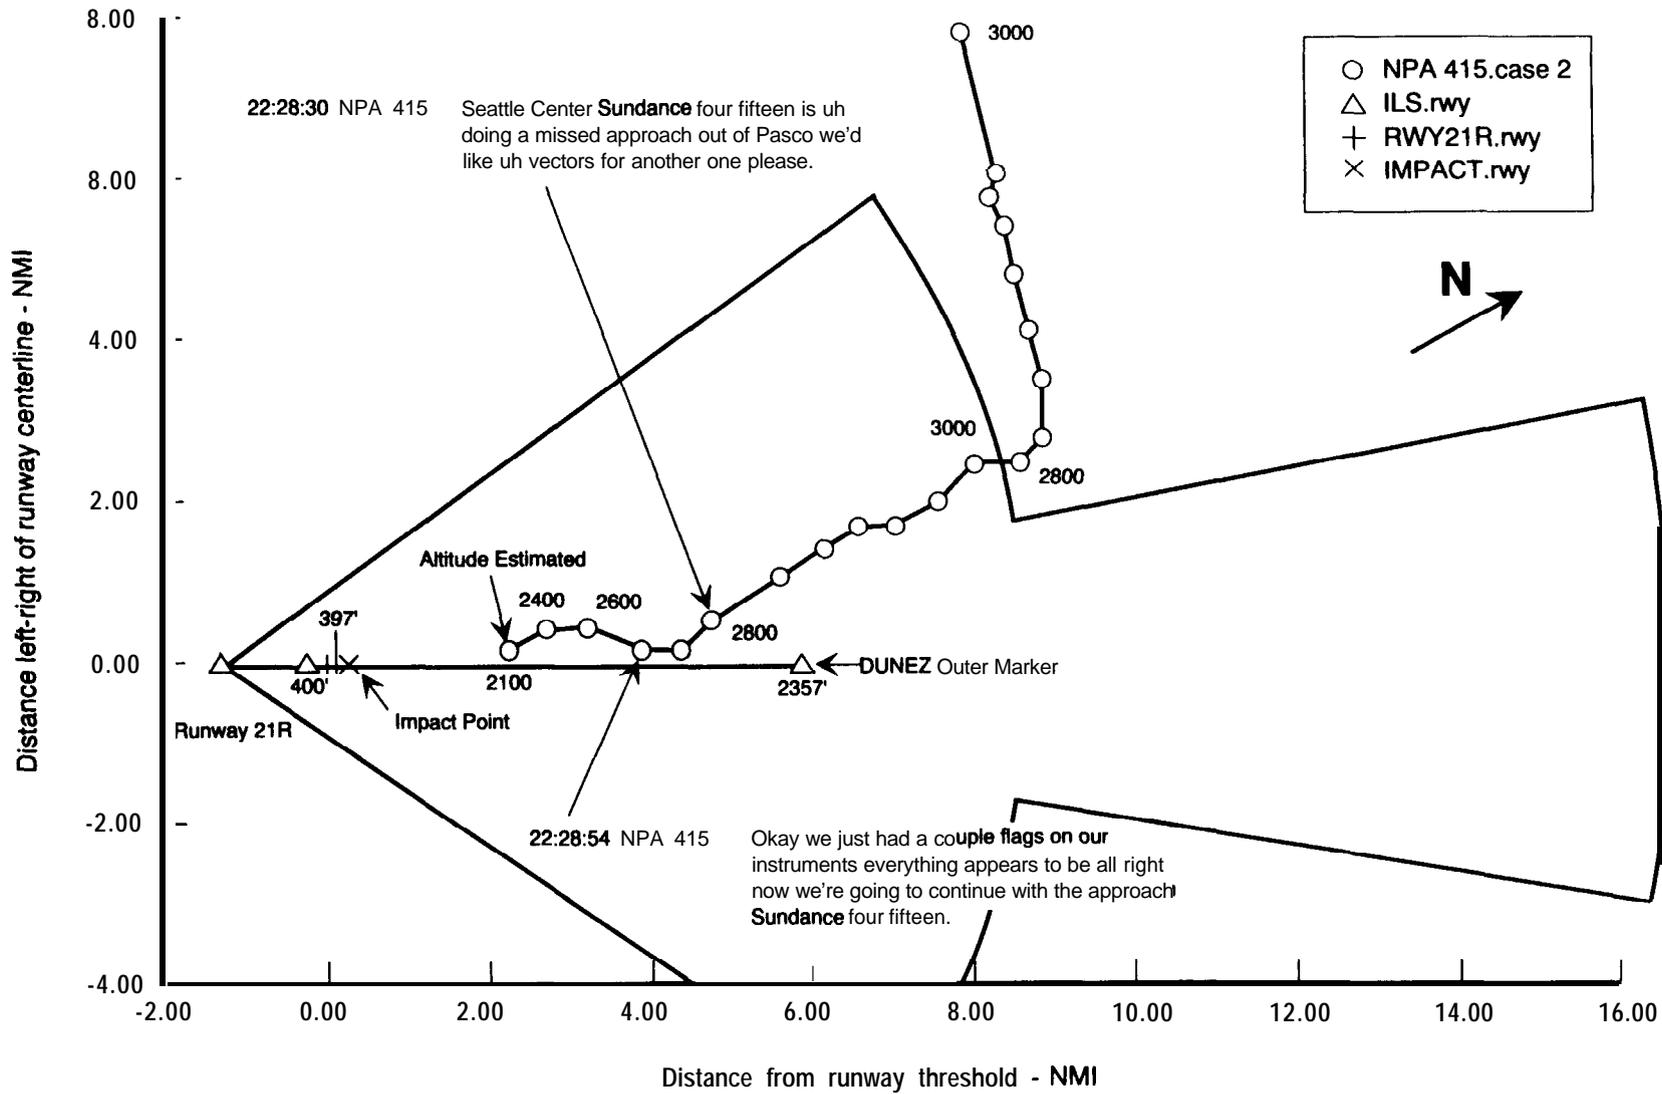
Figure 2.--Planview of radar data.

Figures 2 and 3 show these radar data plotted along with localizer and glideslope limits for runway **21R**. The location of the accident flight during FAA-recorded radio transmissions is also presented in these figures.

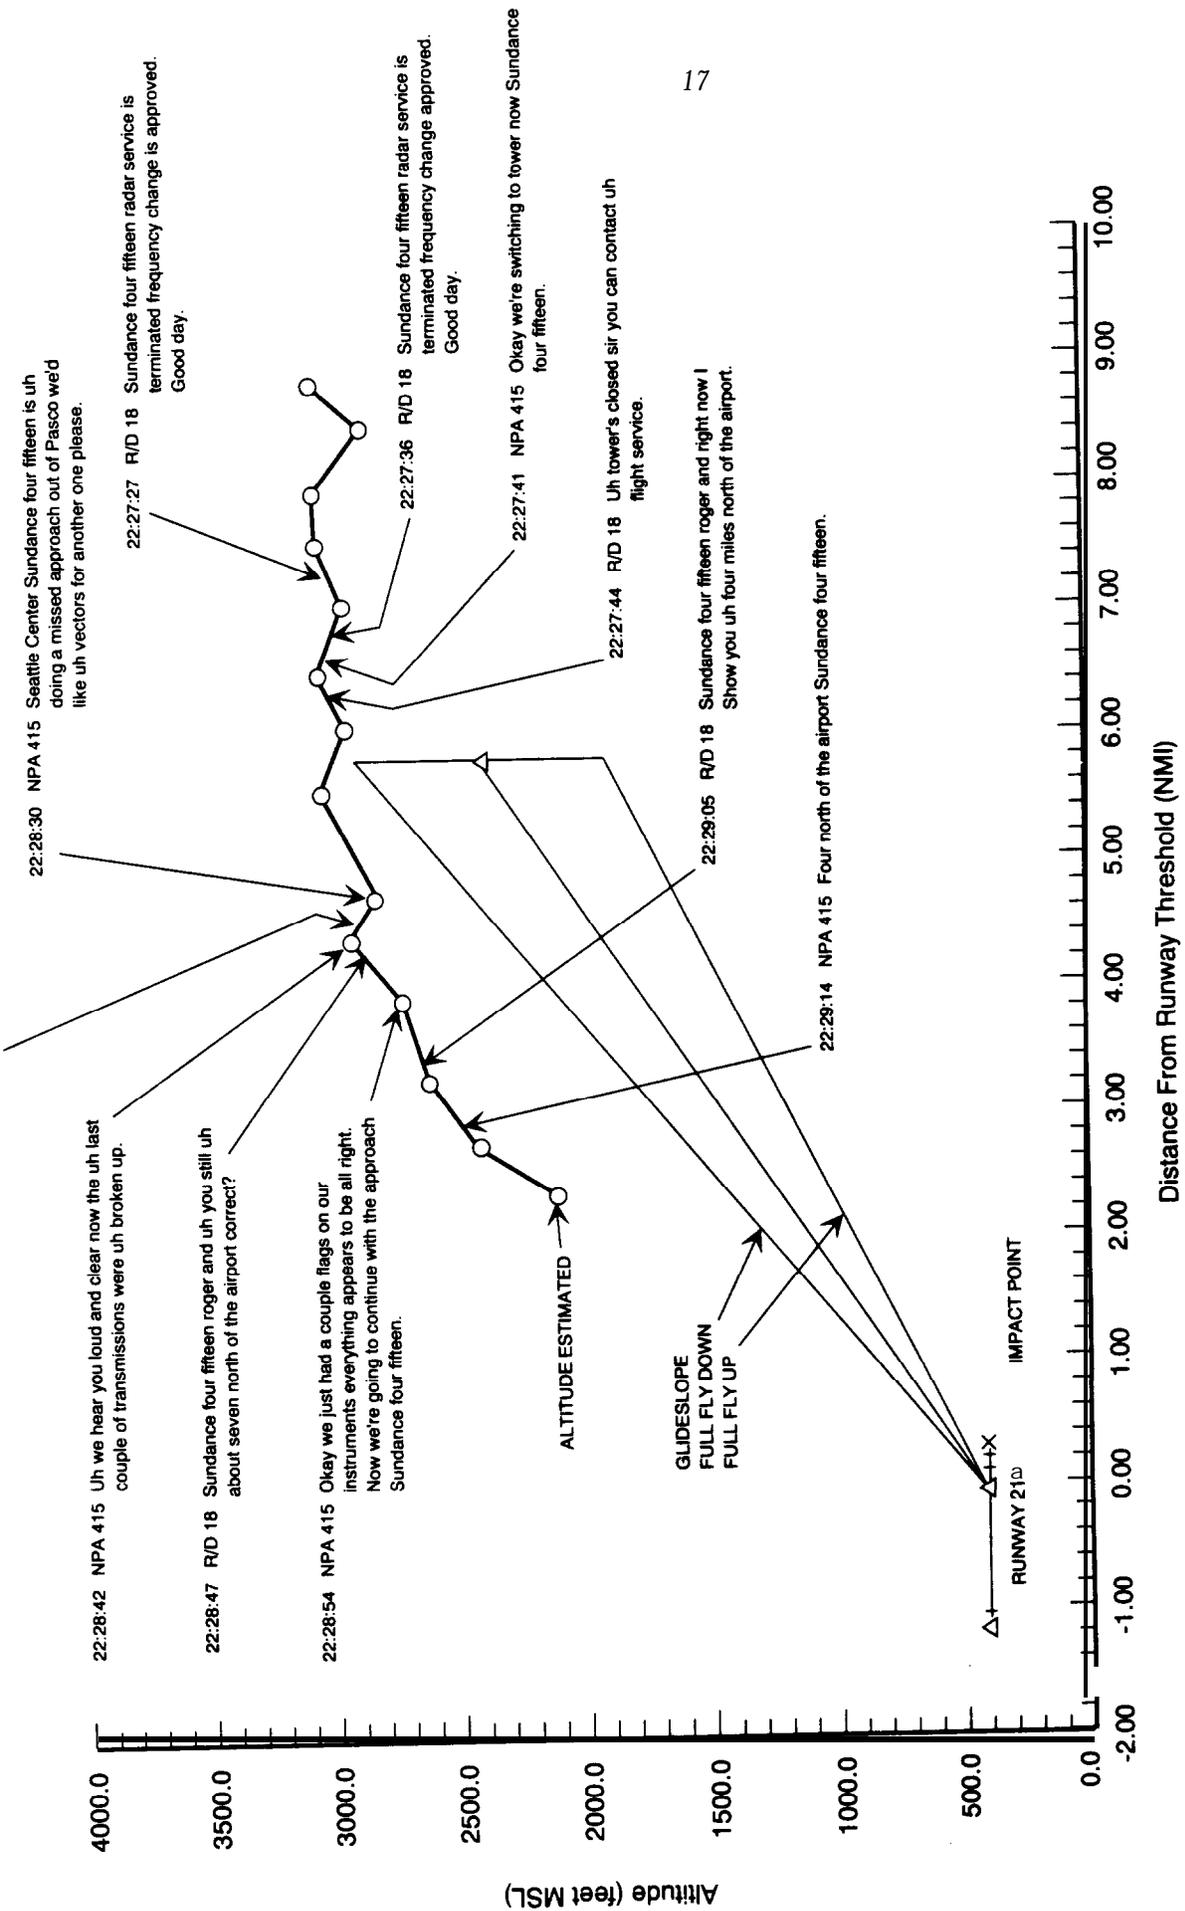
Figure 3.--Profile view of radar data.
