# NATIONAL TRANSPORTATION SAFETY BOARD

## AIRCRAFT ACCIDENT REPORT

IN-FLIGHT ICING ENCOUNTER AND  
UNCONTROLLED COLLISION WITH TERRAIN  
COMAIR FLIGHT 3272  
EMBRAER EMB-120RT, N265CA  
MONROE, MICHIGAN  
JANUARY 9, 1997

**Abstract:** This report explains the accident involving an EMB-120RT, operated by COMAIR Airlines, Inc., as flight 3272, that crashed during a rapid descent after an uncommanded roll excursion near Monroe, Michigan, on January 9, 1997. Safety issues in the report focused on procedures for the use of ice protection systems, airspeed and flap configuration information, stall warning/protection system capabilities, operation of the autopilot in icing conditions, aircraft icing certification requirements, and icing-related research. Safety recommendations concerning these issues were addressed to the Federal Aviation Administration and the National Aeronautics and Space Administration.

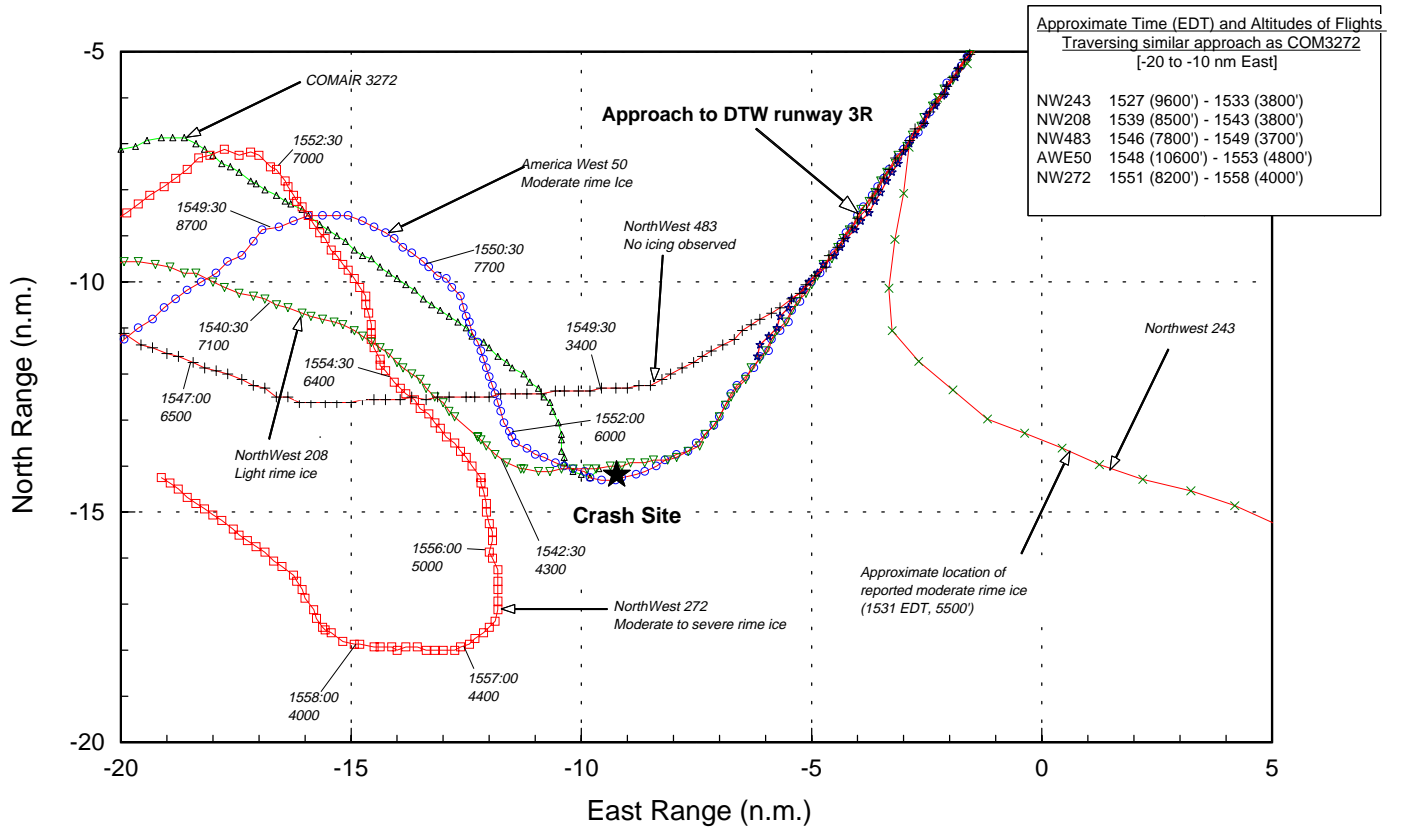
Figure 7.--Ground tracks of aircraft.

**Relative Positions of COMAIR 3272  
and several other flights using a similar approach  
1/9/97, Monroe, MI**

Because a wide variety of conditions were reported by pilots operating in the Detroit area (see figure 7), the Safety Board tried to narrow the focus to those airplanes that were closest to the accident time and location. Radar data<sup>60</sup> and pilot statements indicated that the ground tracks of NW flight 208, NW flight 483, Cactus 50, and NW flight 272 passed near the accident site within minutes of the accident and reported the following icing conditions:
