NATIONAL TRANSPORTATION SAFETY BOARD

SAFETY STUDY

ULTRALIGHT VEHICLE ACCIDENTS

NTSB/SS-85/01

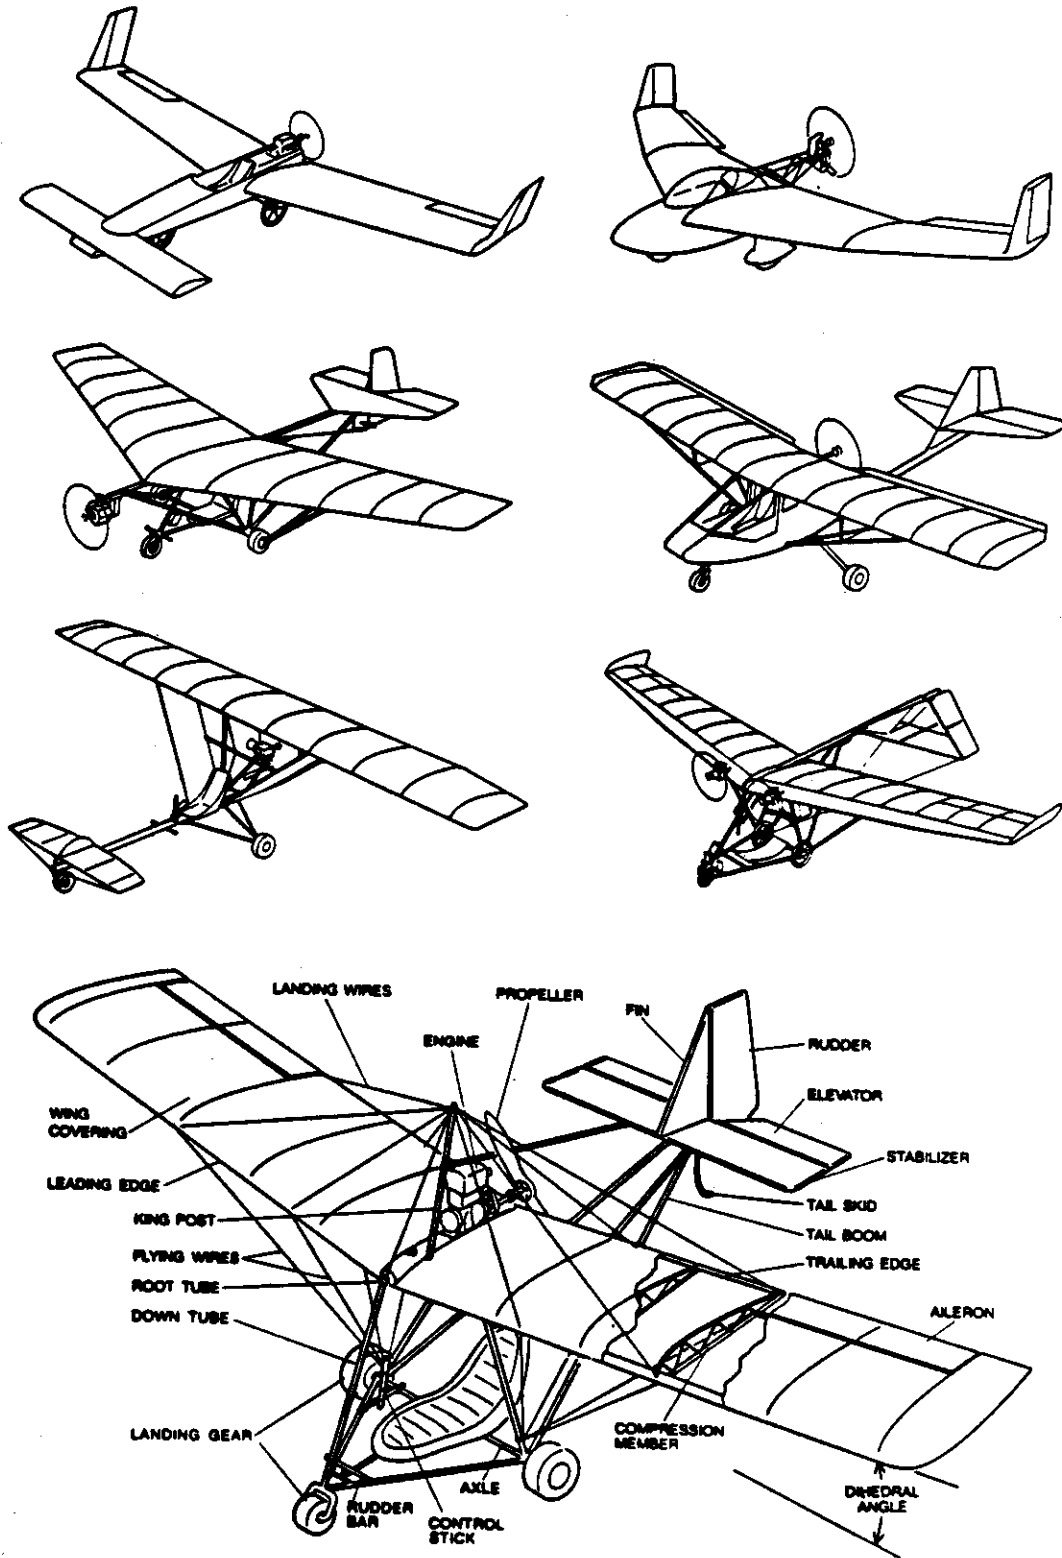
Figure 1.--Six different ultralight vehicle designs (top), and components of a typical ultralight vehicle (bottom). Illustrations from Scientific American, July 1982, pp. 63 and 64.

Typically, a powered ultralight will be 15 to 20 feet long with a wing span of 30 to 35 feet. The empty weight of most vehicles is between 185 and 260 pounds. The powered ultralight usually cruises at 50 to 60 miles per hour, has a power-off stall speed of 24 to 30 miles per hour, and can fly from 50 to 135 miles on a tank of gas. Powered ultralights usually are constructed from aluminum or steel tubing supported by wires, and fabric coverings are used for wings and control surfaces. The components of a typical powered ultralight and six representative designs are illustrated in figure 1.
