DOT/FAA/AM-98/13

A Human Factors Perspective on Human External Loads

May 1998

Final Report

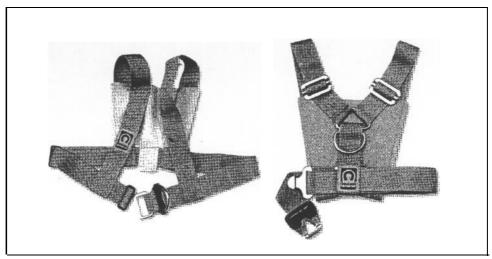
Figure 2. Safety Harnesses (Mustang Survival).

One of the more basic devices provided by HEL manufacturers is variously known as a safety harness, a rescue swimmer's harness, or a chest harness. Typically, these harnesses consist of shoulder straps attached to a waist or chest belt. The design of the straps varies. Some harnesses incorporate suspender style straps with the tether point-of-attachment at a D-ring on the front center of the chest/waist strap. Others utilize a Y-shaped design (on the front or back) for the harness, where the shoulder straps meet a strap extending vertically from the waist belt to form a threepoint intersection. This design is sometimes used at the chest, at which point a D-ring is used for tether attachment. The harnesses are either designed to be fully adjustable to accommodate a variety of users or are available sized for the individual user. The harness is constructed of nylon webbing with at least a 2 in. width. Custom padding is an optional feature offered by some manufacturers. The harness is designed to support the load (i.e., body weight) by the torso and shoulders of the user. Figure 2 presents two versions of safety harnesses manufactured by Mustang Survival (1). These types of harnesses are utilized to transport or suspend people from helicopters for short durations.

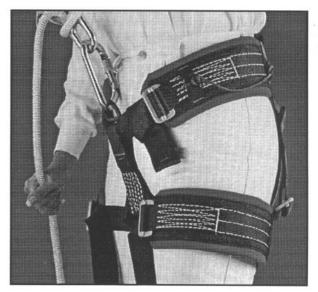
Figure 4. Pro Series Rescue Harness (CMC Rescue Equipment).

A different design attaches the waist belt to the leg loops with vertically oriented connector straps, one located in the front middle, and others located on the sides or the back (see Figure 4). The point-of-attachment is located at the intersection of the waist belt and the front vertical strap. Various other modifications exist to these basic designs. Most of these harnesses are fully adjustable at the waist and legs, with the "vertical" design allowing adjustable leg loop height. Additionally, quick and easy buckling mechanisms are provided for fast donning of the harness. A minimum of 2 in. webbing is used for the harness, although larger widths and padding are available on some models. Other variations to the sit harness include alternate locations for the D-ring attachment points

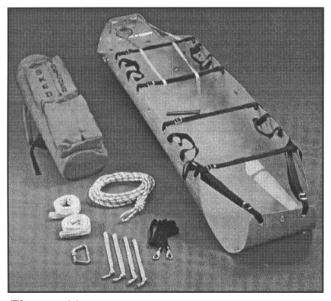
Figure 10. SKED Stretcher (Skedco, Inc.).

One of the more common devices for short-haul operations with passive users is the rescue litter. Rescue litters are available in a variety of styles, but all are adaptations of rigid or semi-rigid stretchers. The rescue litter has a variety of options, including shape, size, material, rigidity, harness attachments, use of litter shields, and the number and types of tie-down straps. Asemi-rigid rescue stretcher, made by Skedco, Inc. (9), is shown in Figure 10. Again, rescue litters are for passive users and are often accompanied by an active user attached via a harness to both the helicopter and the stretcher.
