ACCIDENTS IN U.S. SCHEDULED AIR CARRIER PASSENGER OPERATIONS

CALENDAR
YEARS
1951-1952

SEPTEMBER 1, 1954

CIVIL AERONAUTICS BOARD
BUREAU OF SAFETY INVESTIGATION

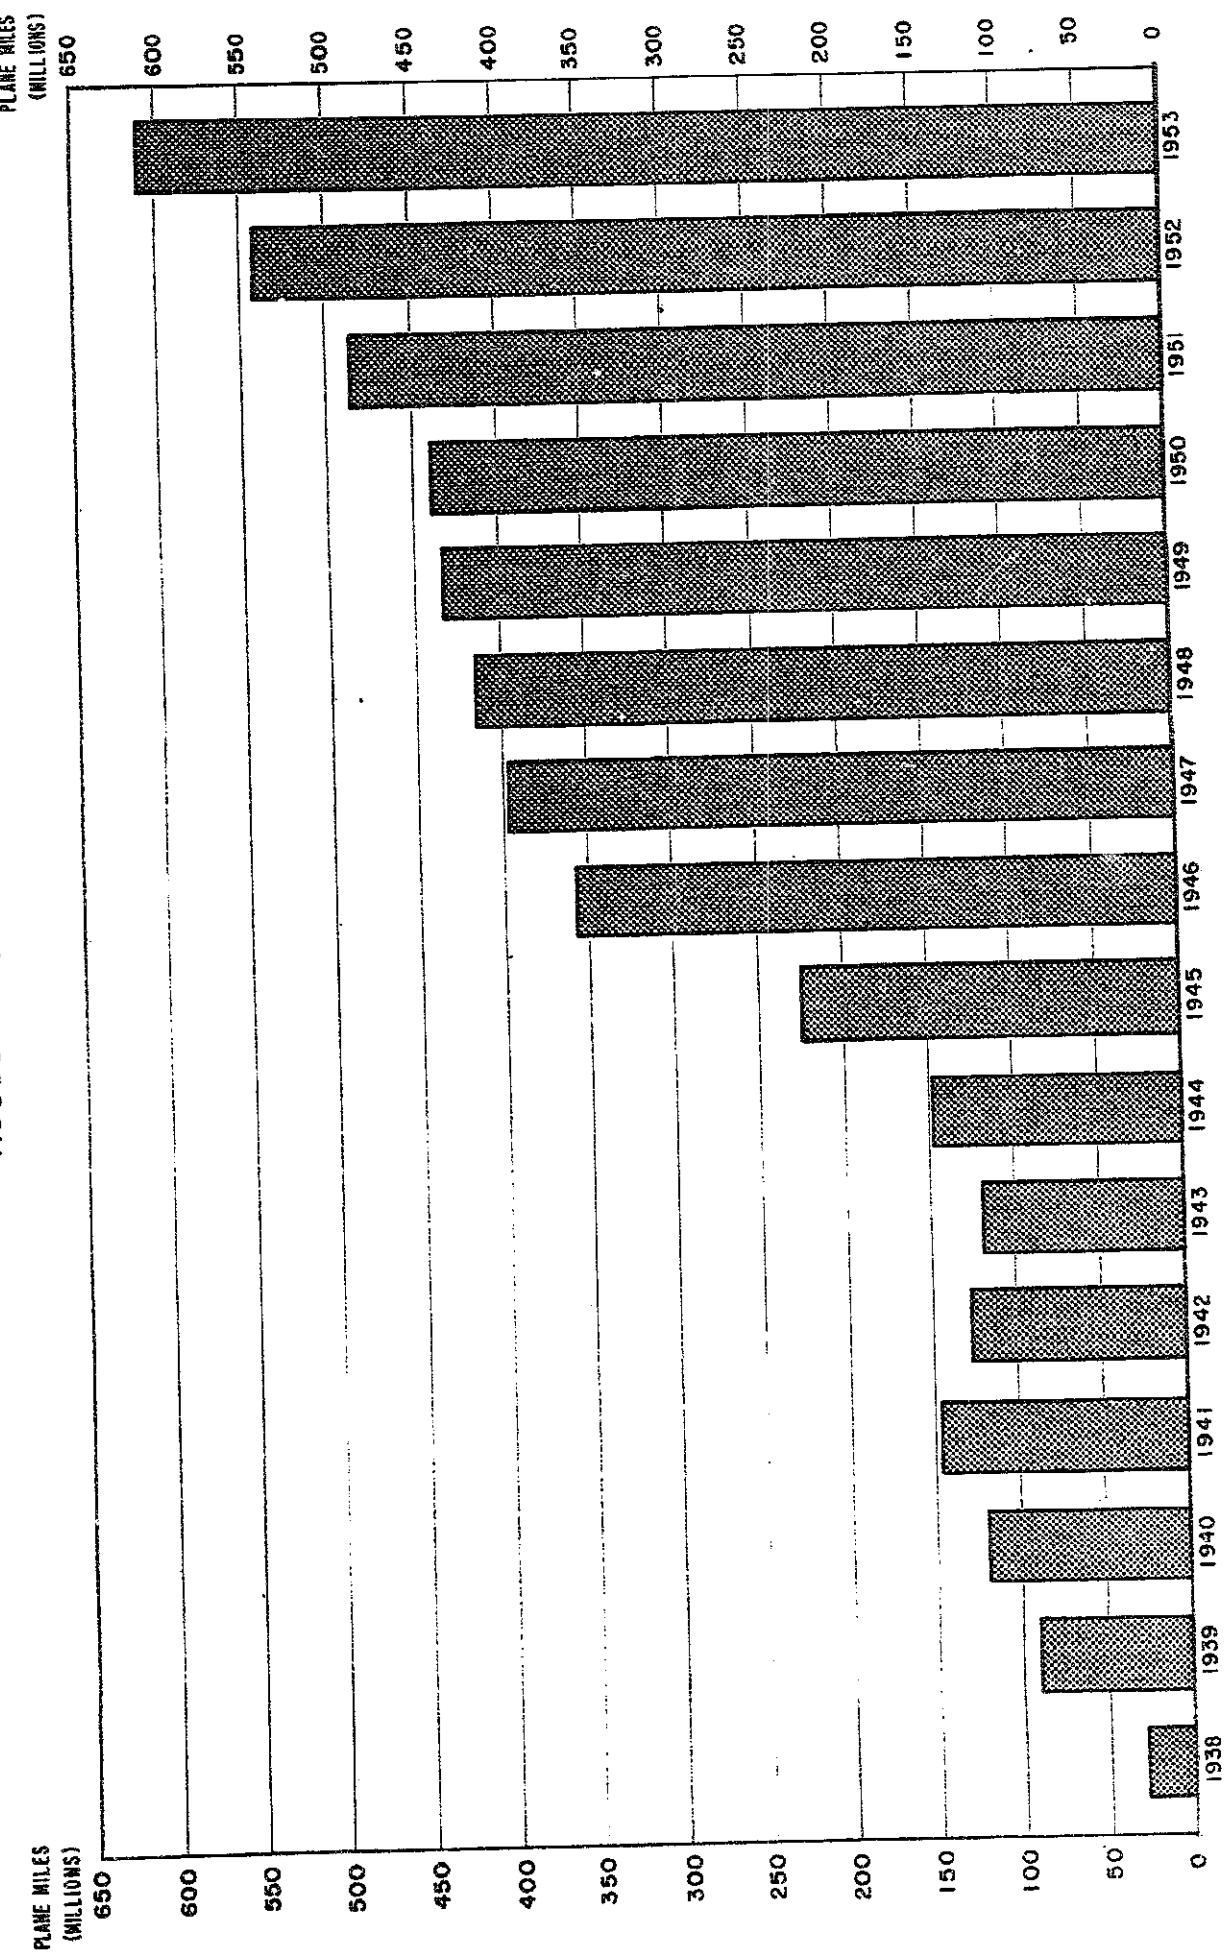
PLANE MILES FLOWN ANNUALLY
IN SCHEDULED DOMESTIC AND FOREIGN/OVERSEAS PASSENGER SERVICES
AUGUST 22, 1938-1953

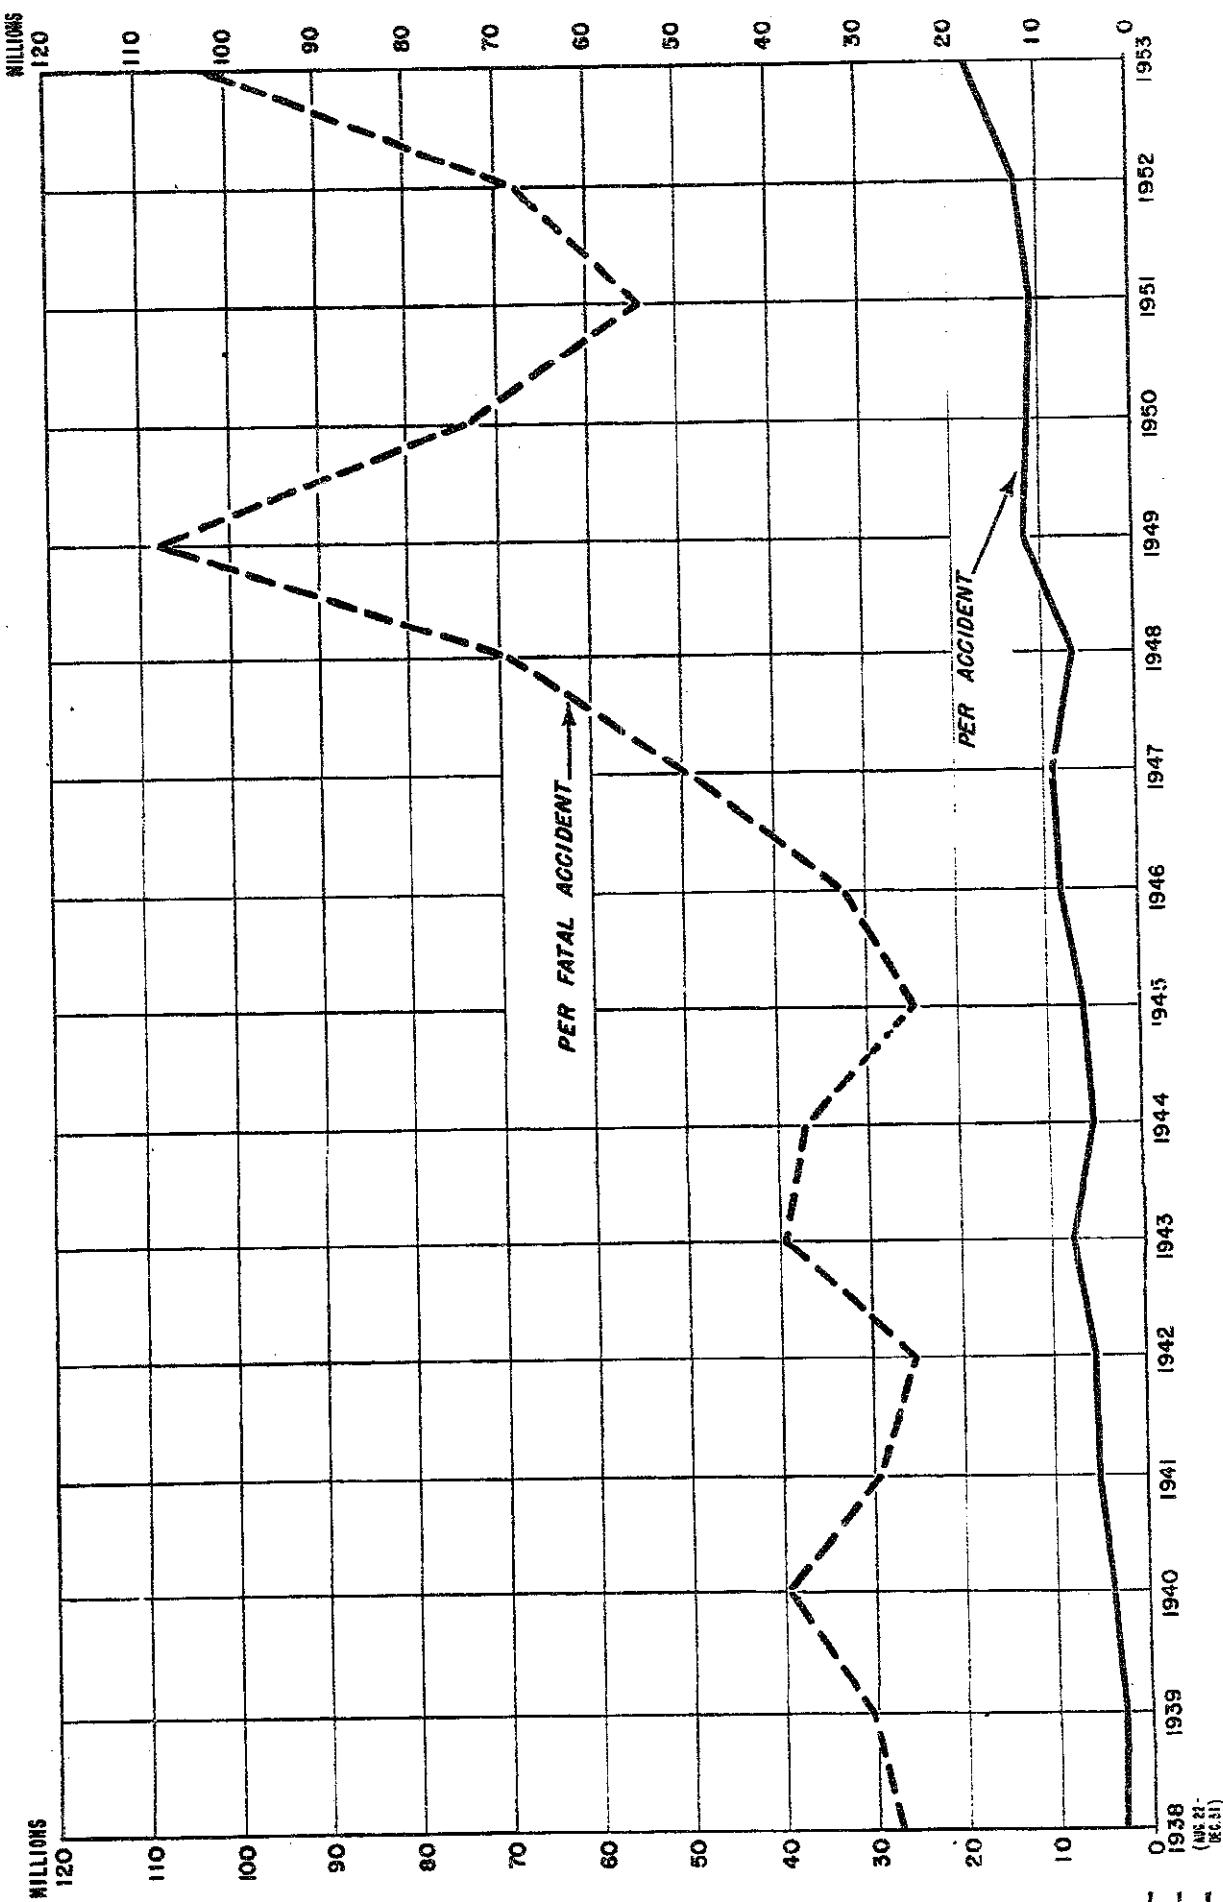
CHART 2

ANNUAL NUMBER OF PLANE MILES Flown
PER ACCIDENT AND PER FATAL ACCIDENT
IN SCHEDULED DOMESTIC AND FOREIGN/OVERSEAS PASSENGER SERVICES
(AUGUST 22, 1938 - 1953)

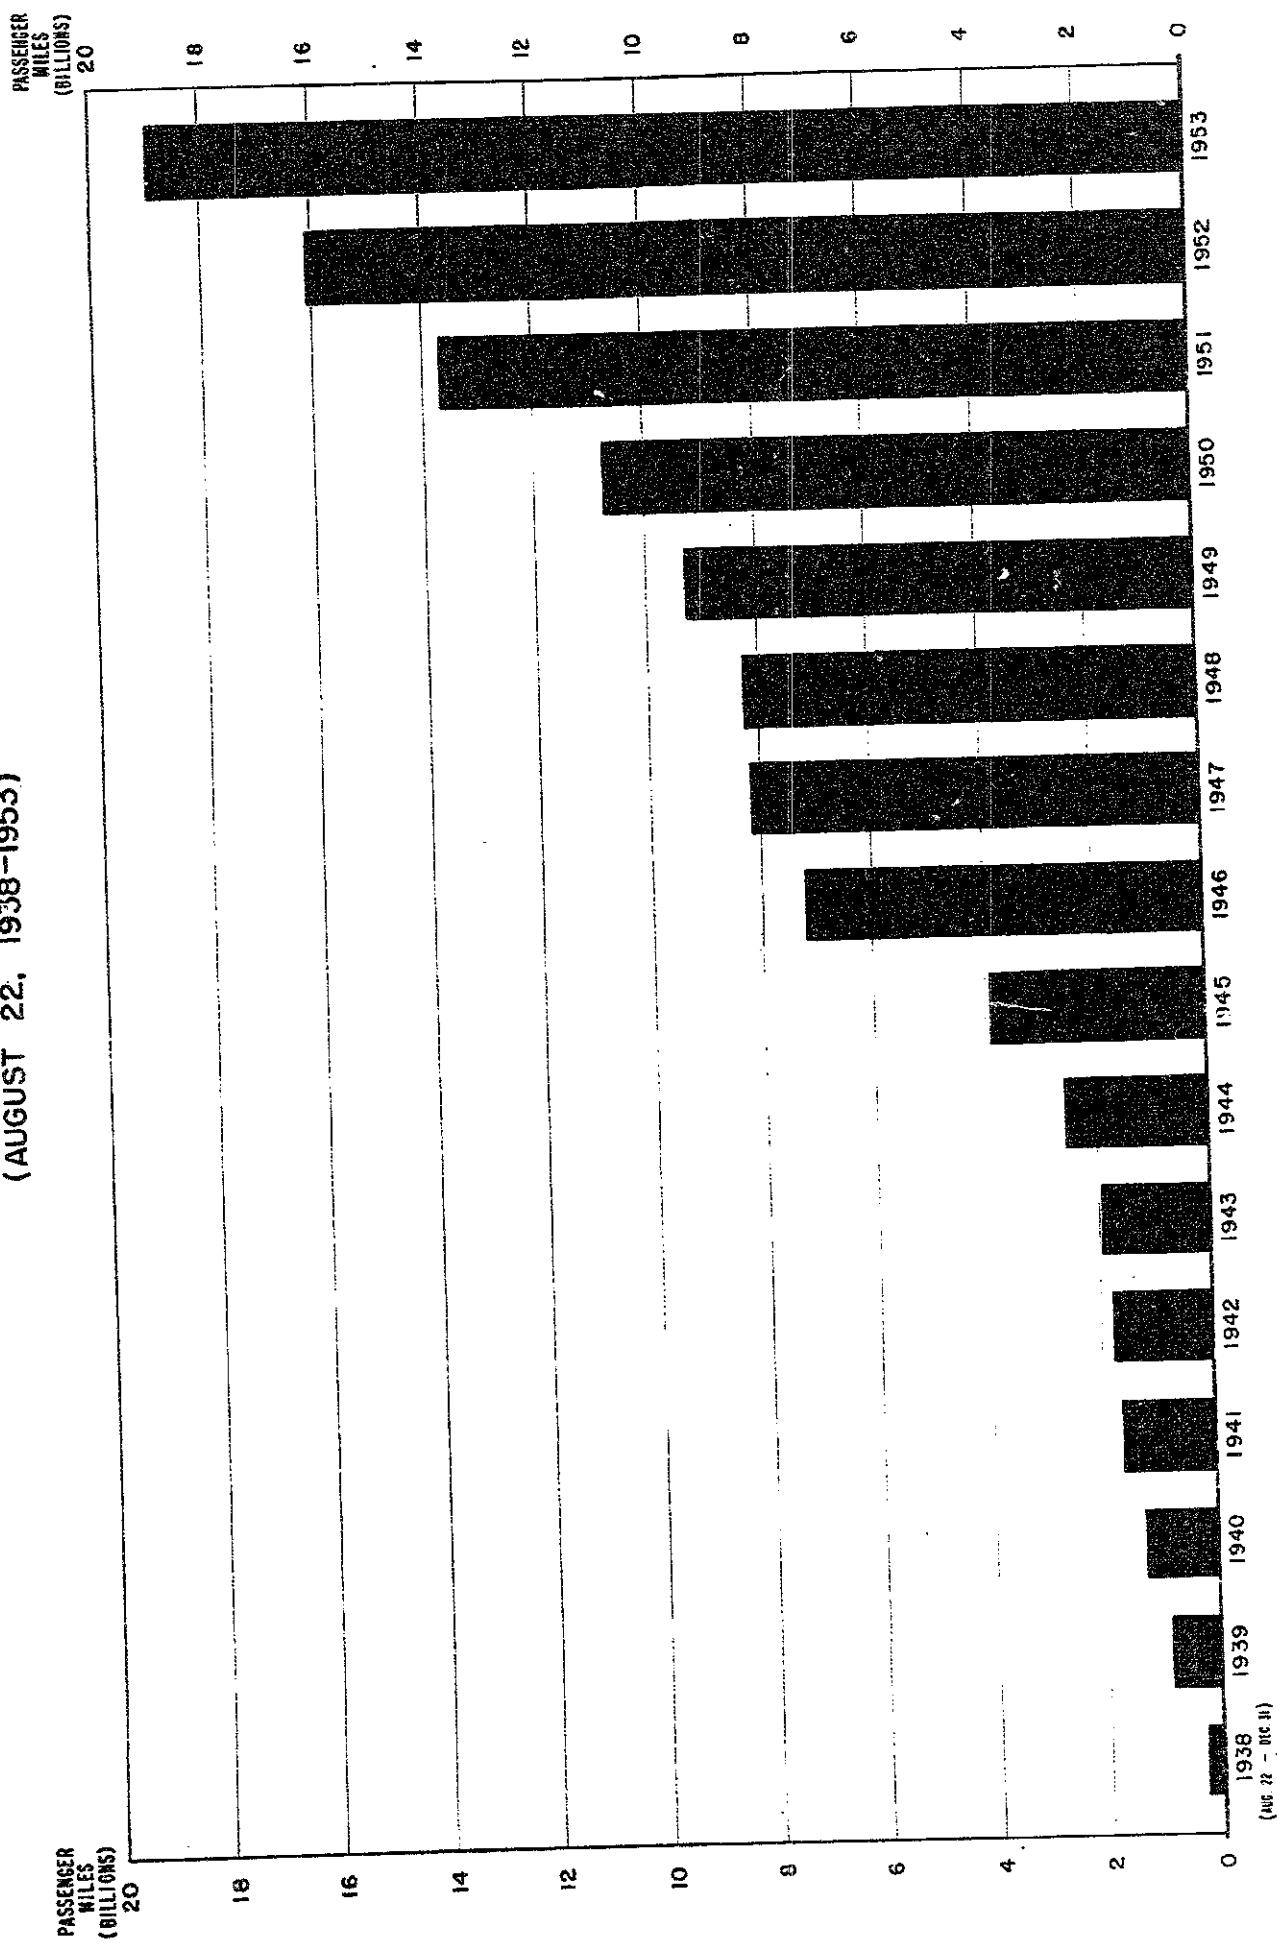
ANNUAL NUMBER OF PASSENGER MILES FLOWN
IN SCHEDULED DOMESTIC AND FOREIGN/OVERSEAS PASSENGER SERVICES
(AUGUST 22, 1938-1953)

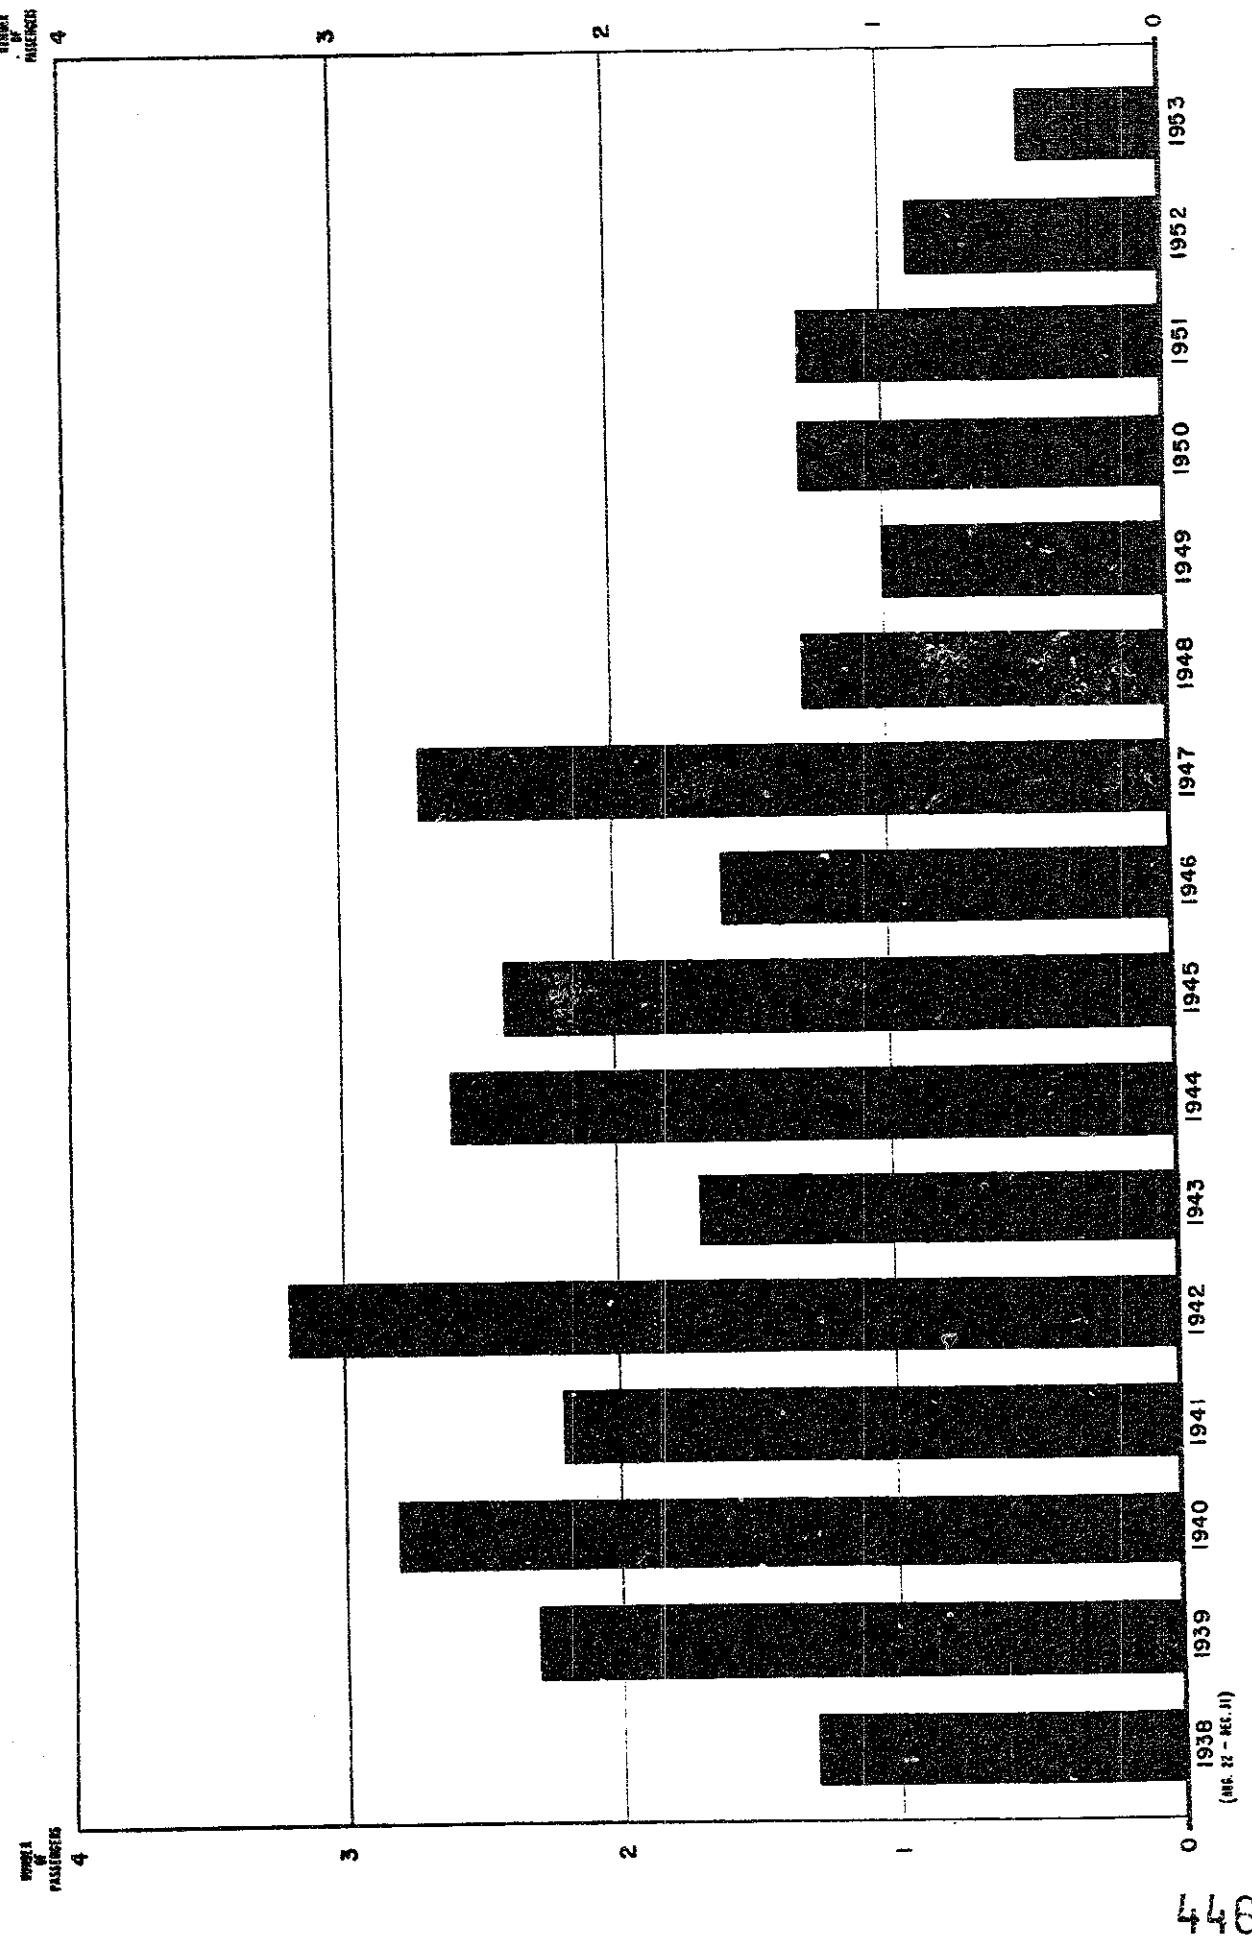
CHART 4

ANNUAL PASSENGER FATALITY RATES
PER 100 MILLION PASSEGER MILES FLOWN
IN SCHEDULED COMMERCIAL AIR
TOWARD CIVILIAN AND CIVILIAN/CARRIER SERVICES
(AUGUST 22, 1938 - 1953)

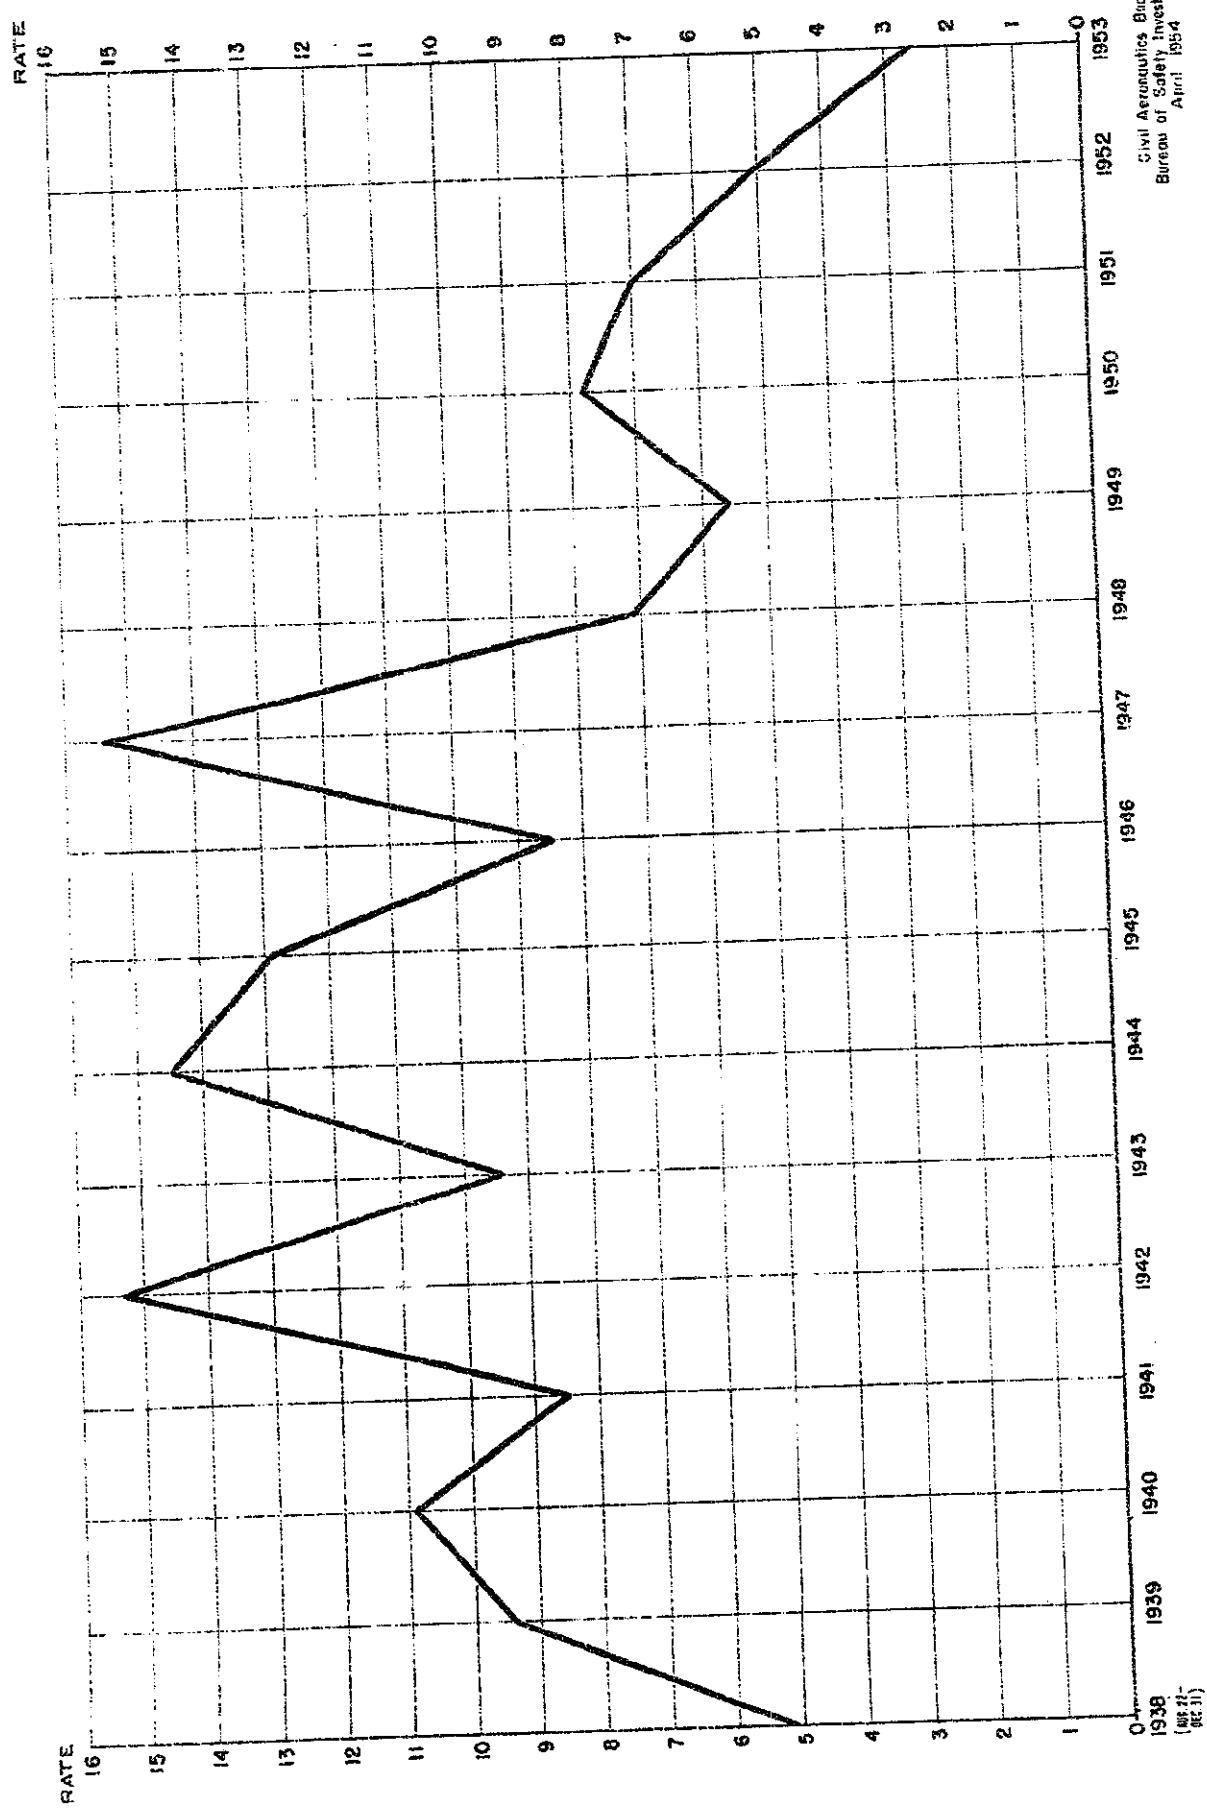
ANNUAL PASSENGER FATALITY RATE
PER ONE MILLION PASSENGERS FLOWN
IN SCHEDULED DOMESTIC AND FOREIGN/ OVERSEAS PASSENGER SERVICES
(AUGUST 22, 1938-1953)
