Aircraft Accident Report

**In-Flight Electrical System Failure
and Loss of Control**

**Raytheon (Beechcraft) Super King Air 200,
N81PF**

**NTSB/AAR-03/01
PB2003-910401
Notation 7358A
Adopted January 15, 2003**

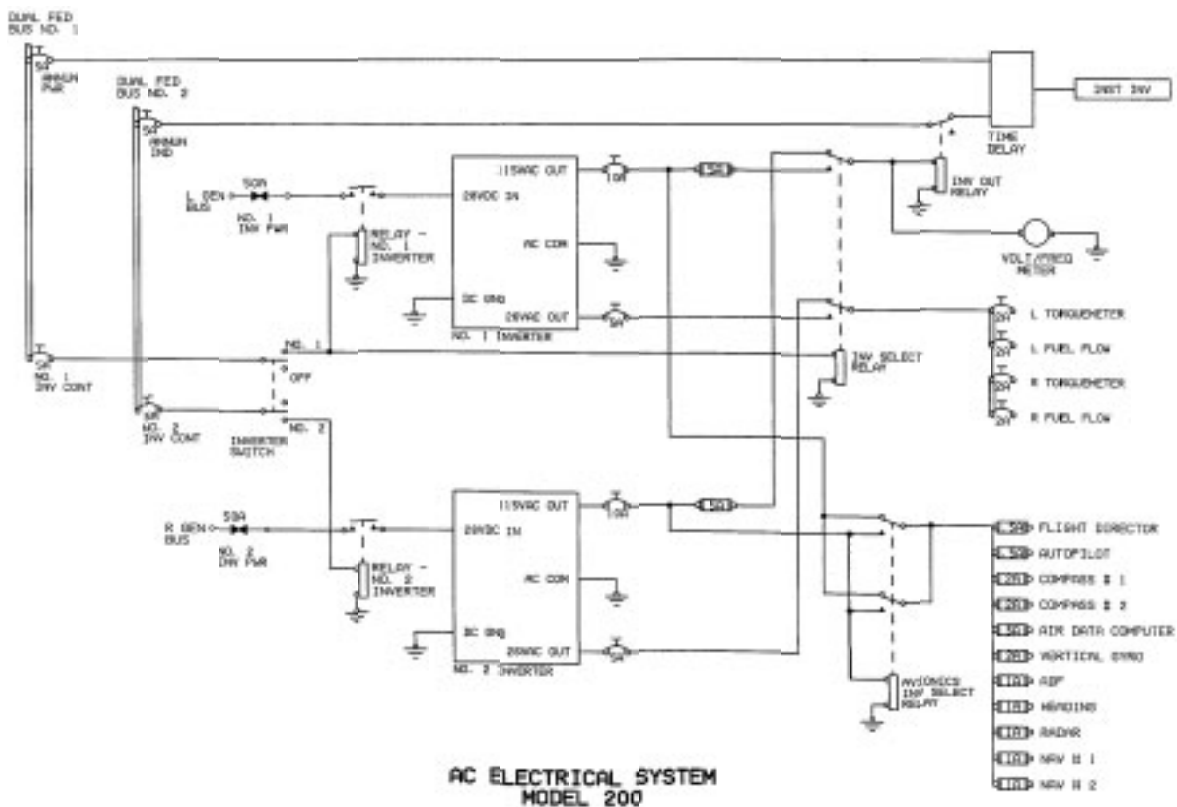
Source: Beechcraft Super King Air 200 Pilot's Operating Handbook.

Figure 2. Schematic of the King Air 200 a.c. electrical system.

Figure 2 shows a schematic of the King Air 200 a.c. electrical system. The figure shows that the inverter select relay, the avionics inverter select relays, and the inverter select switch are located between the inverters and the volt/frequency meter.

Third, the King Air 200 electrical system schematic indicates that, if at least one of the inverters is operational, no a.c. power is present at the volt/frequency meter, and d.c. power is available to the inverters, then one of three components—the inverter selector switch, the inverter select relay, or the avionics inverter select relay—could produce an a.c. power electrical system failure (see figure 2). Thus, all three components are potential sources of single-point failures in the electrical system. None of these items was recovered from the wreckage.
