NATIONAL TRANSPORTATION SAFETY BOARD

AIRCRAFT ACCIDENT REPORT

MIDAIR COLLISION OF SKYWEST AIRLINES
SWEARINGEN METRO II, N163SW,
AND MOONEY M20, N6485U,
KEARNS, UTAH
JANUARY 15, 1987

NTSB/AAR-88/03

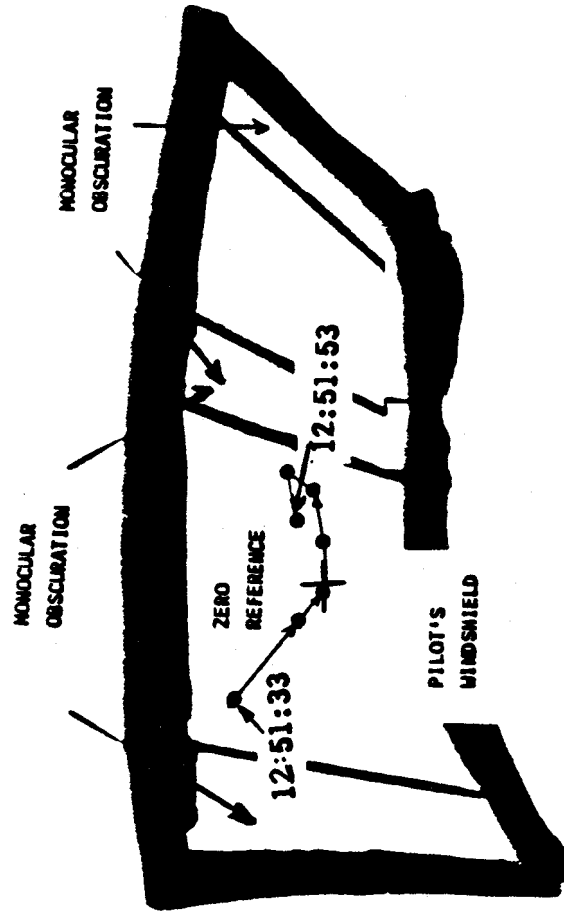
FAIRCHILD METRO II , N163SM
PILOT'S EYE REFERENCE
5 INCHES AFT OF REAR MOST CONTROL COLUMN
POSITION (13.5 INCHES AFT INSTRUMENT PANEL)
44 1/8 INCHES ABOVE SEAT TRACK

ELEVATION (DEG.)

AZIMUTH (DEG.)

APPENDIX D
COCKPIT VISIBILITY PLOTS

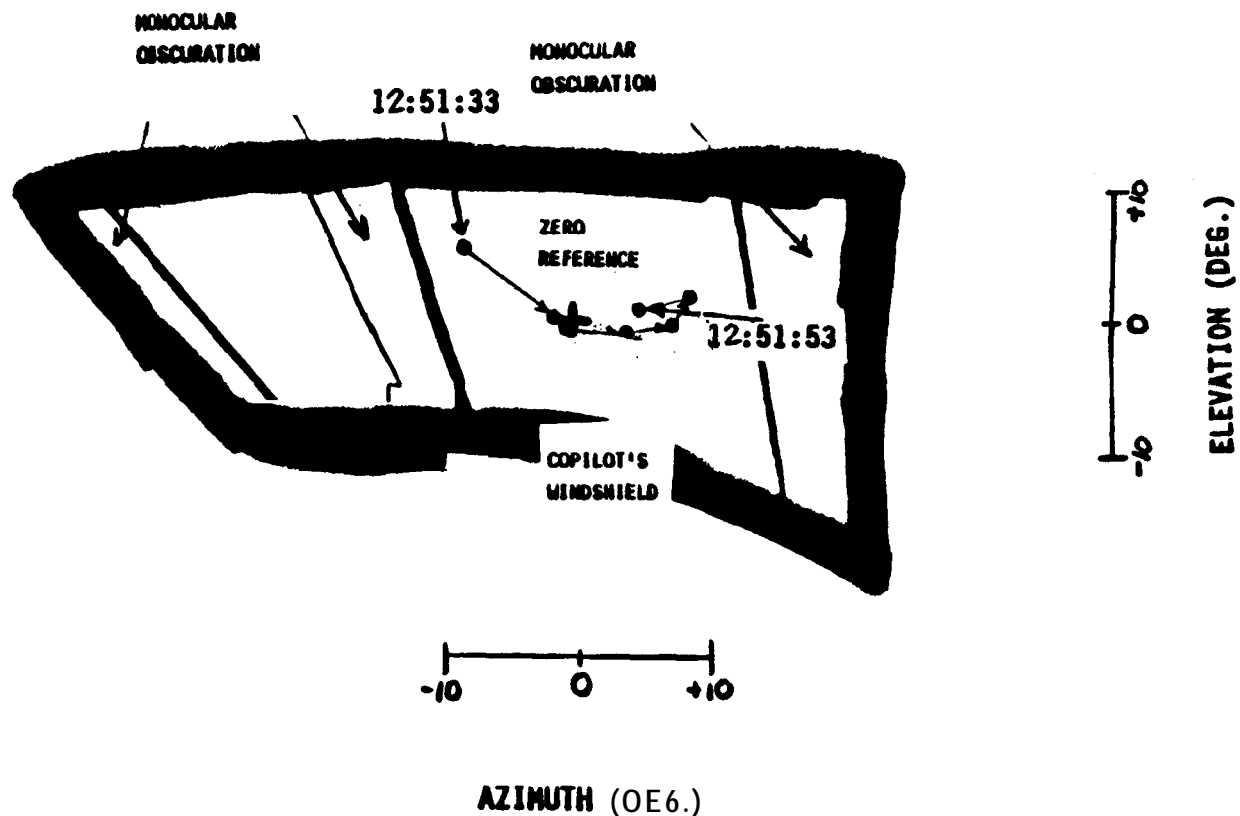
FAIRCHILD METRO II , N163SW
COPILOT'S EYE REFERENCE
5 INCHES AFT OF REAR MOST CONTROL COLUMN
POSITION (13.5 INCHES AFT INSTRUMENT PANEL)
44 1/8 INCHES ABOVE SEAT TRACK

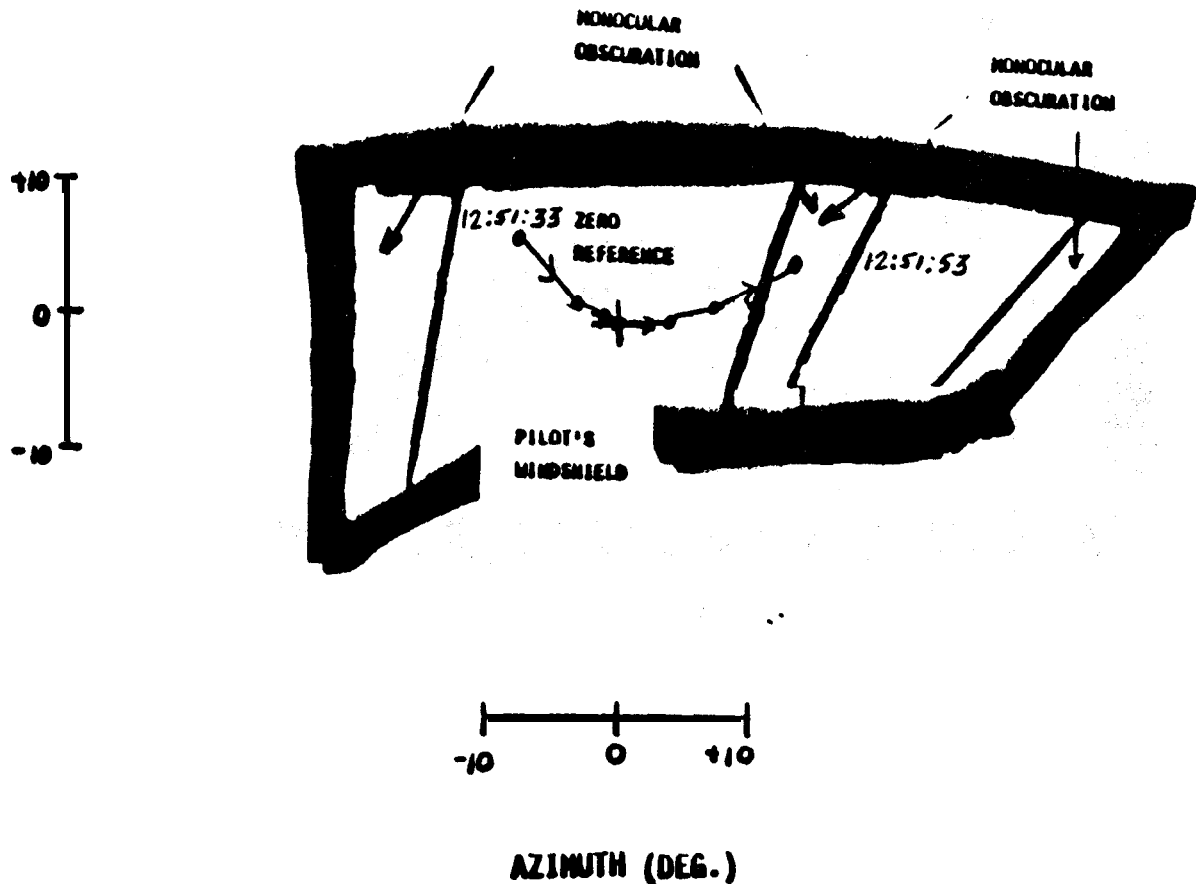
FAIRCHILD METRO II N163SM
PILOT'S EYE REFERENCE
5 INCHES AFT OF REAR MOST CONTROL COLUMN
POSITION (13.5 INCHES AFT INSTRUMENT PANEL)
44 1/8 INCHES ABOVE SEAT TRACK

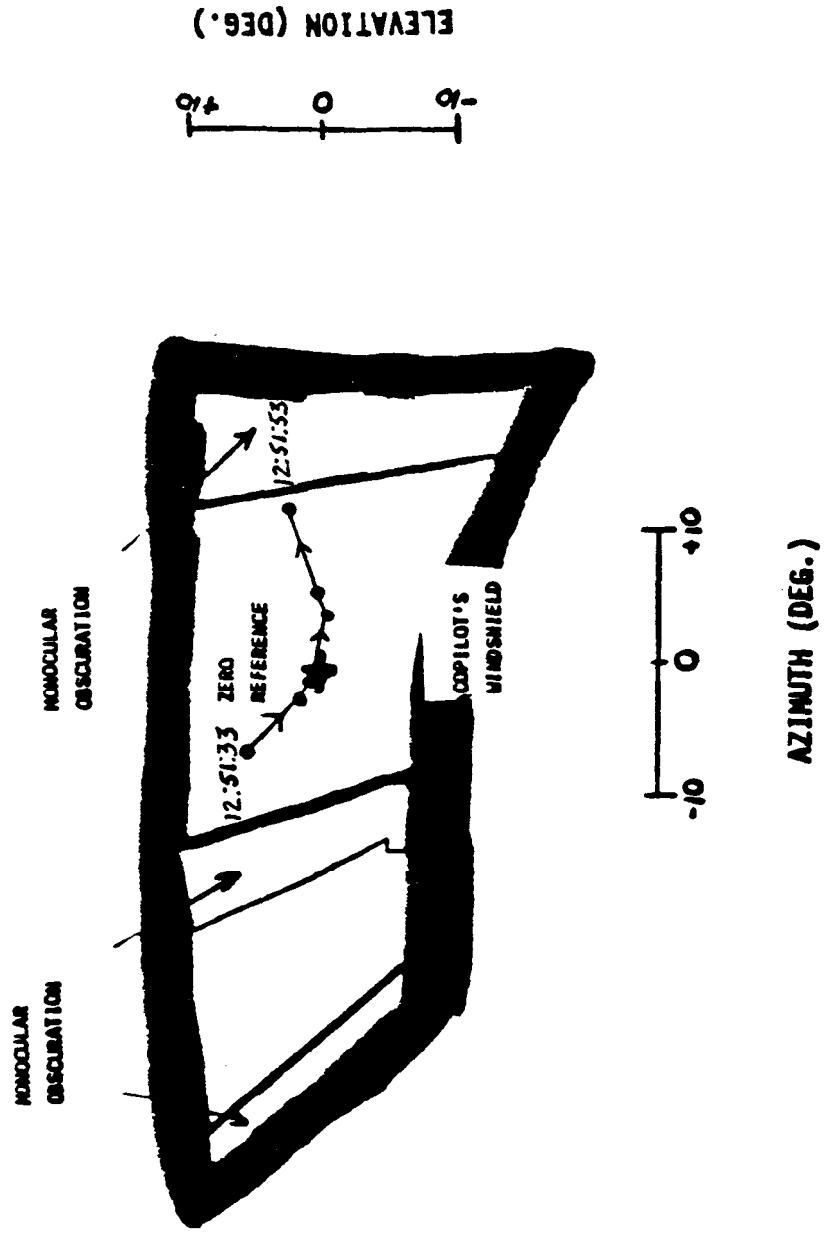
FAIRCHILD METRO 11 , N163SM
COPILOT'S EYE REFERENCE
5 INCHES AFT OF REAR MOST CONTROL COLUMN
POSITION (13.5 INCHES AFT INSTRUMENT PANEL)
44 1/8 INCHES ABOVE SEAT TRACK

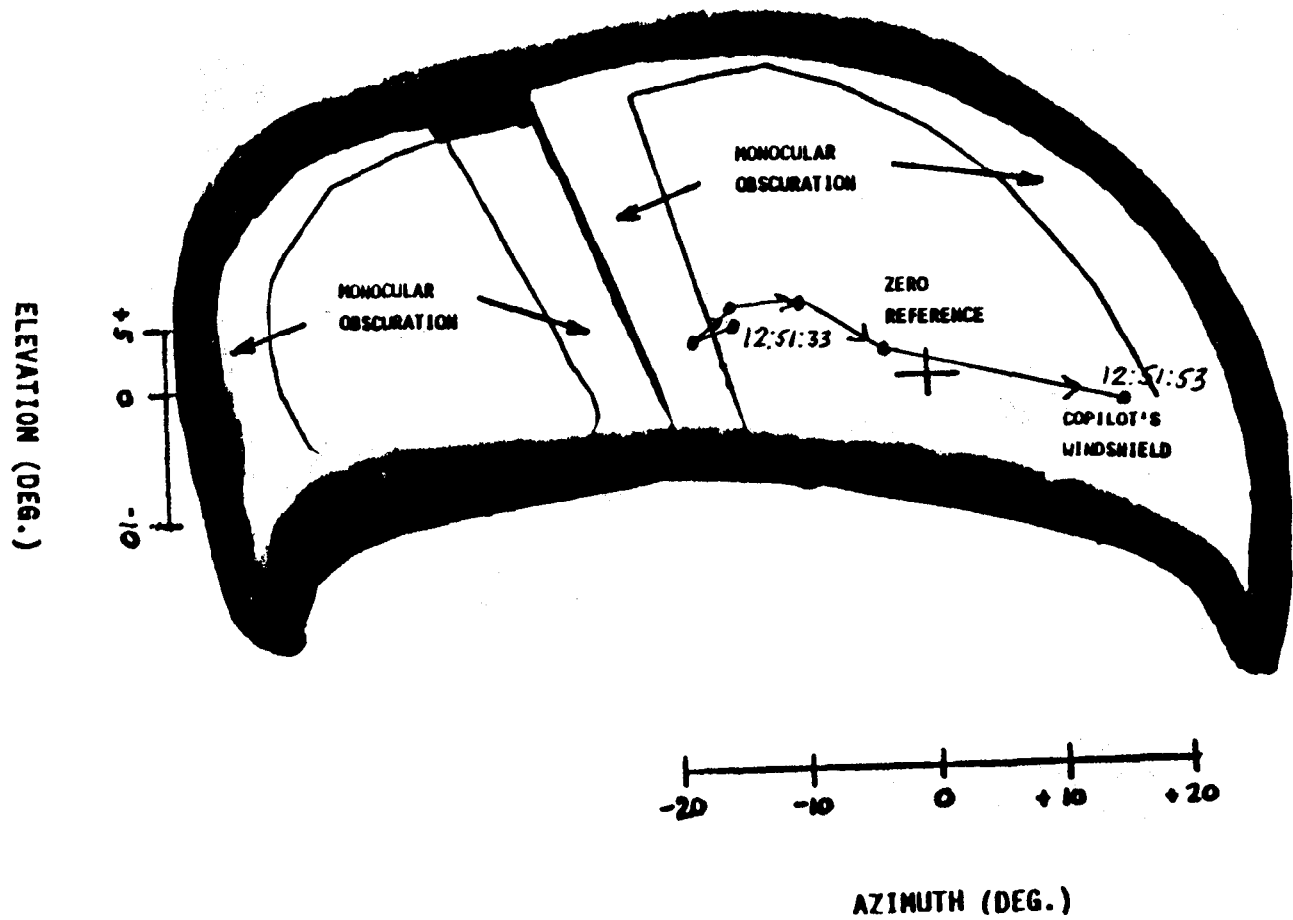
MOONEY 20C, N6485U
COPILOT'S EYE REFERENCE IN ACCORDANCE WITH CAM 4B
37 1/2 INCHES ABOVE SEAT RAIL
21 5/8 INCHES AFT OF INSTRUMENT PANEL

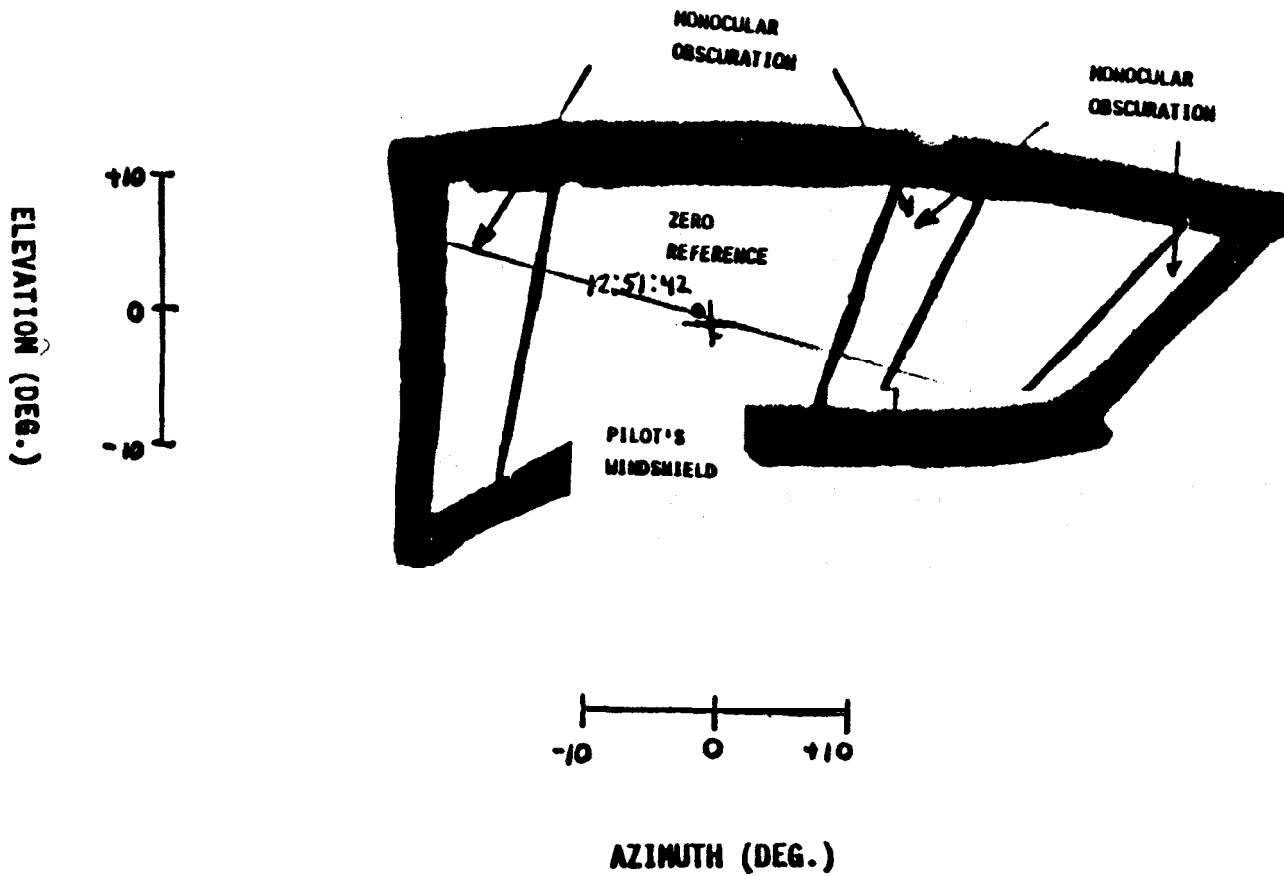
FAIRCHILD METRO II, N163SW
PILOT'S EYE REFERENCE
5 INCHES AFT OF REAR MOST CONTROL COLUMN
POSITION (13.6 INCHES AFT INSTRUMENT PANEL)
44 1/8 INCHES ABOVE SEAT TRACK

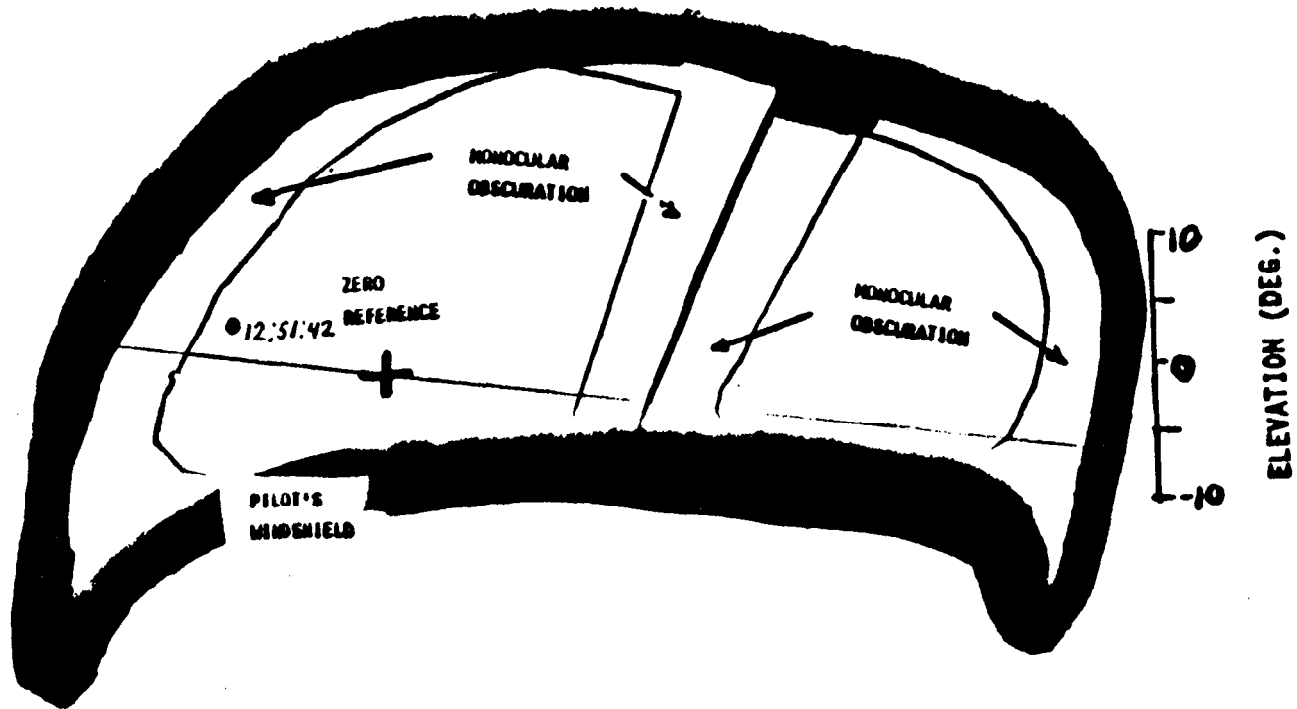
MOONEY 20C, N6485U
PILOT'S EYE REFERENCE IN ACCORDANCE WITH CAN 4B
37 1/2 INCHES ABOVE SEAT RAIL
21 5/8 INCHES AFT OF INSTRUMENT PANEL

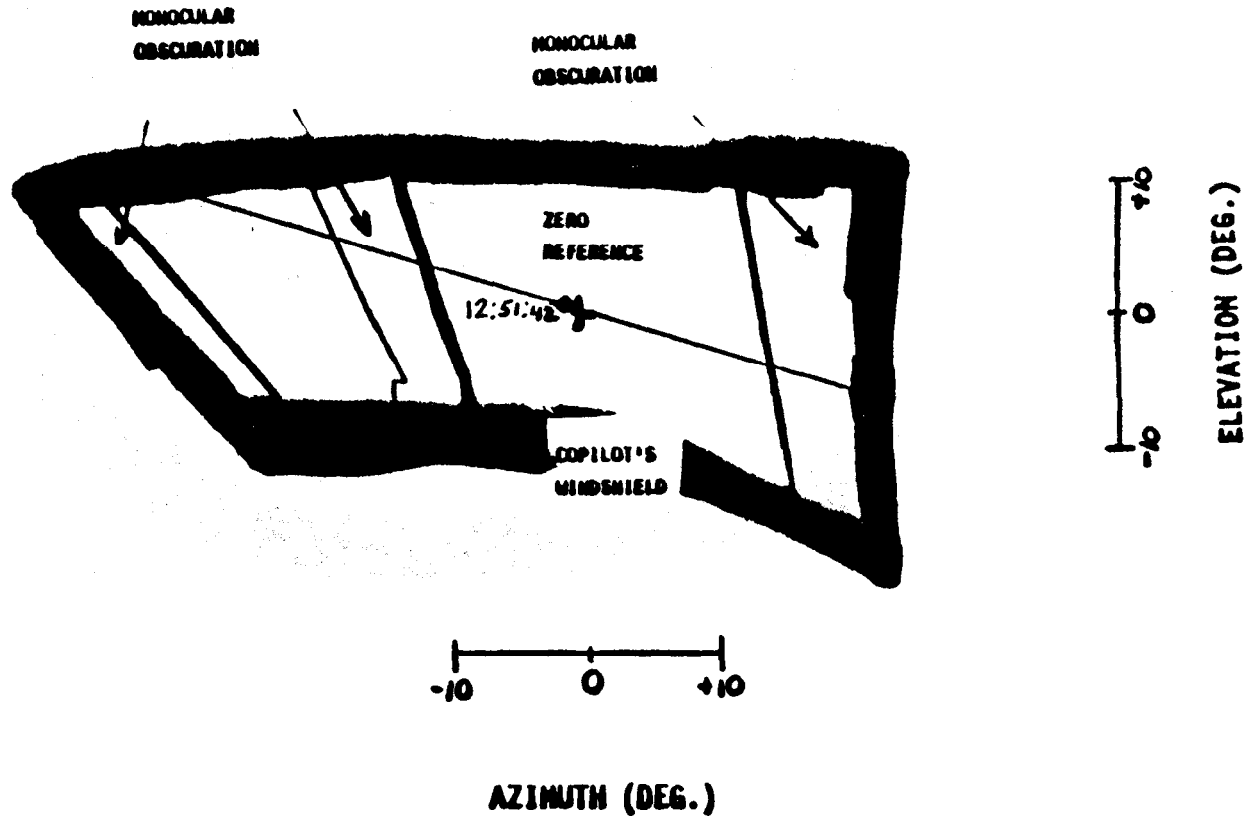
**FAIRCHILD METRO II, M163SM
COPILOT'S EYEREFERENCE
5 INCHES AFT OF REAR MOST CONTROL COLUMN
POSITION (13.6 INCHES AFT INSTRUMENT PANEL)
44 1/8 INCHES ABOVE SEAT TRACK**

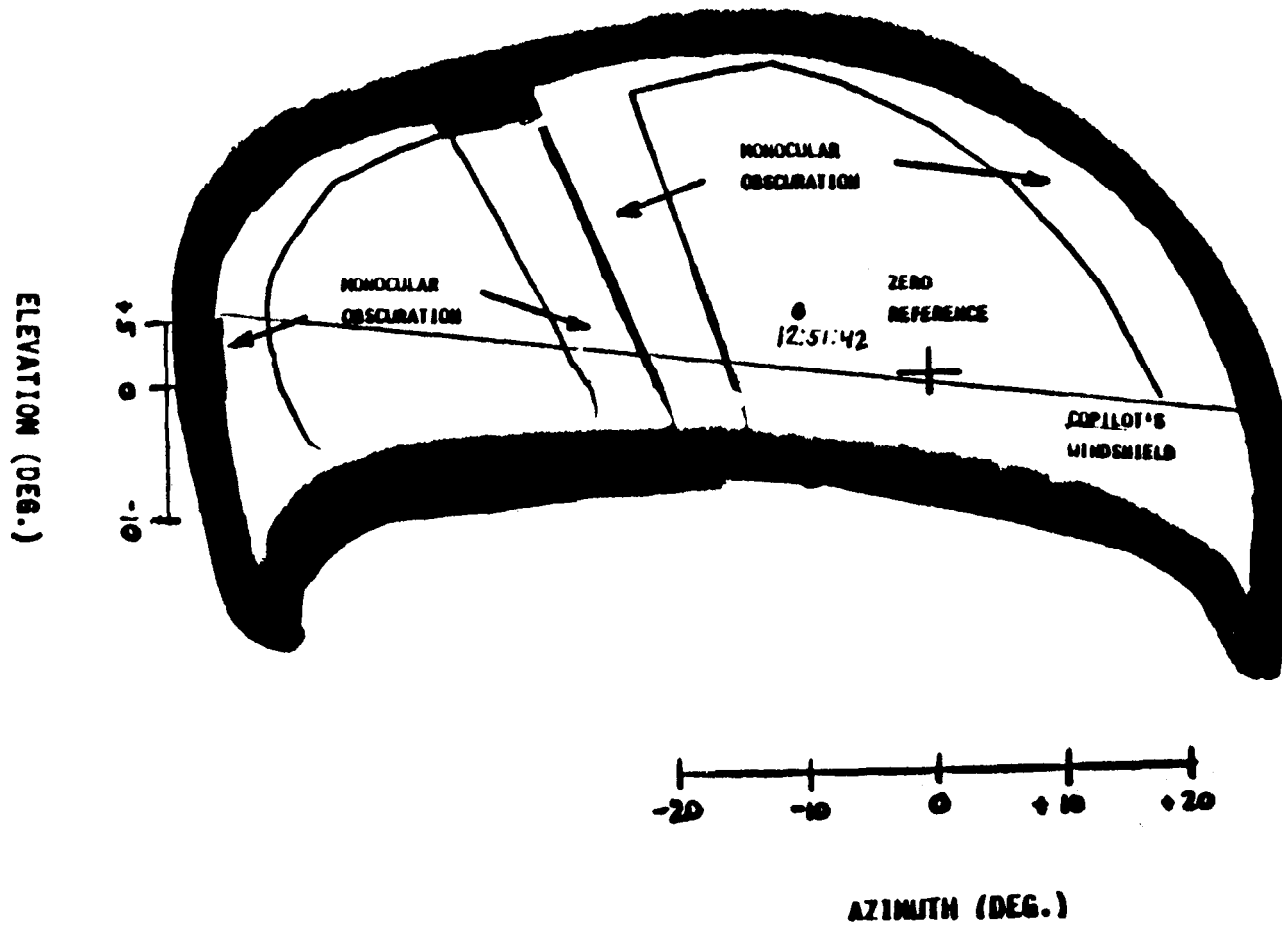
MOONEY 20C, N6485U
COPILOT'S EYE REFERENCE IN ACCORDANCE WITH CAN 48
37 1/2 INCHES ABOVE SEAT RAIL
21 5/8 INCHES AFT OF INSTRUMENT PANEL

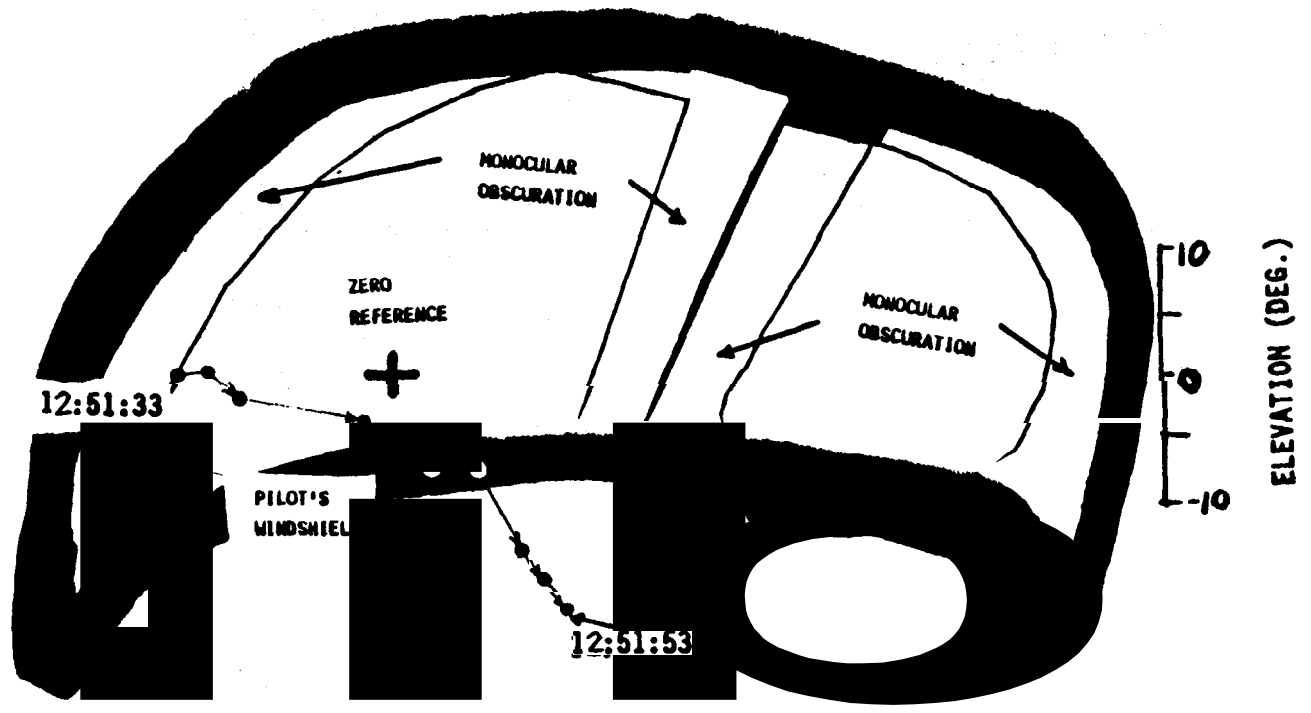
MOONEY 20C, N6485U
PILOT'S EYE REFERENCE IN ACCORDANCE WITH CAM 4B
37 1/2 INCHES ABOVE SEAT RAIL
21 5/8 INCHES AFT OF INSTRUMENT PANEL

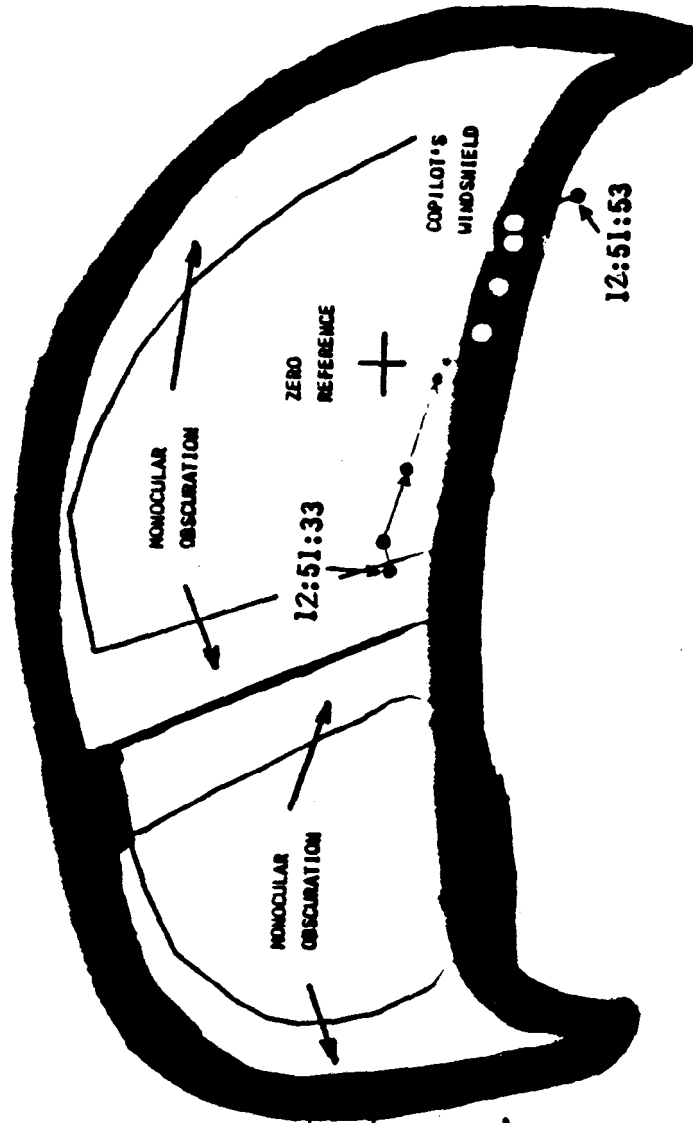
MOONEY 20C, N6485J
COPILOT'S EYE REFERENCE IN ACCORDANCE WITH CAM 48
37 1/2 INCHES ABOVE SEAT RAIL
21 5/8 INCHES AFT OF INSTRUMENT PANEL

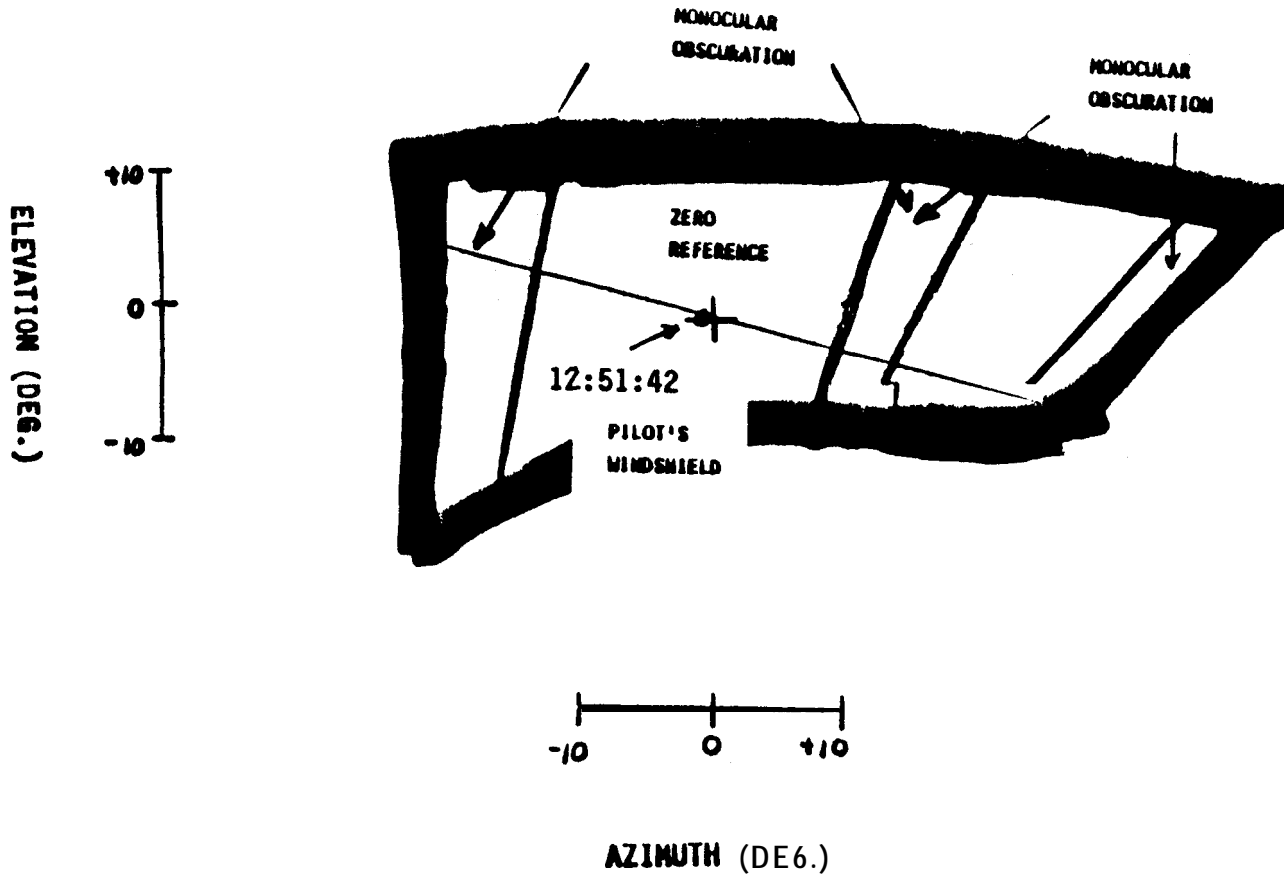
FAIRCHILD METRO II, N163SM
PILOT'S EYE REFERENCE
5 INCHES AFT OF REAR MOST CONTROL COLUMN
POSITION (13.5 INCHES AFT INSTRUMENT PANEL)
44 1/8 INCHES ABOVE SEAT TRACK

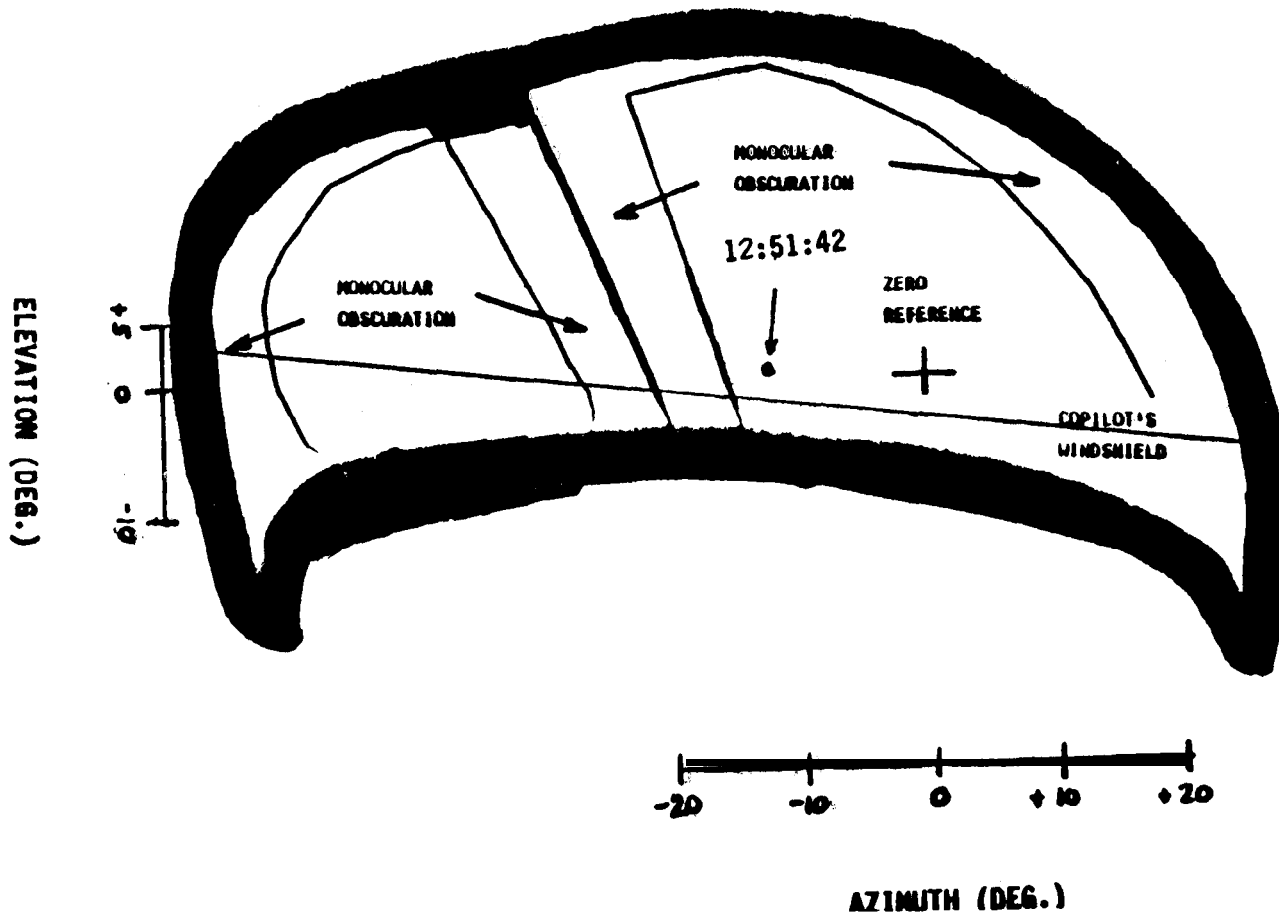
MOONEY 20C, N6485U
COPILOT'S EYE REFERENCE IN ACCORDANCE WITH CAM 48
37 1/2 INCHES ABOVE SEAT RAIL
21 5/8 INCHES AFT OF INSTRUMENT PANEL
