AIRCRAFT ACCIDENT REPORT

UNIVERSAL AIRWAYS, INC. BEECH 65-A80/EXCALIBUR CONVERSION, N100UV NEAR MADISONVILLE, TEXAS

NTSB-AAR-81-17

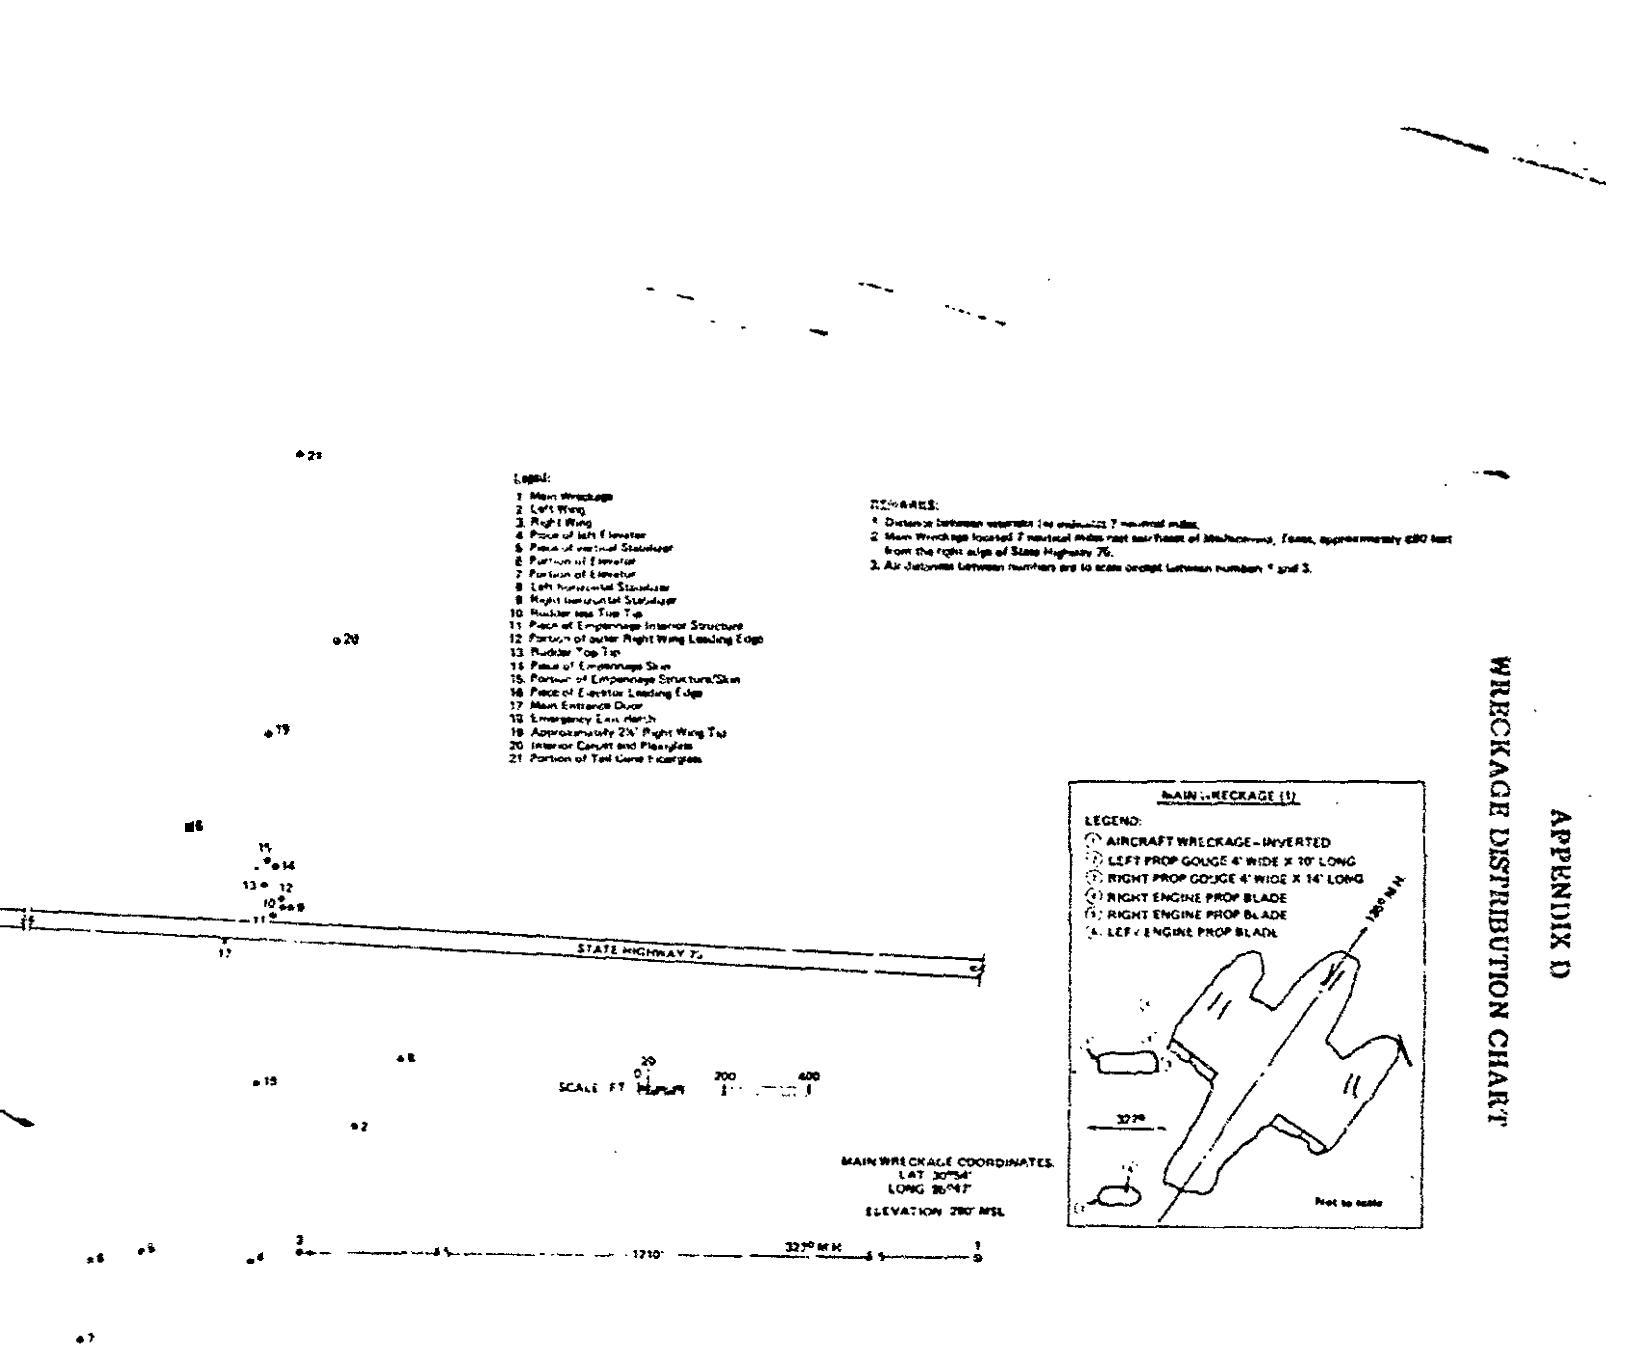
Both wings outboard of the engines and the entire empennage had separated from the aircraft before it struck the ground inverted on a magnetic heeding of about 147°. (See appendix D.) Two gouged areas in the dirt marked the initial impact point. Parts of the corresponding propeller blades, as well as the propeller blade dicing, were found in the gouges. After impact, the aircraft slid through the pasture grass for about 5° feet and came to rest, still inverted, on a magnetic heading of about 135°. The main wreckage consisted of the majority of the fuselage, the left and right wing center sections, the engines in their nacelles, and the retracted landing gear assemblies.
