AM 70-16

**SURVIVAL IN EMERGENCY
ESCAPE FROM PASSENGER AIRCRAFT**

OCTOBER 1970

**OFFICE OF AVIATION MEDICINE
DEPARTMENT OF TRANSPORTATION
FEDERAL AVIATION ADMINISTRATION**

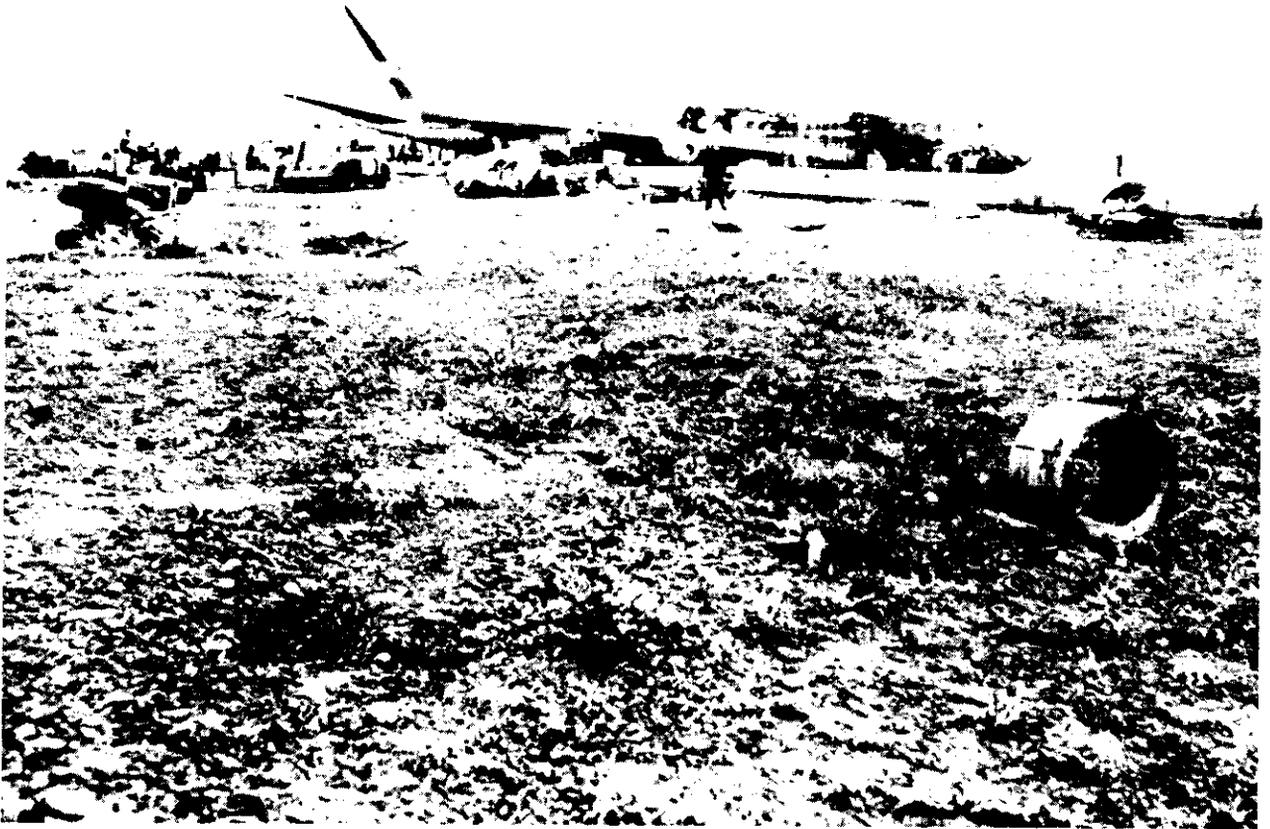
FIGURE 3. View of the aircraft from the right front after fire and removal of fatalities. In foreground are landing gear and one of the 3 engines which were sheared and tumbled forward as the aircraft struck the 18-inch abutment of a new taxiway upon which it came to rest.

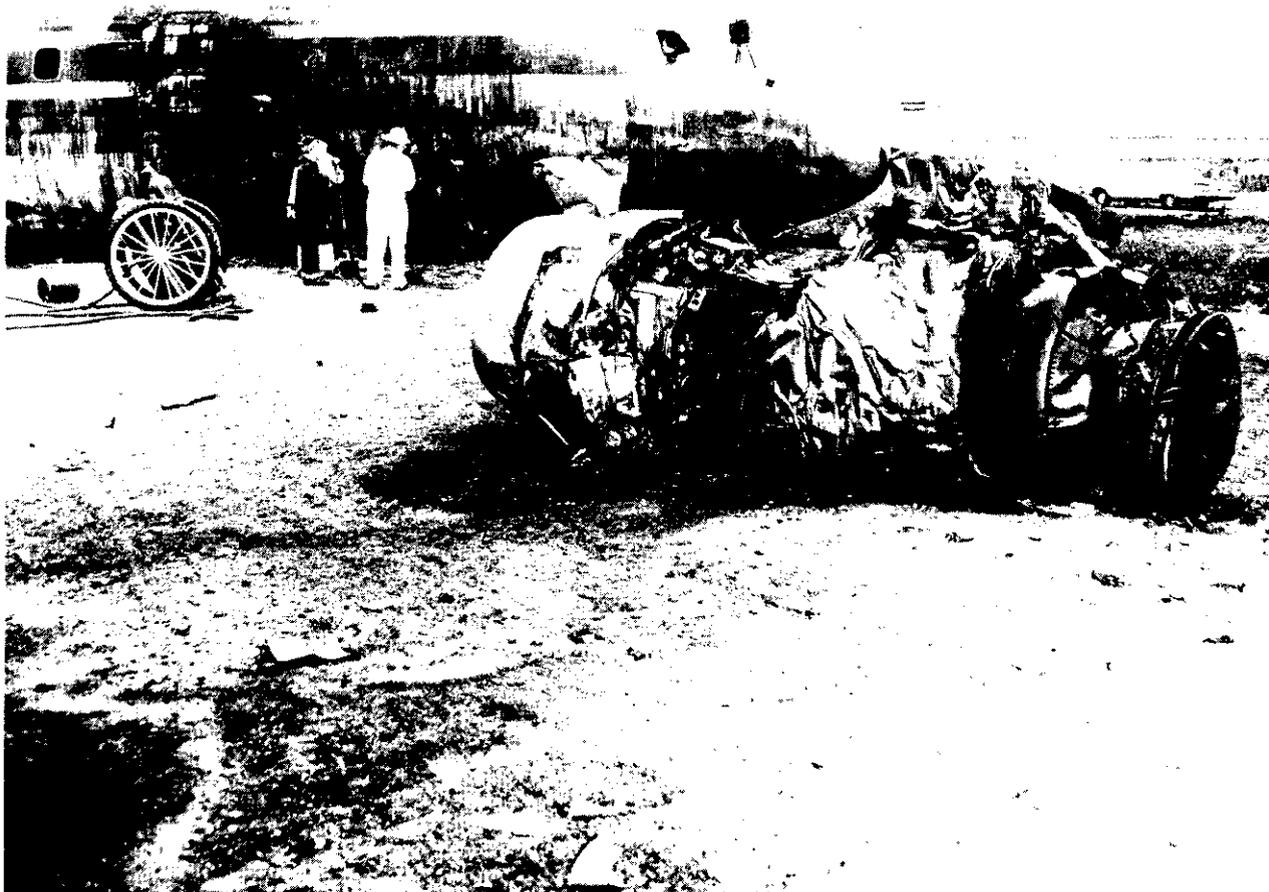
FIGURE 4. Right front view of Denver DC-8 showing detached #4 engine which ignited spilled ground fuel in the right forward area.

The aircraft came to rest lying across the taxiway at an angle of about 100° to the right of its original course with its final heading slightly to the east of true north (Figs. 1-3). Soon after the aircraft stopped, two major fires broke out. One started from an engine which tore free at impact and tumbled to a point about 60 feet forward of the right wing (Fig. 4). Following

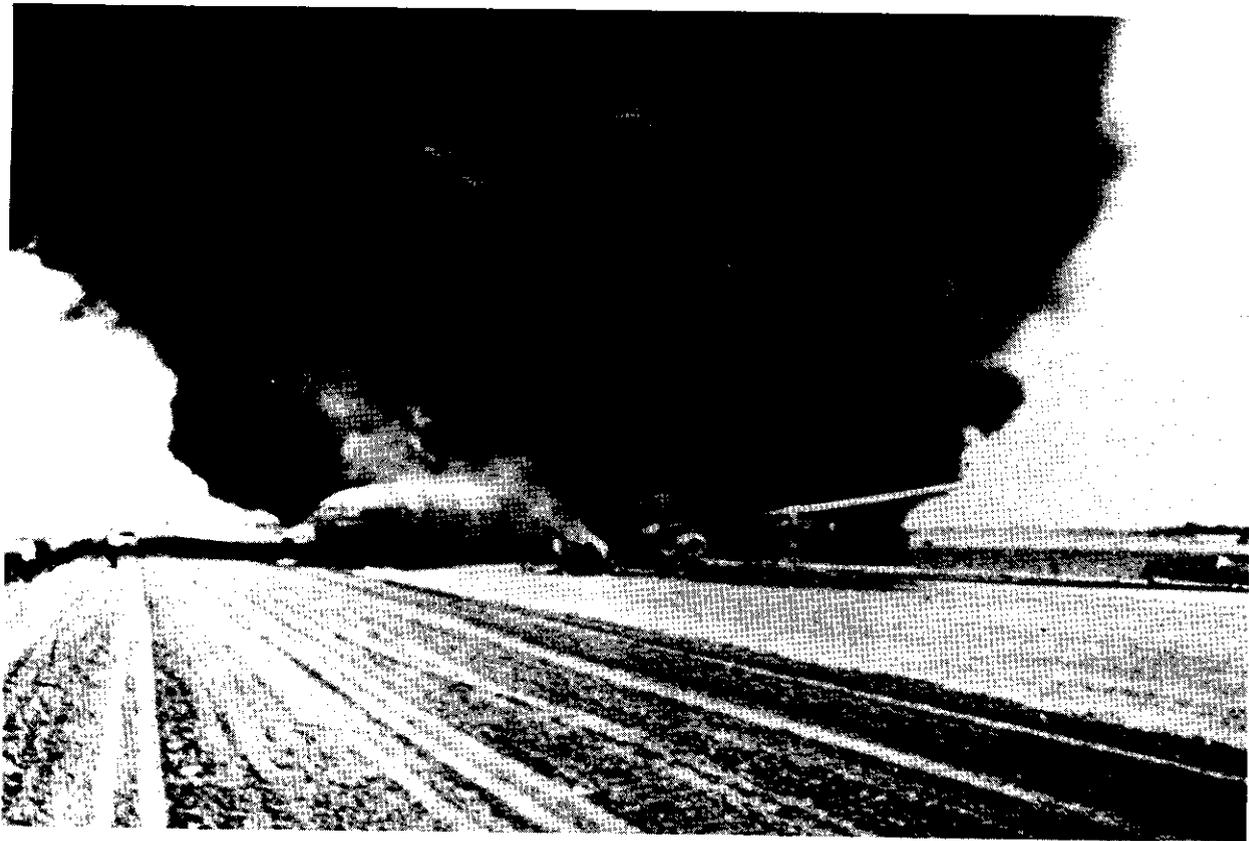
FIGURE 6. Right front view of the Denver DC-8 taken by airport employee soon after aircraft came to rest and before arrival of fire-fighting equipment. It shows the extent of outside fire and the direction of smoke dispersion.

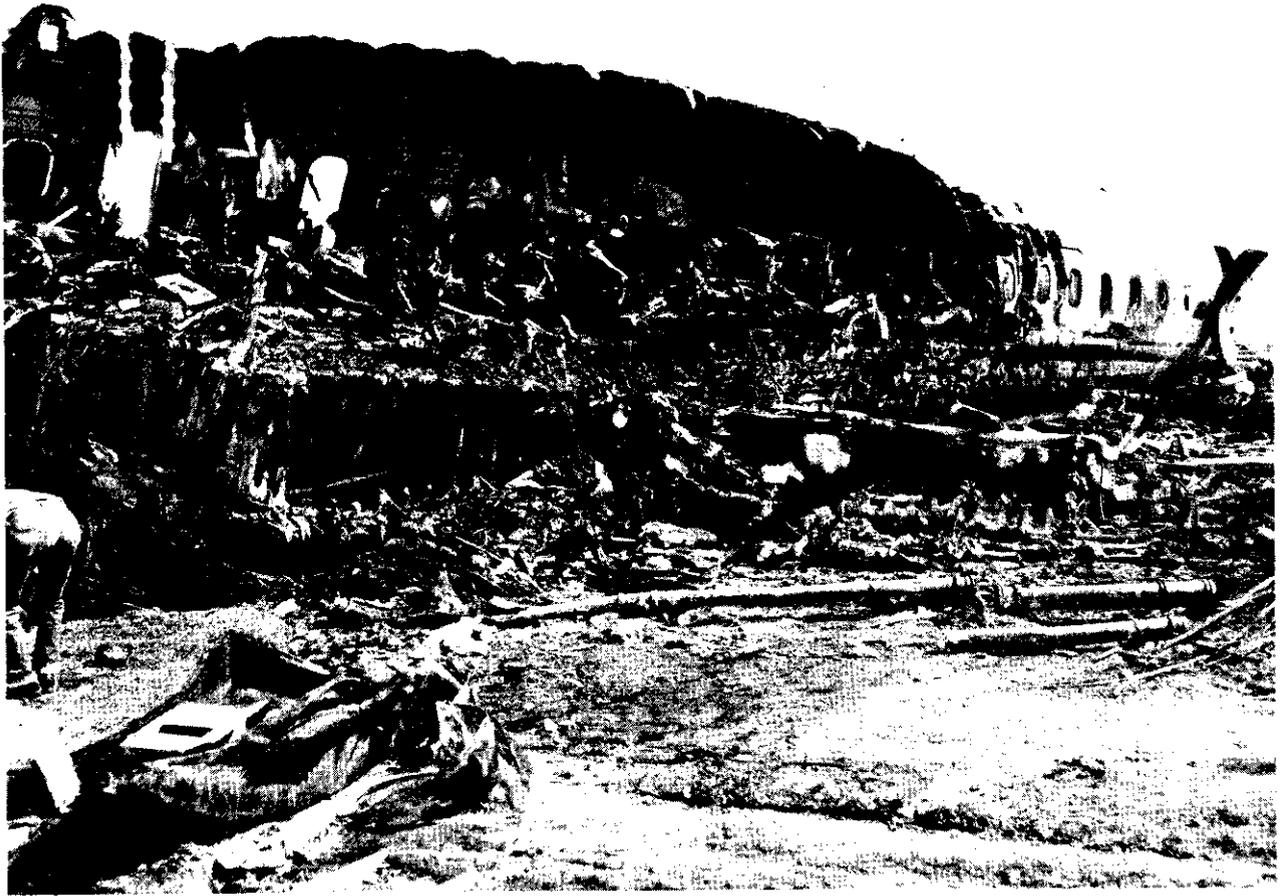
FIGURE 7. Post-fire view of Denver DC-8 from left front. The #1 (left outboard) engine was detached and impacted beneath the left wing root. The resulting fire was initially limited and did not penetrate the cabin until evacuation was complete. It later flared out of control and extensively damaged the aircraft interior.

The second major fire was at the left wing root. It probably originated from the left in-board engine which had been torn loose and lay crushed under the wing. Although sufficient to prevent the use of the left window exits, this fire

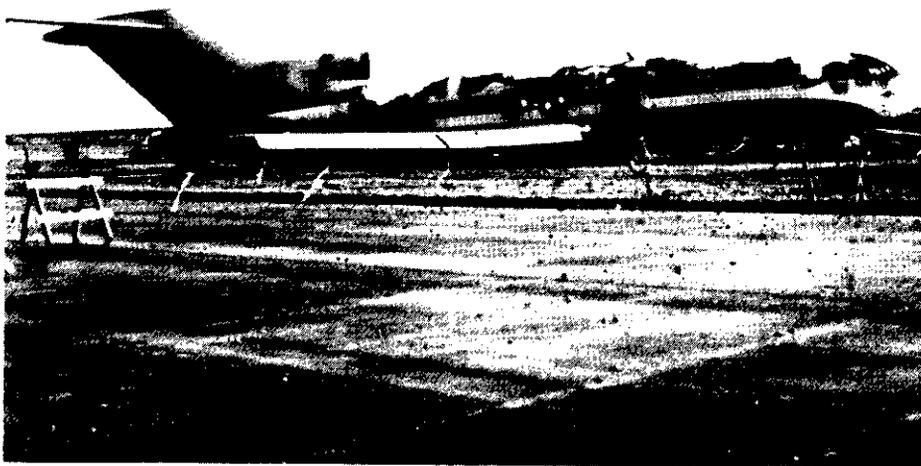
FIGURE 17. Left (above) and right (below) post-crash views of Salt Lake City 727, showing final attitude and exterior fire damage.

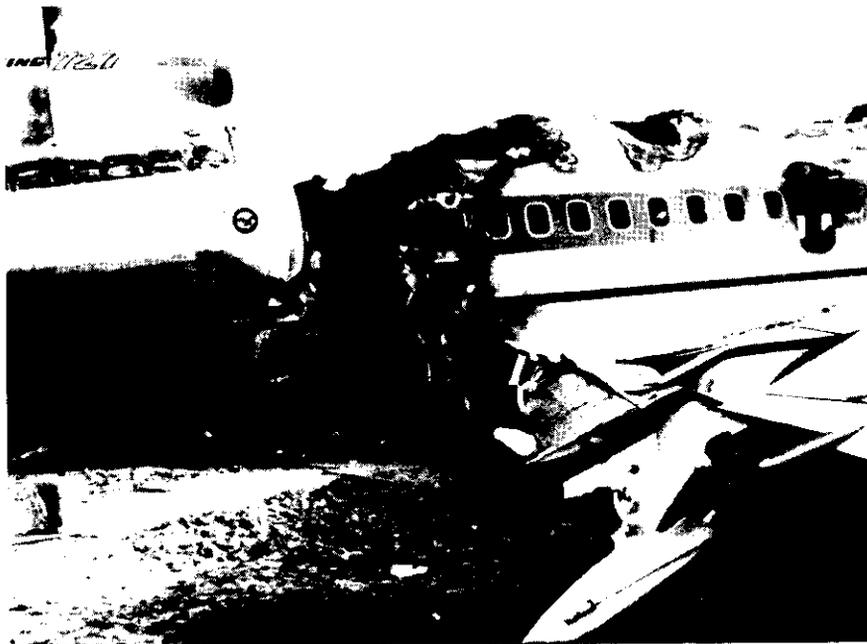
FIGURE 22. *Above.* Left view of Salt Lake City 727 tail section showing ventral stairway resting on ground. The opening was insufficient to allow the escape of the aft stewardess and two male passengers trapped within the stairwell. *Below.* Burned out section of floor and fuselage near initial fire focus in left aft cabin area. Approximately 25 minutes post-impact, firemen entered through this hole to rescue the three persons trapped in the stairwell.

20, one of whom was already badly burned. Once inside, they found that there was only a 6-inch opening to the outside because the ventral stair was resting on the ground (Fig. 22). They tried but could not completely reclose the pressure bulkhead door. However, the intense fire inside the cabin apparently produced a draft which drew enough fresh air up through the stairwell to provide some oxygen and to keep the temperature in the stairwell within tolerable limits. The events that followed are best described in the stewardess' statement made from her hospital bed on the night of the crash:

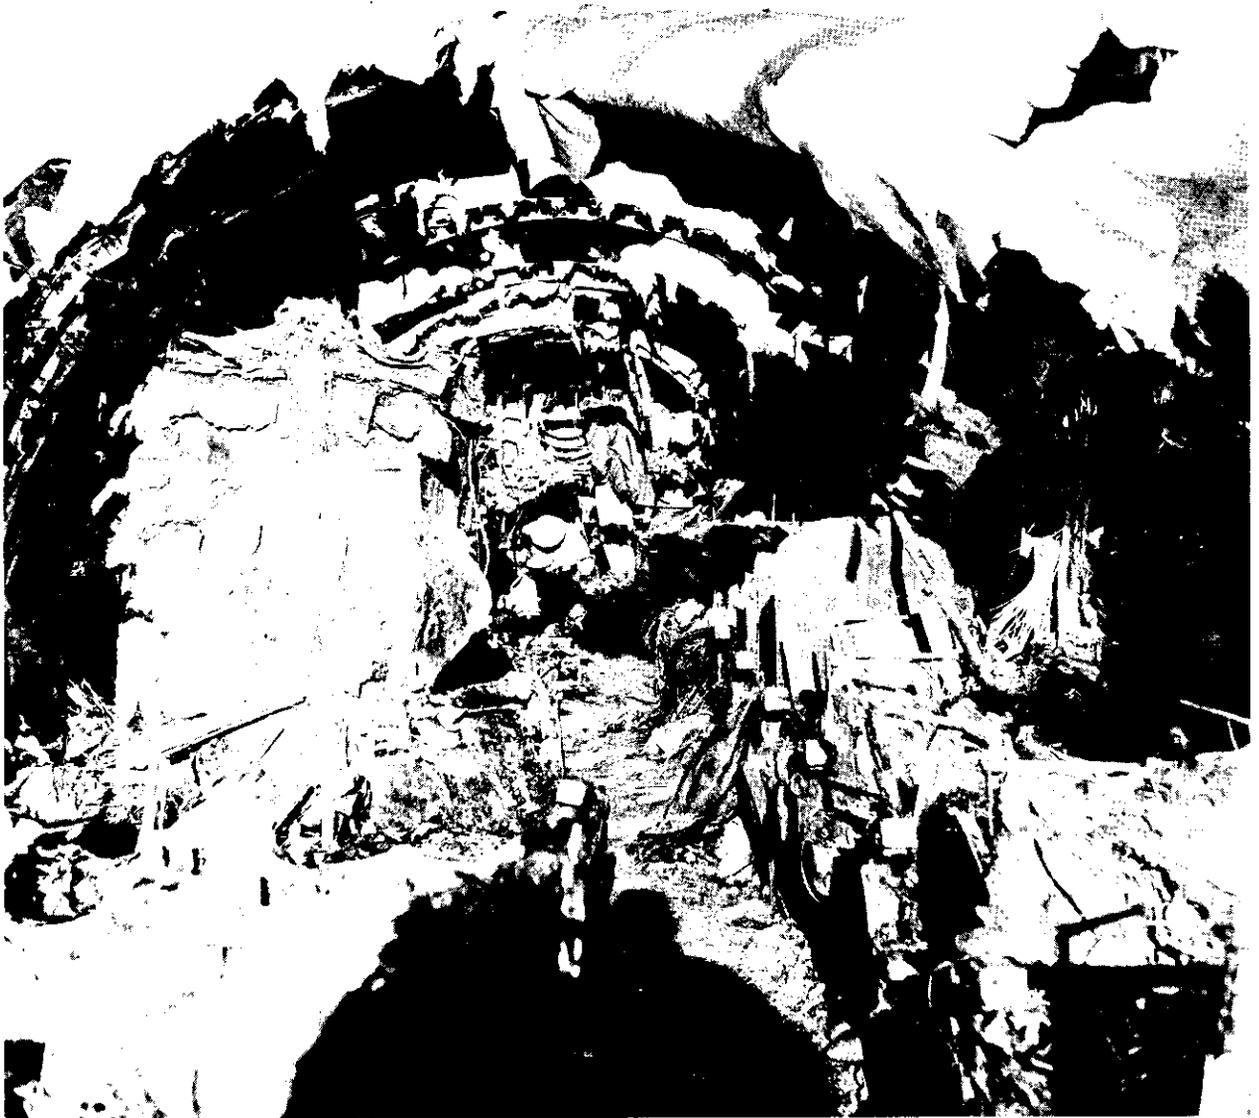
FIGURE 23. Aft view into Salt Lake City 727 passenger cabin showing interior fire damage.

One survivor, who estimated he was the sixth person out of the left aft window exit, timed the propagation of fire after he was outside the aircraft. He estimated that within 90 seconds after impact the entire cabin was engulfed in flame; shortly afterward he heard a small explosion and fire invaded the cockpit. A subsequent analysis of firefighting activities⁷ indicated that the first fire truck arrived about 3 minutes after impact. The firemen reported that the fire was free-burning and that flames were coming out of the fuselage from a large hole on the right side at about row 18 and from another place in the vicinity of the right window exits. The cabin interior appeared totally involved, with the fire most intense in the rear section. With the exception of the survivors in the tail, no one was observed to escape after the arrival of the fire equipment. Figure 23 shows the interior fire damage to the aircraft.
