NATIONAL TRANSPORTATION SAFETY BOARD  
WASHINGTON, D.C. 20594  
AIRCRAFT ACCIDENT/INCIDENT REPORT  
BRIEF FORMAT  
U.S. CIVIL AVIATION

NTSB FILE NO. 5  
LAX 77-F-A050

IDENTIFICATION OF ACCIDENT    Riverside, California  
   06-07-77  
   Cessna 177RG, N-1599H

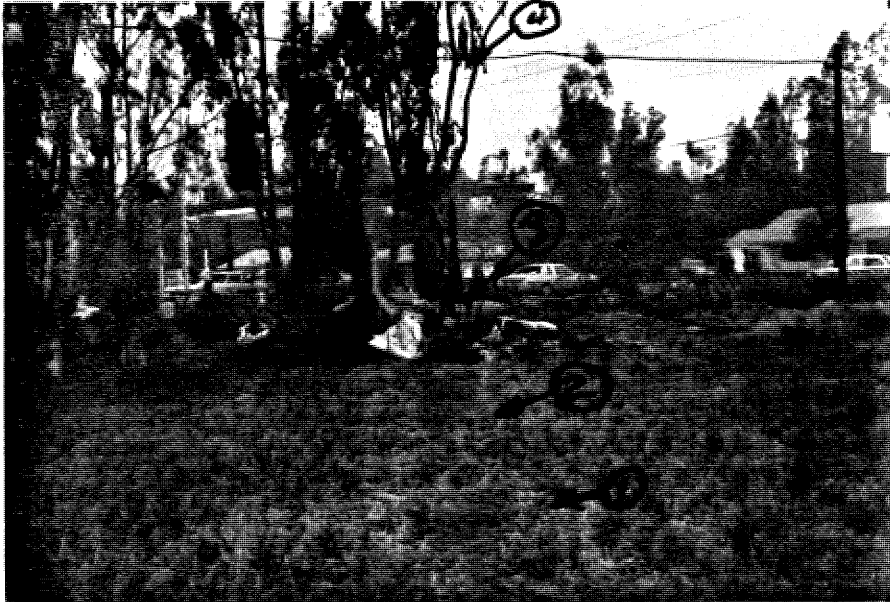
1. A view of the principal impact area looking on a 120 degree heading. No. 1 arrow points to the area where the right horizontal stabilizer made contact with the ground. No. 2 arrow points to the area where the right wing tip made contact with the ground. No. 3 arrow points to the tree that was struck by the main body of the aircraft. No. 4 arrow points to the wires that were struck by the left wing panel.

The aircraft made contact with the ground during a steep right turn on a heading of 120 degrees prior to striking one large tree. The right wing tip made a ground imprint about 37 feet long and one foot wide before the main body of the aircraft made contact with the trunk of the tree. Also, during the right wing tip contact, the right horizontal stabilizer tip made contact with the ground, leaving an imprint about 5 feet long and 6 inches wide. For details of the ground marks and wreckage distribution, see Page 7 of this report. Following the striking of the tree, the wing panel, the engine and a section of the instrument panel separated from the fuselage. These parts were found lying approximately 201 feet east of the principal impact area.

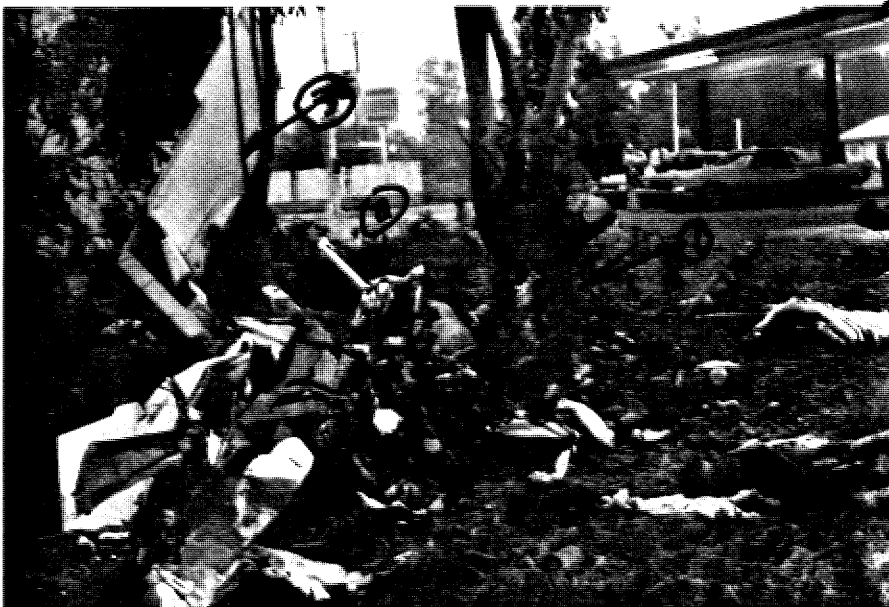
2. A close-up view of the tree that was struck by the nose section of the aircraft. No. 1 arrow points to the tree. No. 2 arrow points to the lower section of the fuselage. No. 3 arrow points to the empennage.

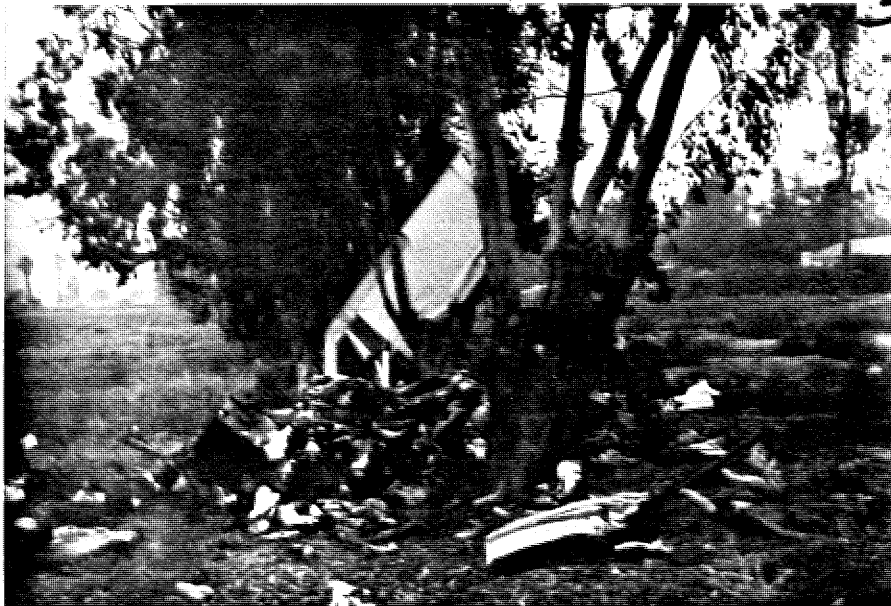
3. Another view of the principal impact area looking in a northerly direction.

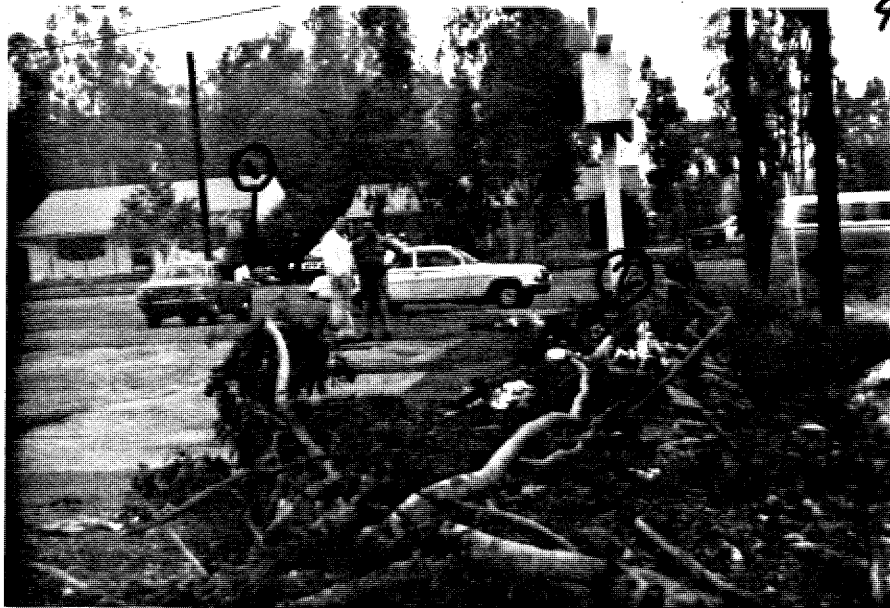
4. A view of the scatter pattern of the wreckage taken from the principal impact area. No. 1 arrow points to the engine and wing panel that were found 201 feet southeast of the principal impact area. No. 2 arrow points to debris of the aircraft.

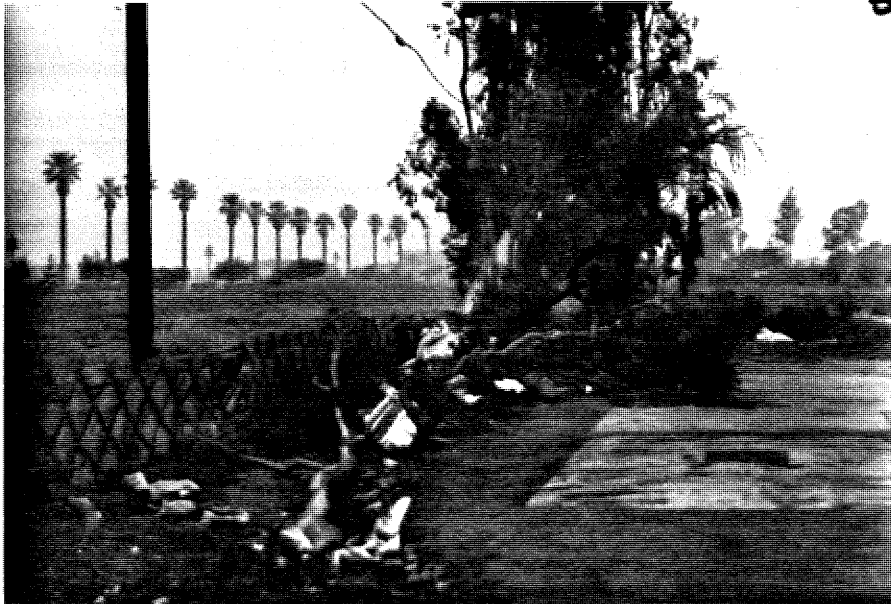
5. A view of the debris looking in a north-westerly direction. No. 1 arrow points to the principal impact area.

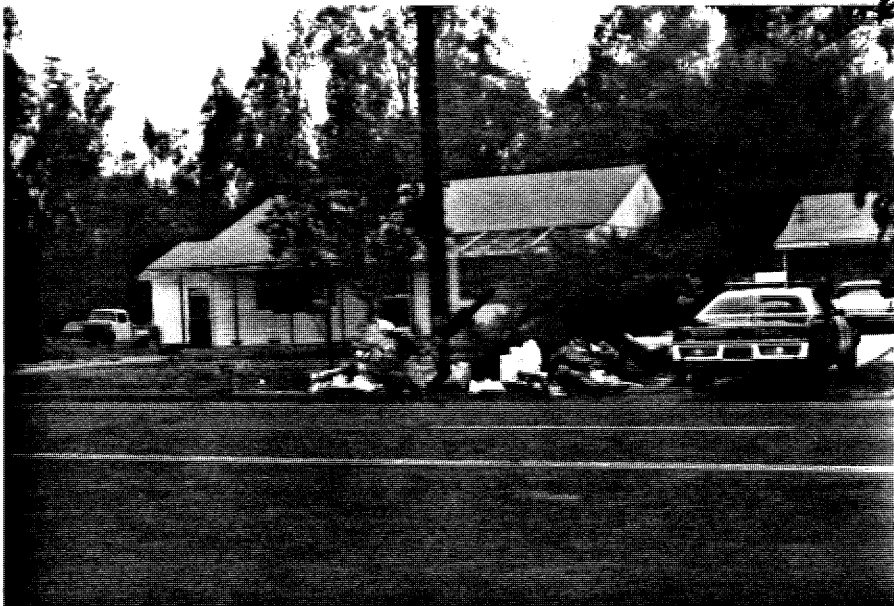
6. A view of the wing panel that was found lying 201 feet south-east of the impact area. Arrow points to the power line pole that was struck by the wing panel.

The wing panel was found wrapped around a power line pole near Arlington Avenue. The position of this wing reflects that it rotated during its travel from the initial impact to its final resting place. The propeller blade displayed numerous gouges, twists and transversal scratch marks. Both the blades were broken free of the hub and could be separated by a limited amount of force.

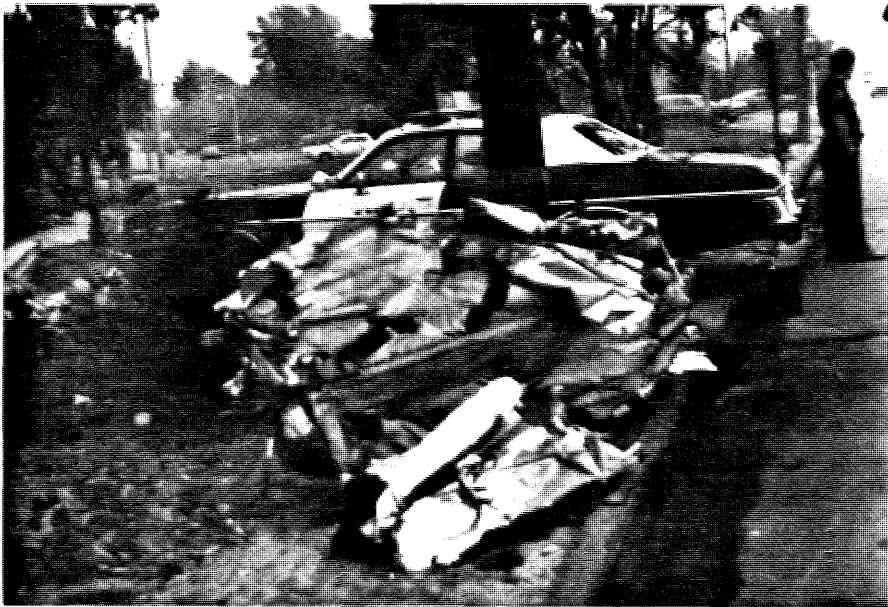
7. A view showing the right wing panel.

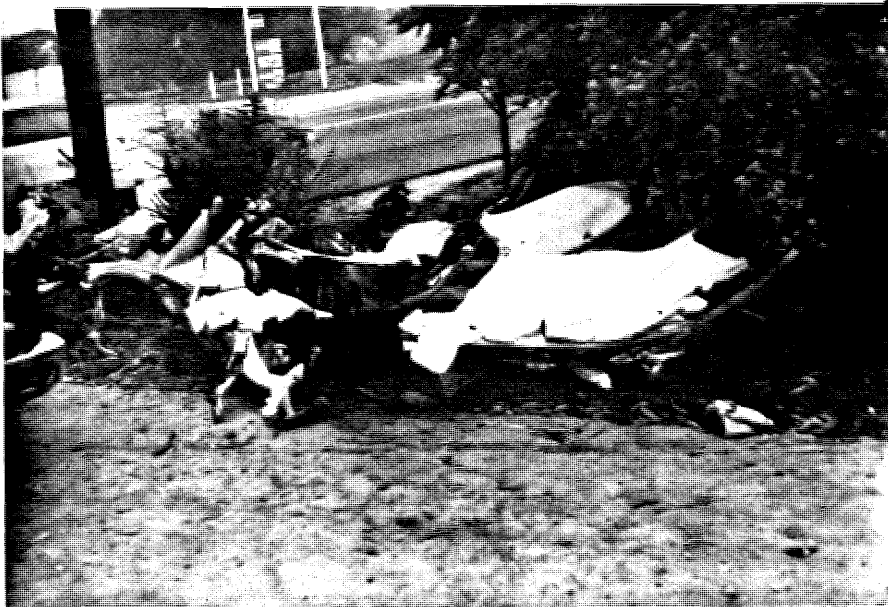
8. A view showing the center section and part of the left wing panel.

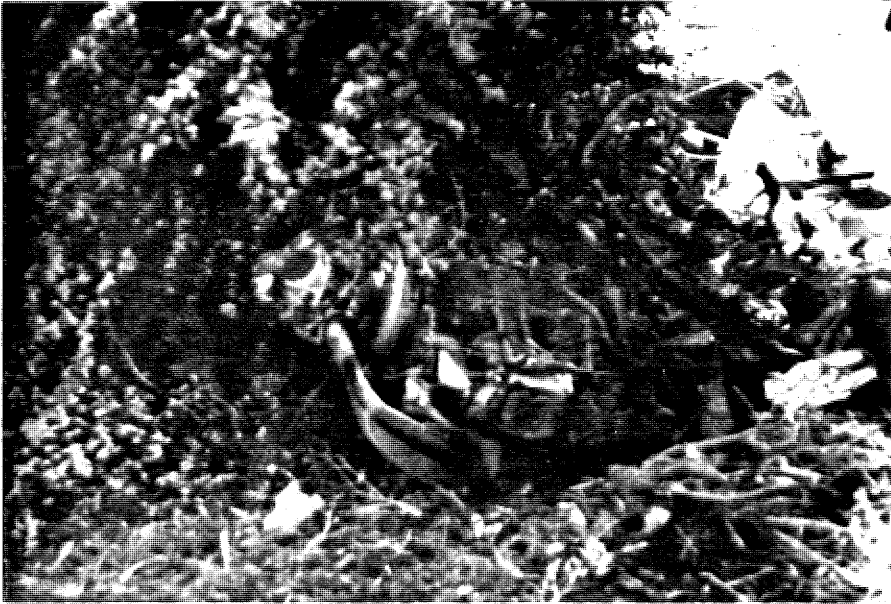
9

9. A view showing the engine and propeller.

The engine was taken to Hagelin Aircraft Motors in Long Beach, California, for a complete teardown. An inspection of all components of the engine failed to disclose any evidence of a prior failure. Although the aircraft was demolished at impact, inspection of the aircraft failed to disclose any evidence of a malfunction or prior failure.

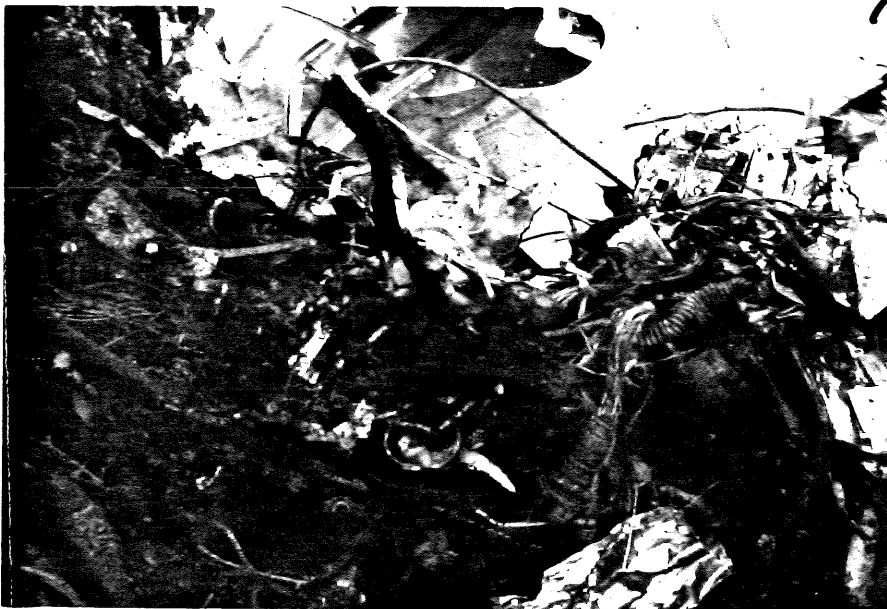
10

10. A close-up view of the throttle mixture control and the propeller control.

ITEM	REMARKS	ITEM	REMARKS
Mixture Control	Rich		
Throttle	Full forward		
RPM Control	Full forward		
Heat Control	Cold		
Ignition Switch	On both
